GCRE

## **Appendix D. Site Walkover**

**Client Name: Global Centre of  
Rail Excellence**
**Site: GCRE (Onllywyn Washery)**
**Project No.  
5209796**

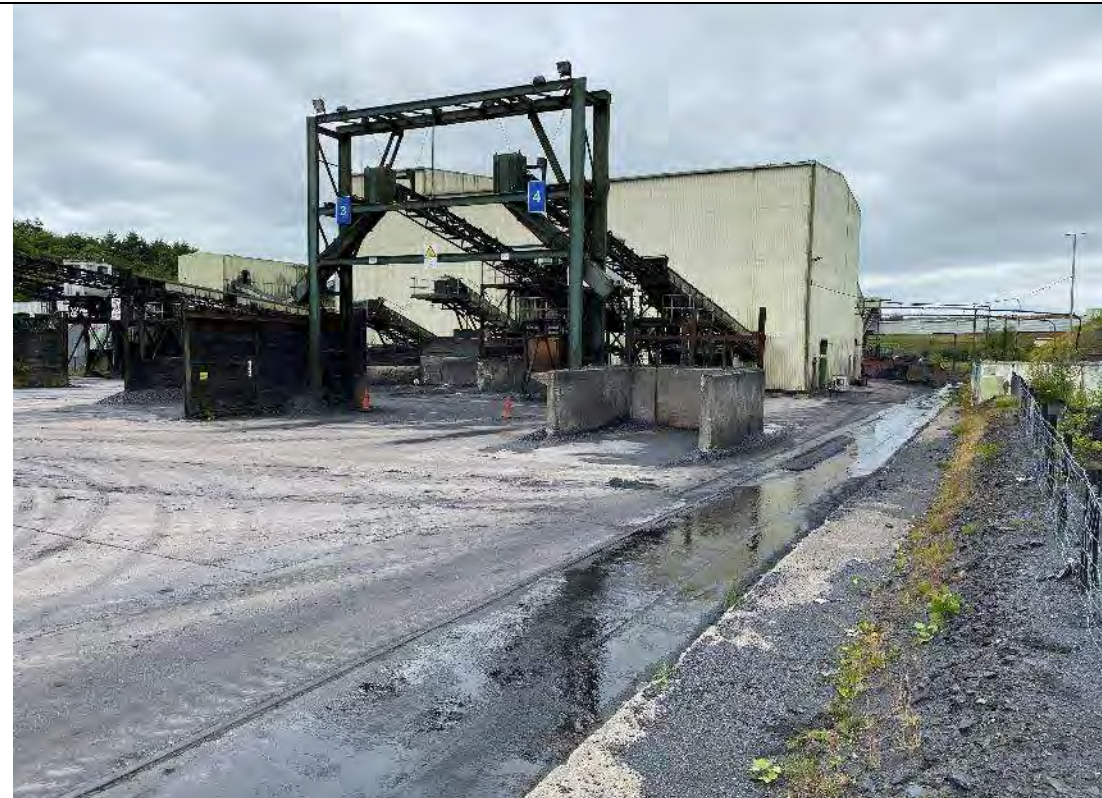
| <b>Photo No.</b><br>32 | <b>Date:</b><br>6 July 2022 | |

| <b>Washery (014)</b><br><br>View of washery structure (014), surface water running off to west on road in foreground. Empty shipping container to right labelled as having held "autowash".<br><br>The photograph aspect is west. | | |

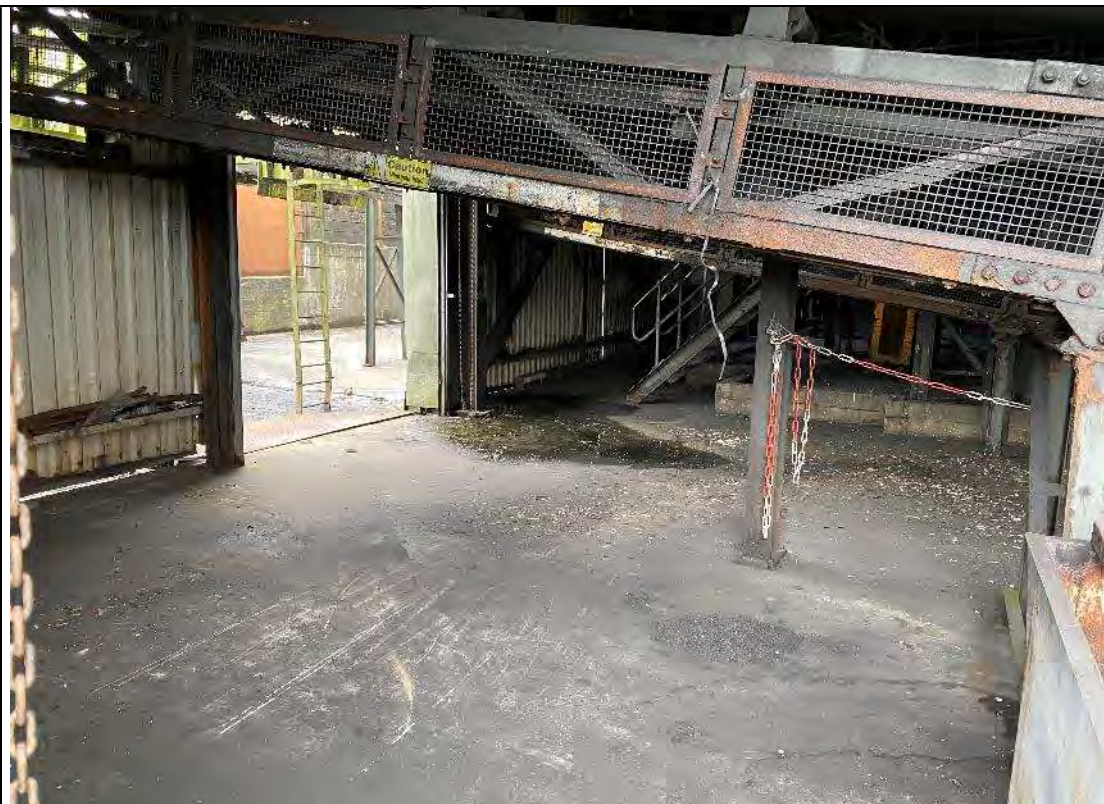
**Client Name: Global Centre of  
Rail Excellence**
**Site: GCRE (Onllywyn Washery)**
**Project No.  
5209796**
**Photo No.**  
33

**Washery Structure  
(014)**

View of interior of  
structure 014, no entry  
inside due to lone  
working restrictions.

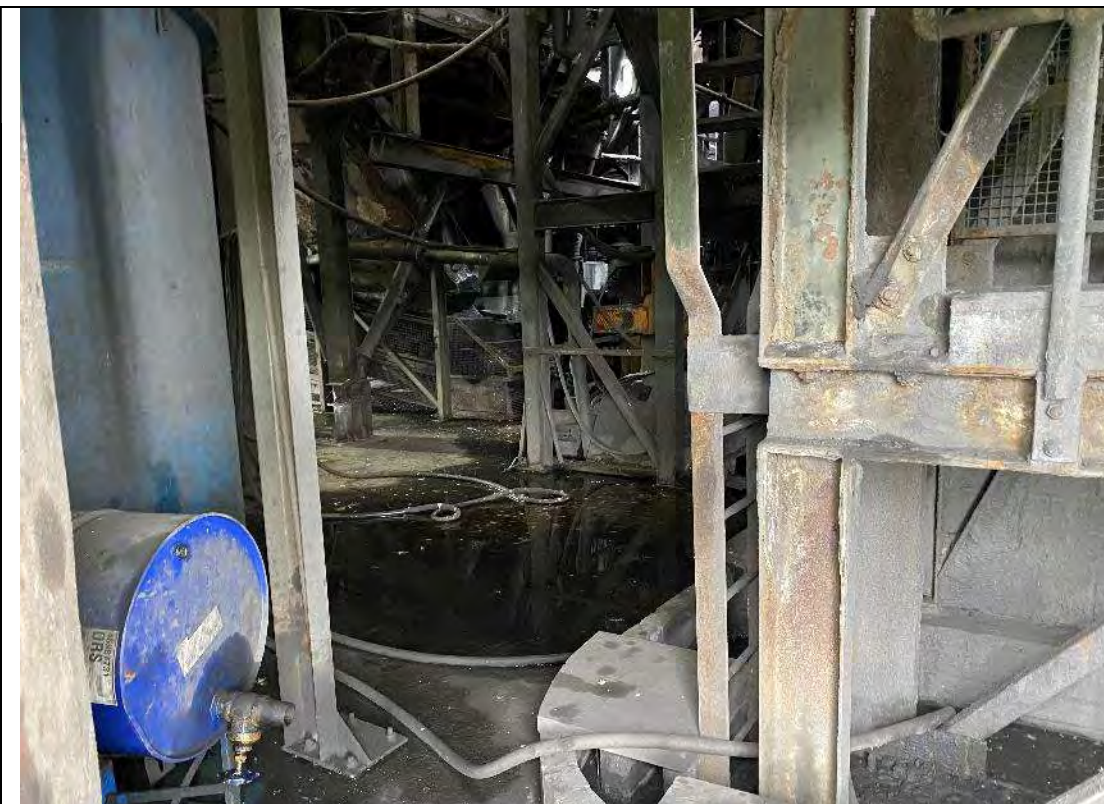
**Photo No.**  
34

**Washery Structure  
(014)**

View of interior of  
structure 014, no entry  
inside due to lone  
working restrictions.

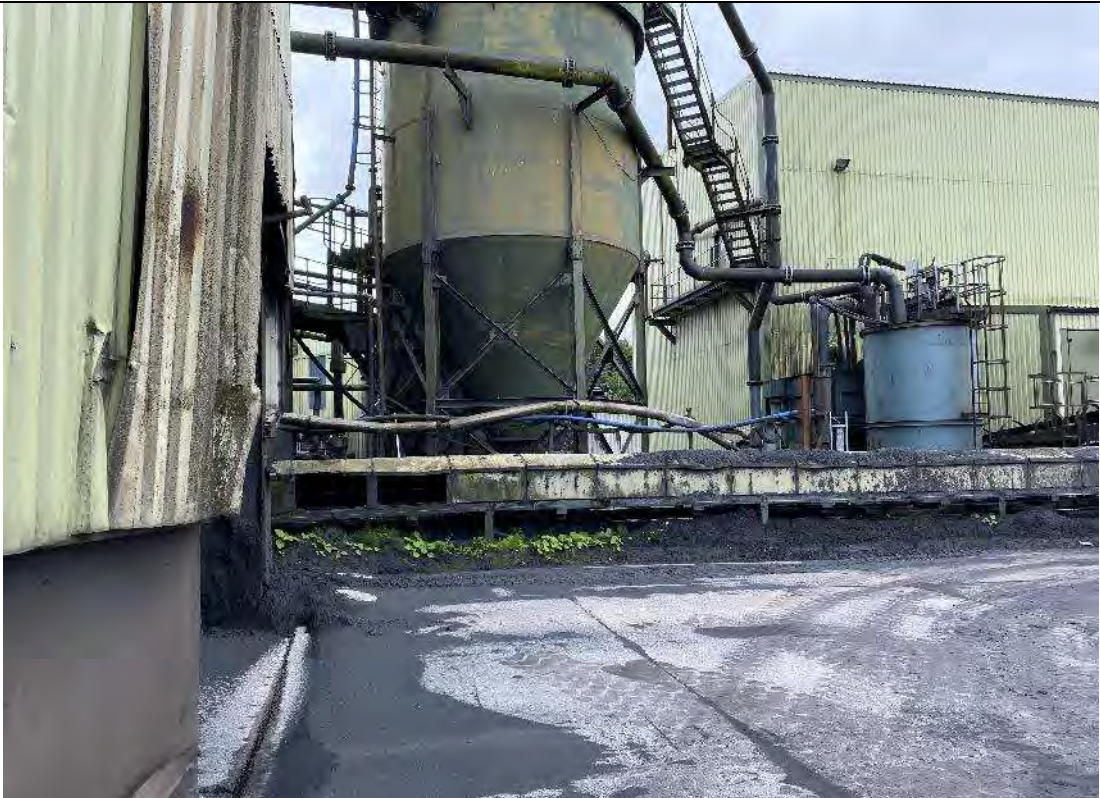
| <p><b>Photo No.</b><br/>35</p> | <p><b>Date:</b><br/>6 July 2022</p> | |

| <p><b>Washery Structure (018)</b></p> <p>View of AST tanks, believed to hold water.</p> <p>The photograph aspect is south.</p> | | |

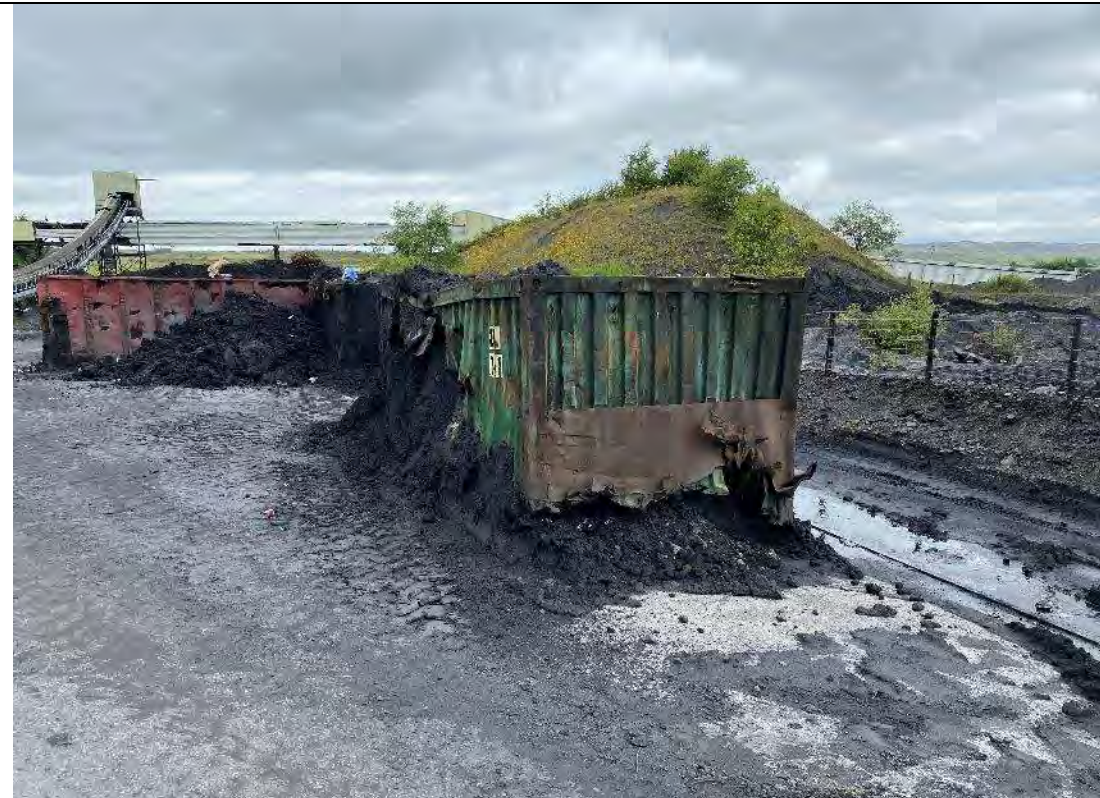
| <p><b>Photo No.</b><br/>36</p> | <p><b>Date:</b><br/>6 July 2022</p> | |

| <p><b>Washery Structure (019)</b></p> <p>View of skips / shipping containers holding waste coal.</p> <p>The photograph aspect is west.</p> | | |

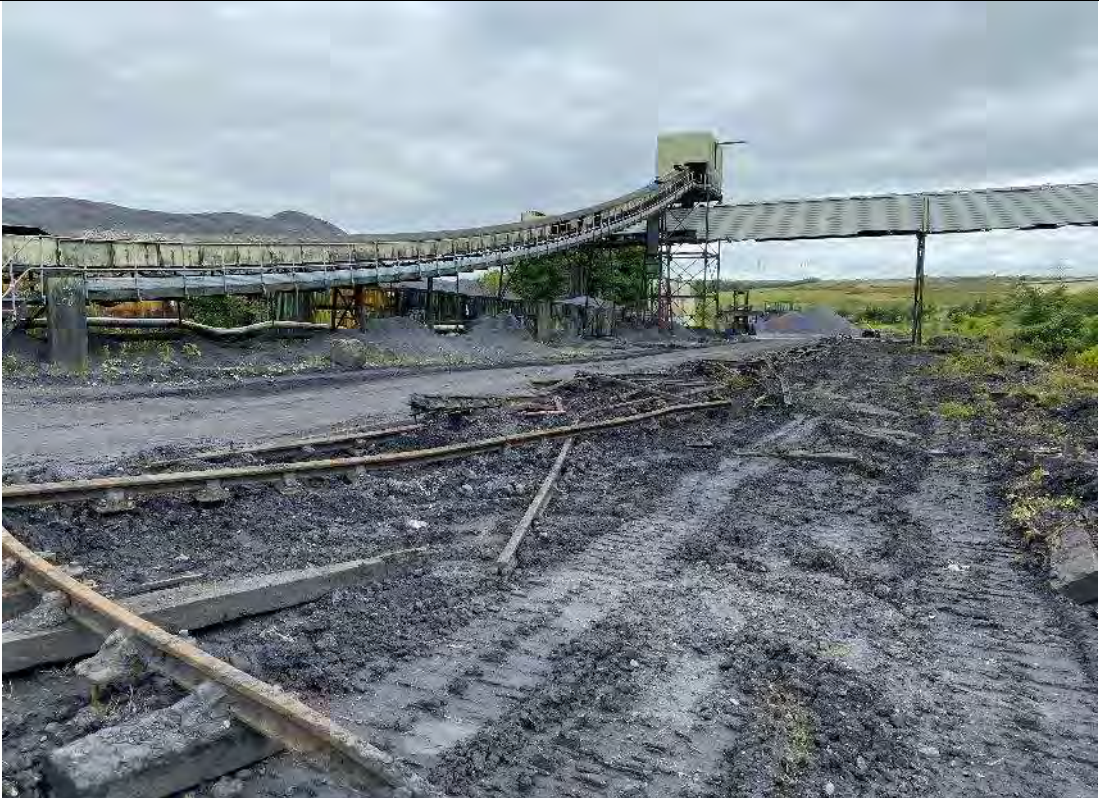
| <b>Conveyor Belt (020)<br/>and former railway line<br/>(021)</b><br><br>View of conveyor belt systems used to transfer washed coal to stockpiles / load trains.<br><br>Areas of former railway track in process of being grubbed up to right.<br><br>The photograph aspect is west. | | |

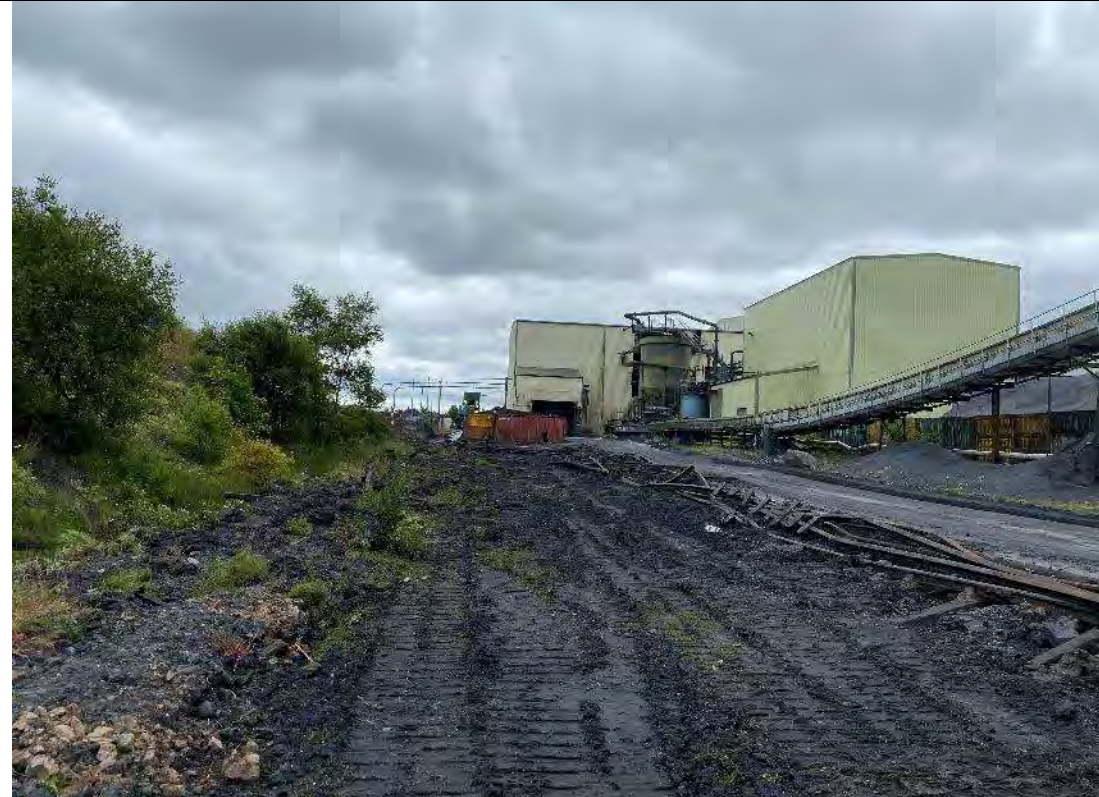
| <b>Photo No.</b><br>38 | <b>Date:</b><br>6 July 2022 | |

| <b>Washery (014)</b><br><br>View of washery building conveyor belt (020) and former area of railway track (021). Stockpile of unknown material to left.<br><br>The photograph aspect is east. | | |

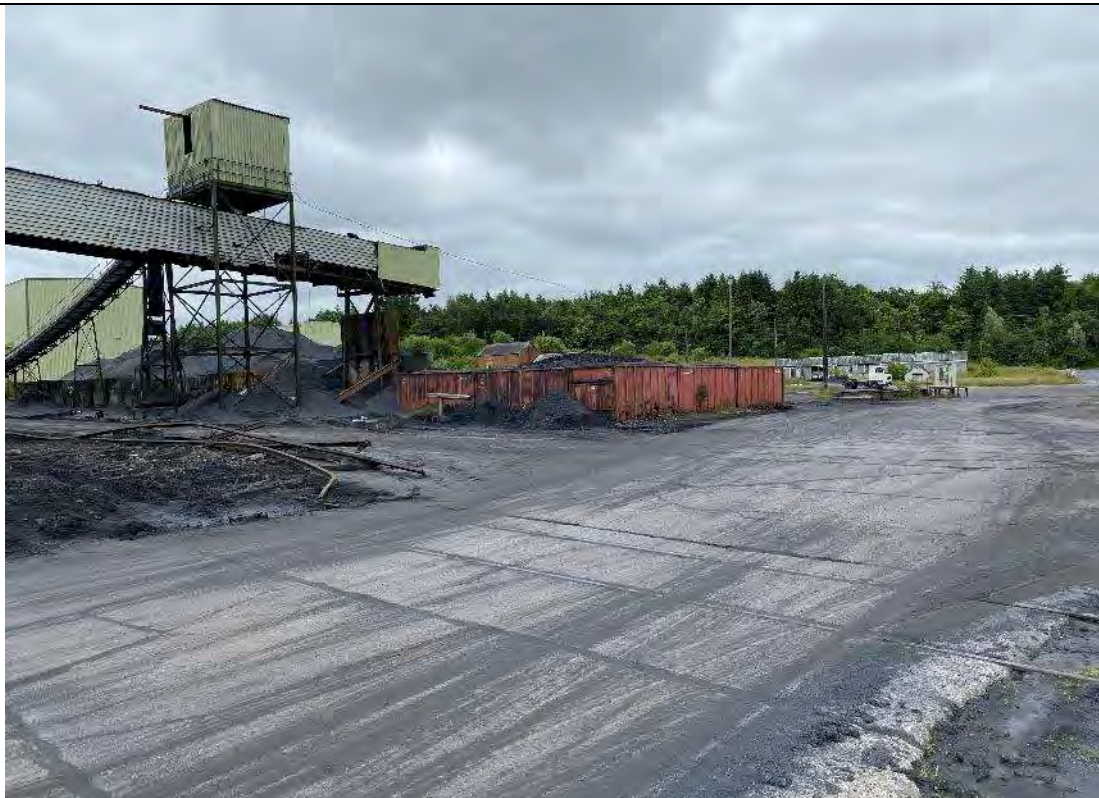
| <b>Photo No.</b><br>39 | <b>Date:</b><br>6 July 2022 | |

| <b>Washery Structures</b><br><br>View of conveyor belt from building 014 connecting with additional conveyor. Railway tracks (021) crossing concrete road way in foreground.<br><br>The photograph aspect is east. | | |

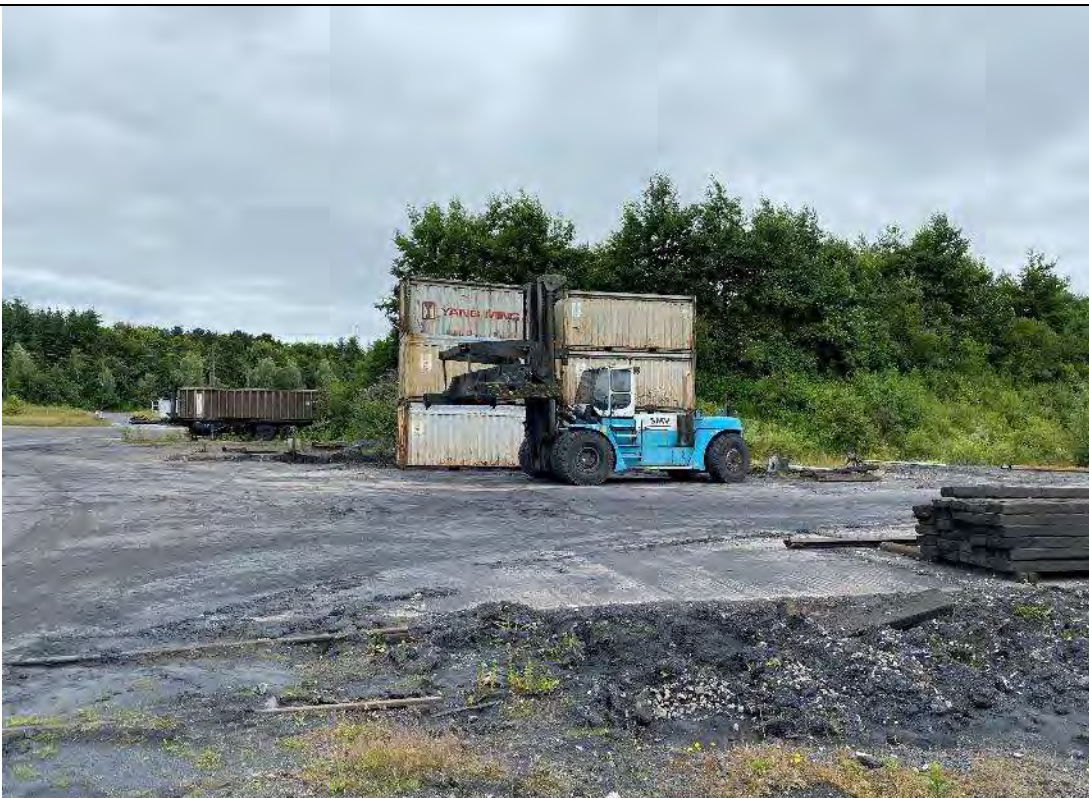
| <b>Photo No.</b><br>40 | <b>Date:</b><br>6 July 2022 | |

| <b>Washery Area (023)</b><br><br>View of unknown stockpile (023) and shipping container storage. Railway land in foreground.<br><br>The photograph aspect is south. | | |

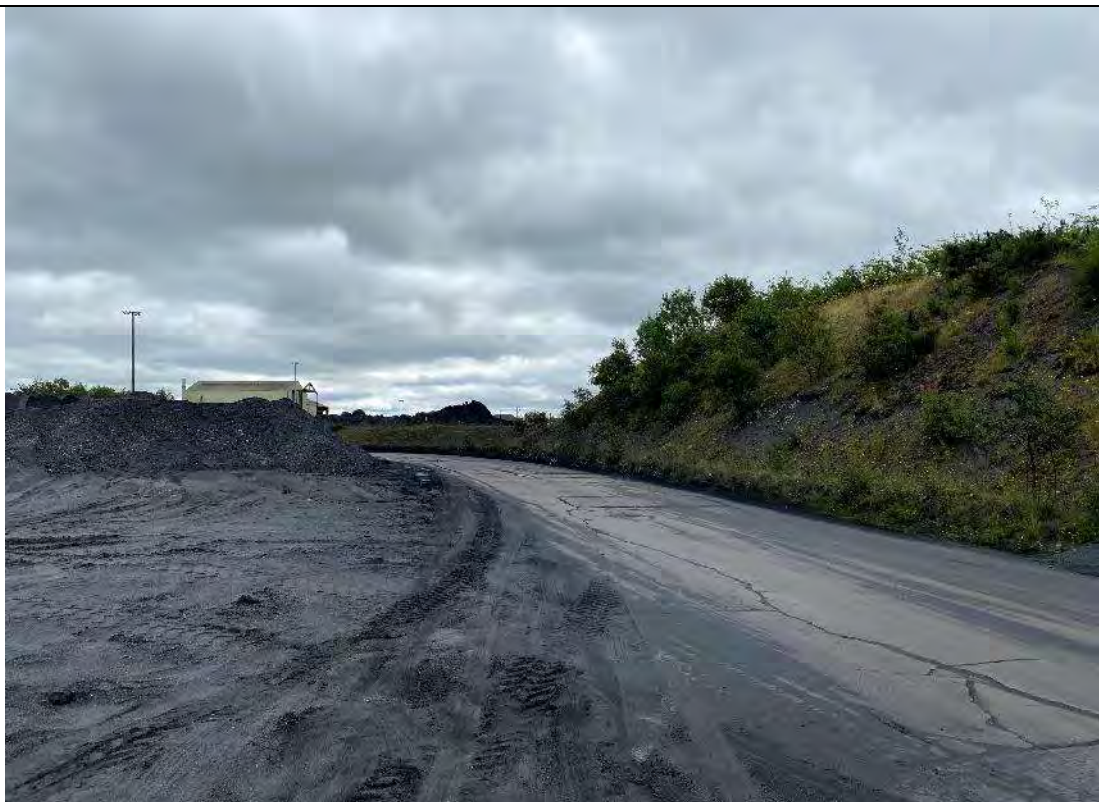
| <b>Photo No.</b><br>41 | <b>Date:</b><br>6 July 2022 | |

| <b>Stockpiles (022)</b><br><br>View of stockpile /<br>colliery spoil separating<br>Washery Structures from<br>stockpile area served by<br>conveyor belts.<br><br>The photograph aspect<br>is east. | | |

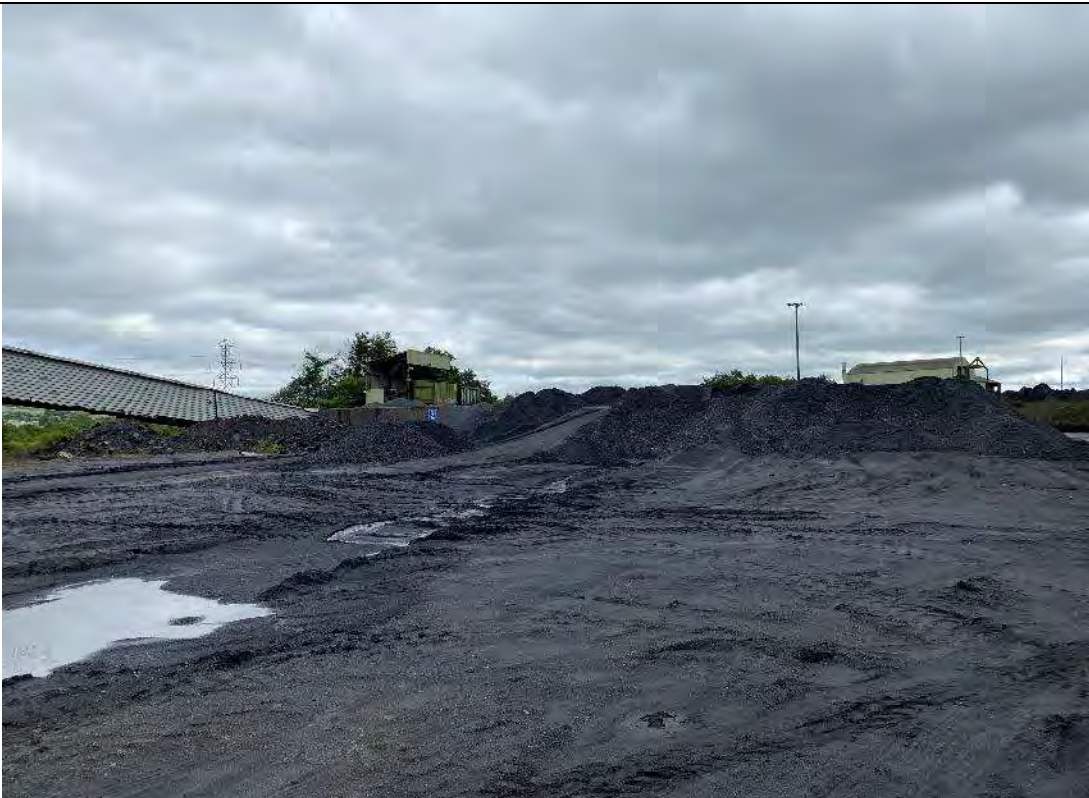
| <b>Photo No.</b><br>42 | <b>Date:</b><br>6 July 2022 | |

| <b>Stockpiles (022)</b><br><br>View of coal stockpile adjacent to base of conveyor belt.<br><br>The photograph aspect is north-east. | | |

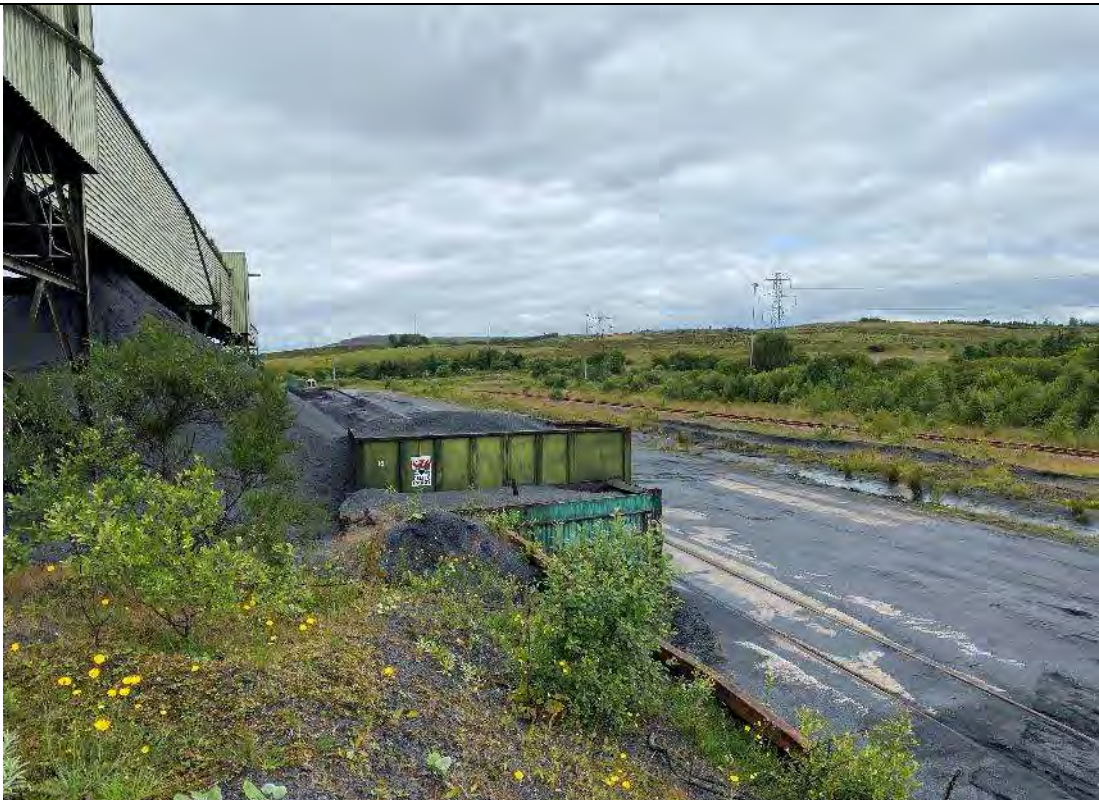
| <b>Railway Land (024)</b><br><br>View of the northern portion of Washery site with Nant Helen in the background. Railway tracks and railway land present.<br><br>Land falls at 1:1, exposed soils appear to be made ground of colliery spoil.<br><br>The photograph aspect is north-west. | | |

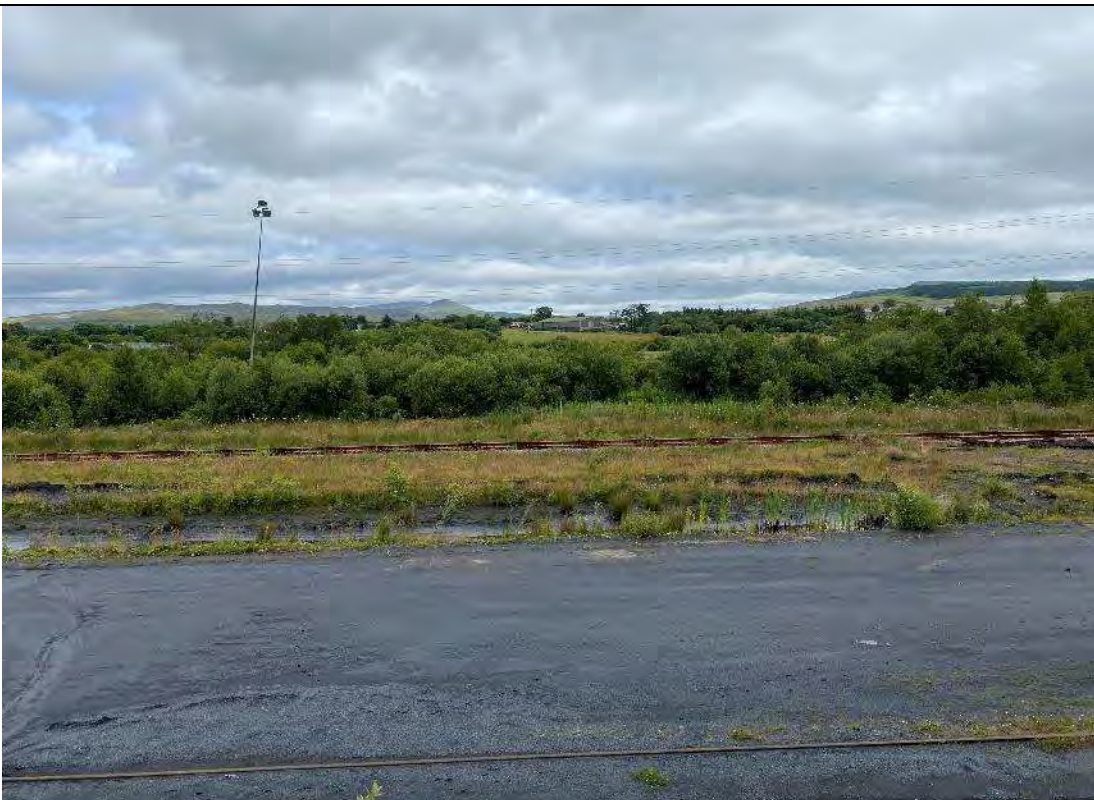
| <b>Photo No.</b><br>44 | <b>Date:</b><br>6 July 2022 | |

| <b>Retaining wall (025)</b><br><br>View of the northern portion of Washery site. Railway tracks and railway land present.<br><br>The photograph aspect is north. | | |

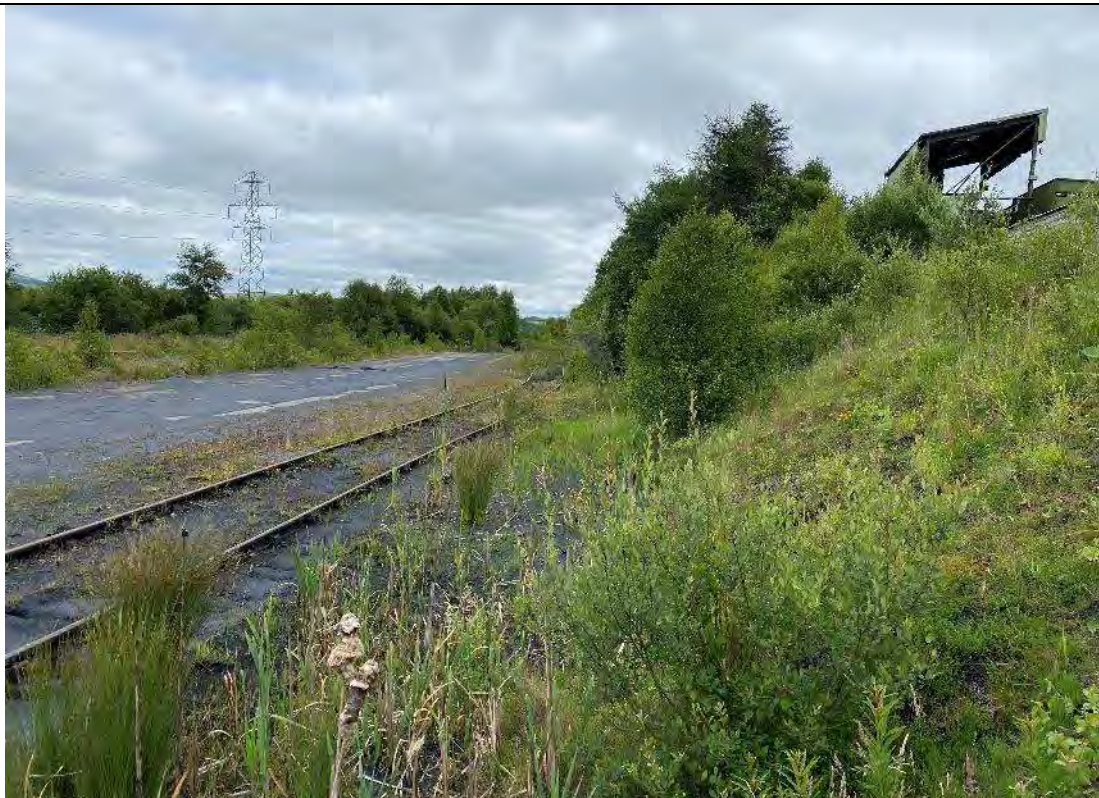
| <b>Photo No.</b><br>45 | <b>Date:</b><br>6 July 2022 | |

| <b>Retaining wall (025)</b><br><br>View of the northern portion of Washery site. Railway tracks and railway land present.<br><br>The photograph aspect is north-east. | | |

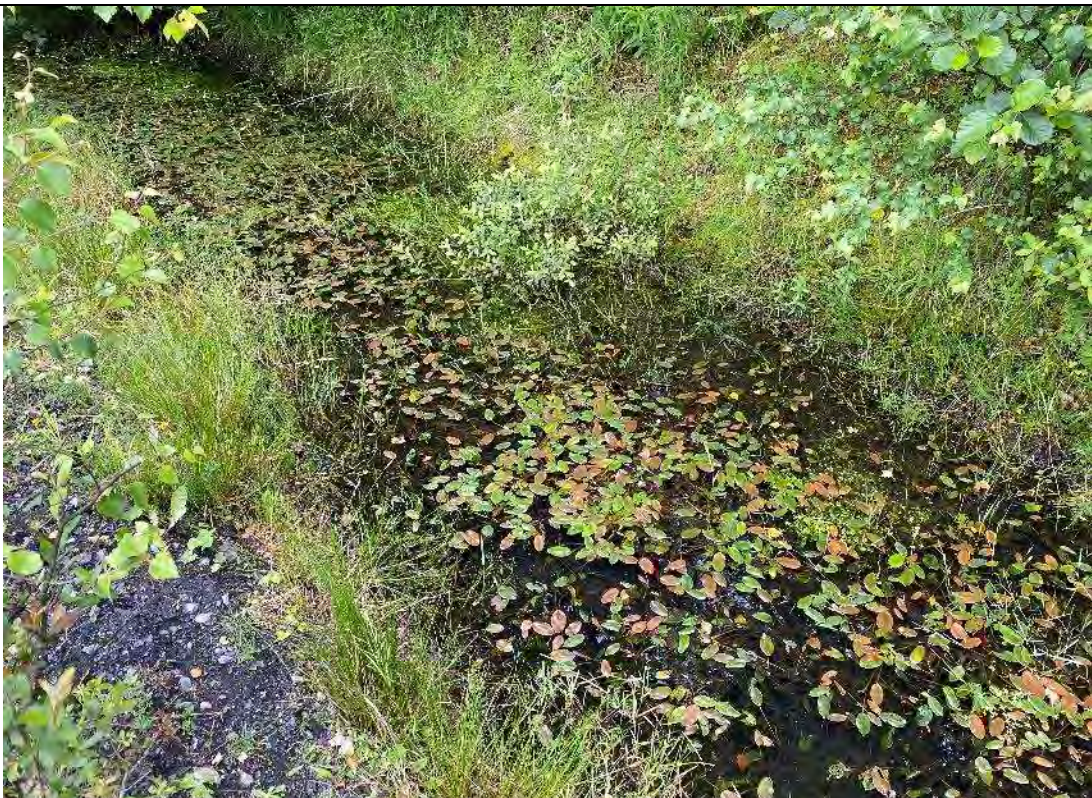
| <b>Photo No.</b><br>46 | <b>Date:</b><br>6 July 2022 | |

| <b>Drain at base of slope<br/>in area of railway land.</b><br><br>The photograph aspect<br>is east. | | |

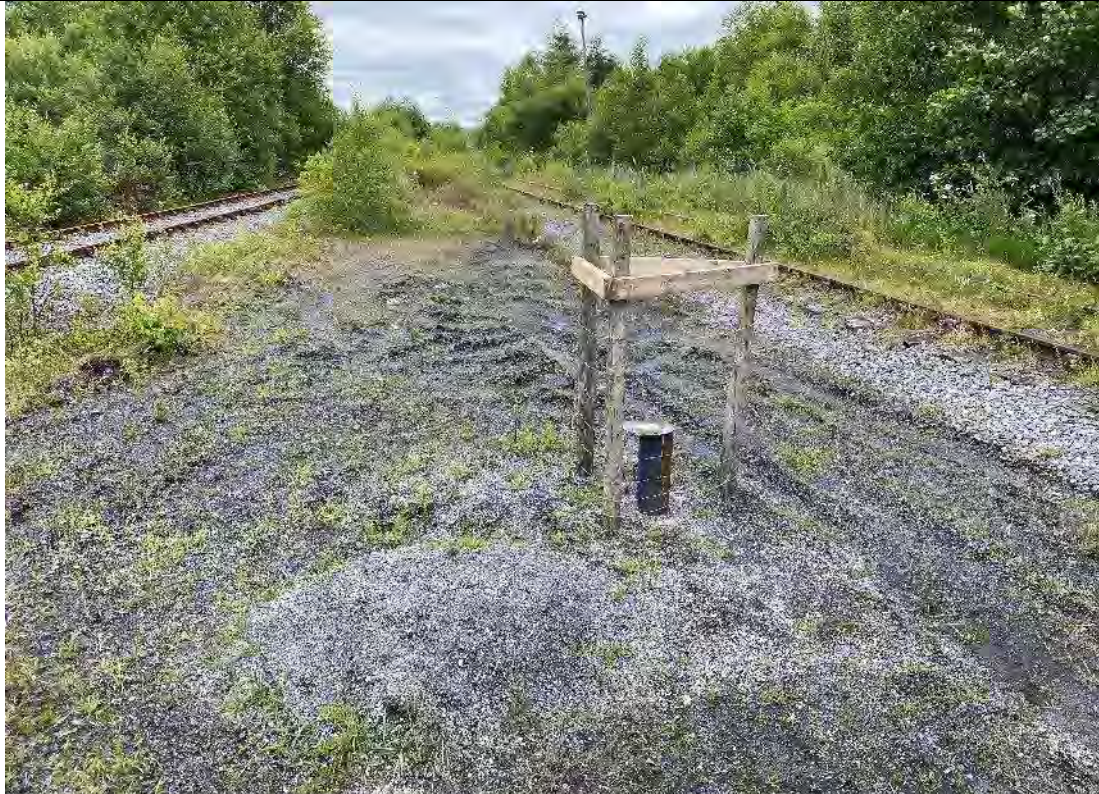
| <b>Photo No.</b><br>47 | <b>Date:</b><br>6 July 2022 | |

| <b>Railway Land (023)</b><br><br>View of railway sidings, two tracks currently present, with relict evidence of two unused tracks.<br><br>Ballast appears clean and made of BOS slag.<br><br>Monitoring well BH29R from Arup GI.<br><br>The photograph aspect is east. | | |

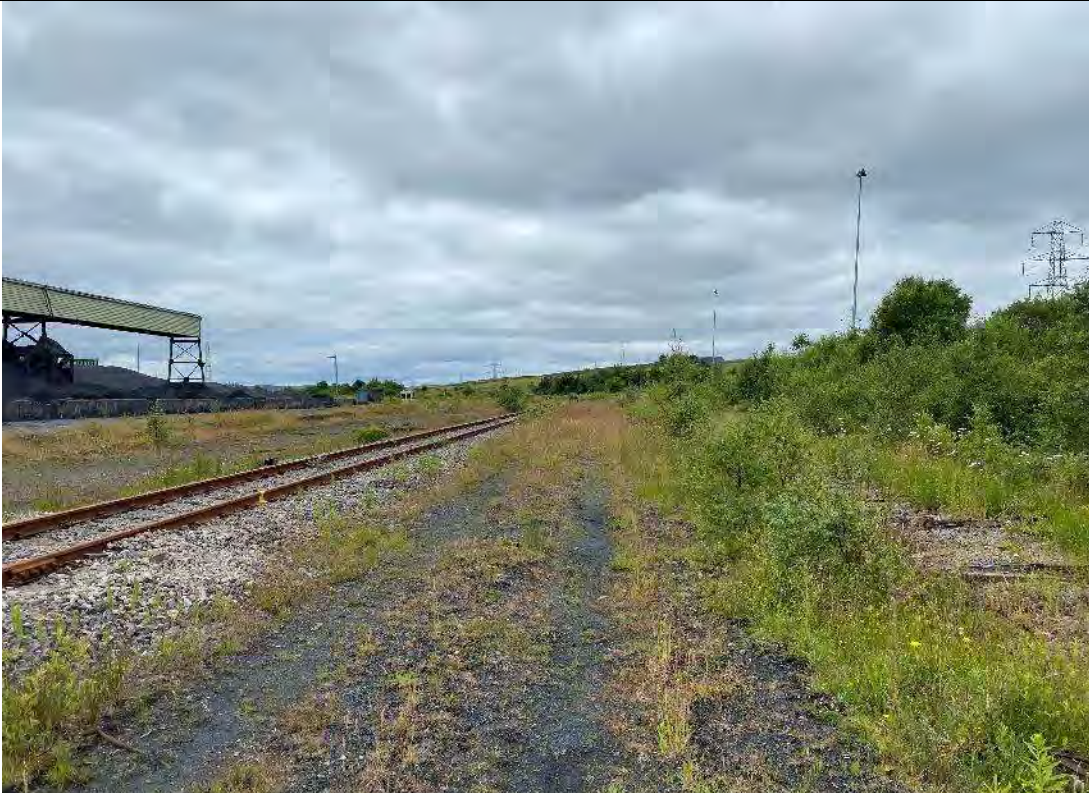
| <b>Photo No.</b><br>48 | <b>Date:</b><br>6 July 2022 | |

| <b>Railway Land (023)</b><br><br>View of railway sidings, two tracks currently present, with relict evidence of two unused tracks.<br><br>The photograph aspect is west. | | |

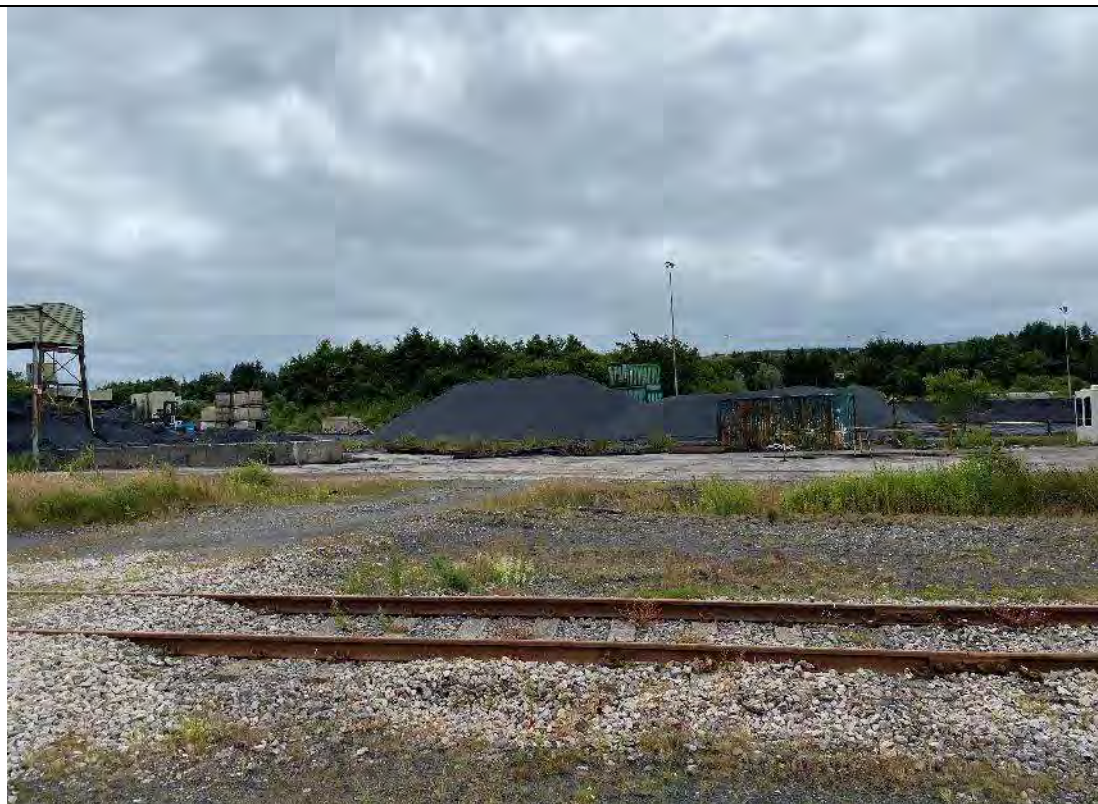
**Client Name: Global Centre of  
Rail Excellence**
**Site: GCRE (Onllywyn Washery)**
**Project No.  
5209796**
**Photo No.**  
49

**Stockpile (023)**

View south across  
washery from railway  
land.

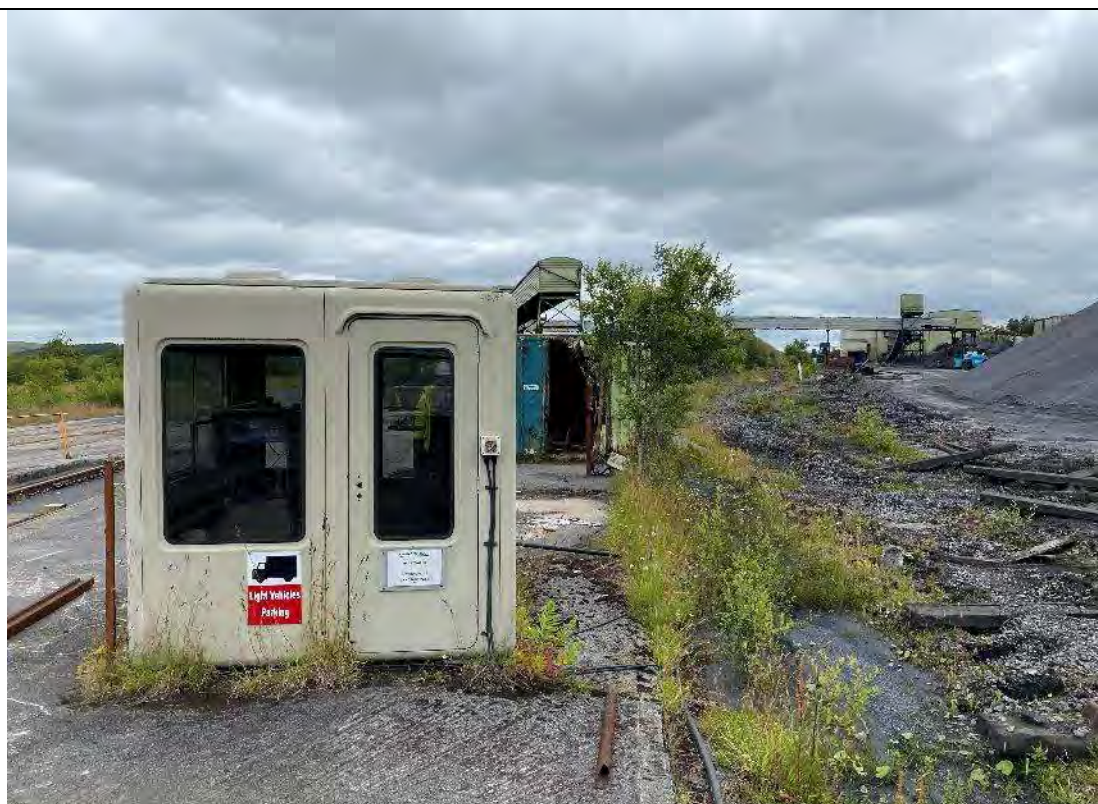
**Photo No.**  
50

**Electricity substation /  
control room on  
railway land (024)**

View of prefabricated  
cabin holding electrical  
equipment.

Former railway tracks to  
right running up to  
building 014.

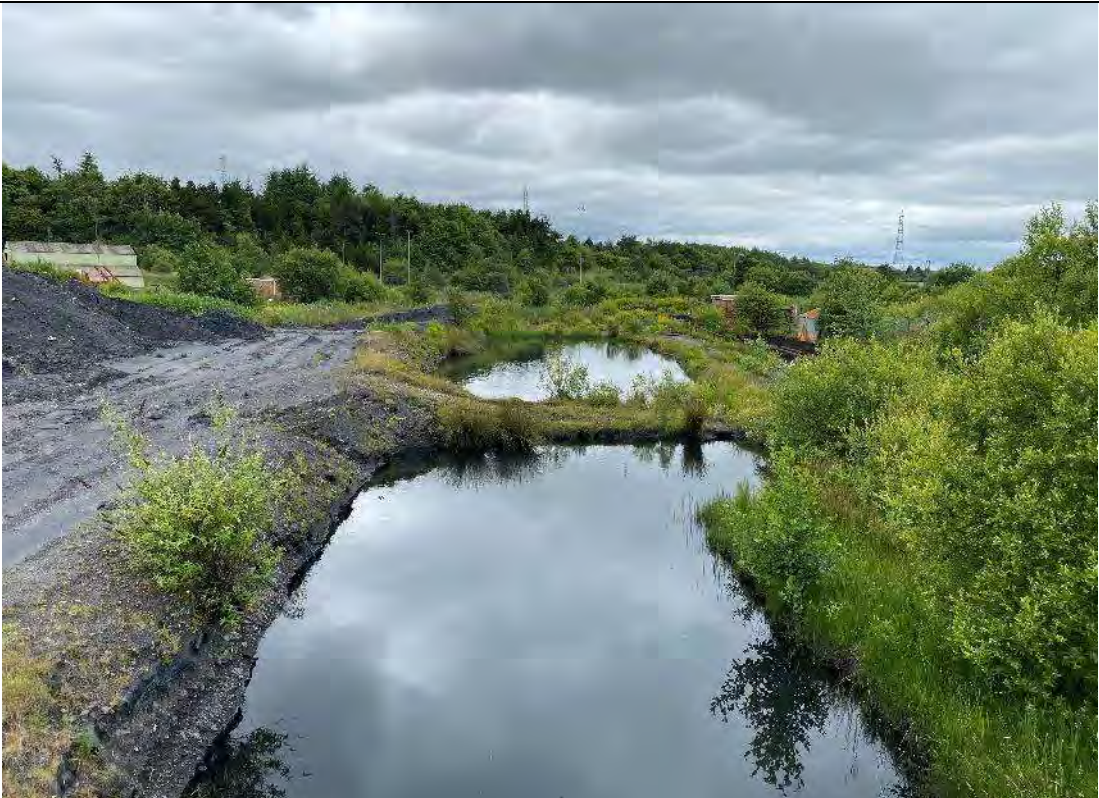
| <b>Photo No.</b><br>51 | <b>Date:</b><br>6 July 2022 | |

| <b>Lagoons (025)</b><br><br>View of lagoons in north of site.<br><br>The photograph aspect is south-west. | | |

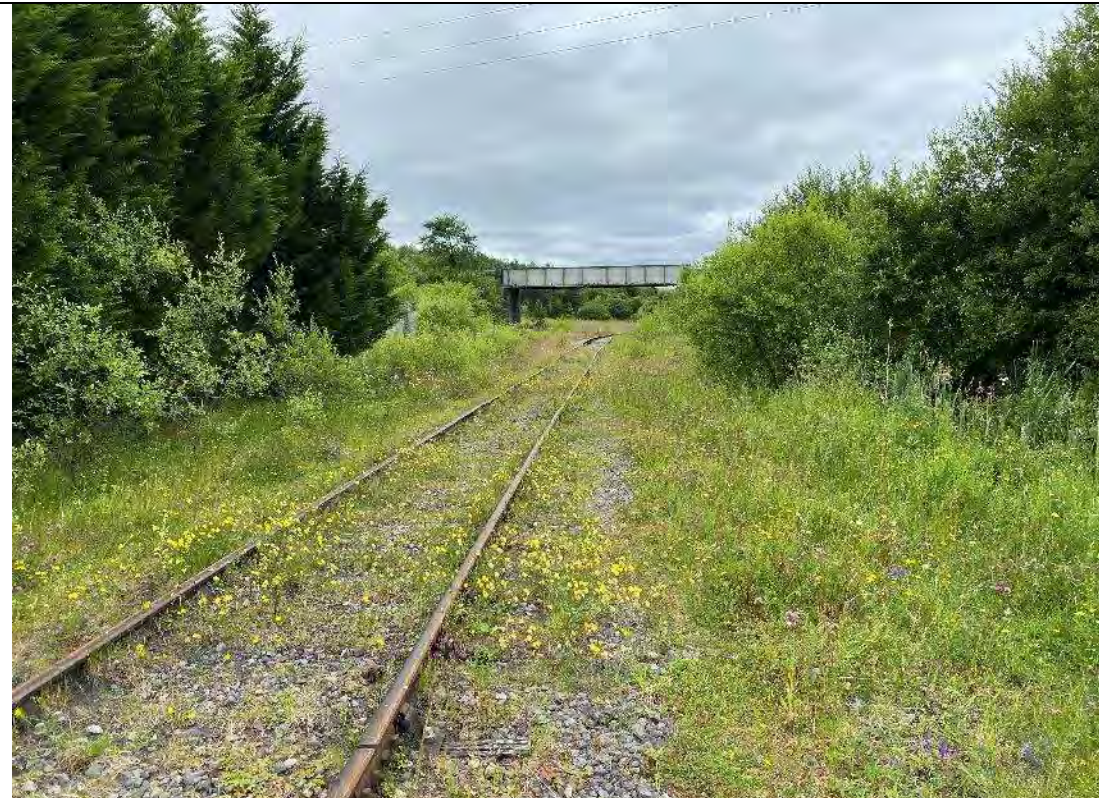
| <b>Photo No.</b><br>52 | <b>Date:</b><br>6 July 2022 | |

| <b>Railway Land (023)</b><br><br>View of railway land and off-site bridge crossing it used to access Washery from the north.<br>Light staining on ballast.<br><br>The photograph aspect is west. | | |

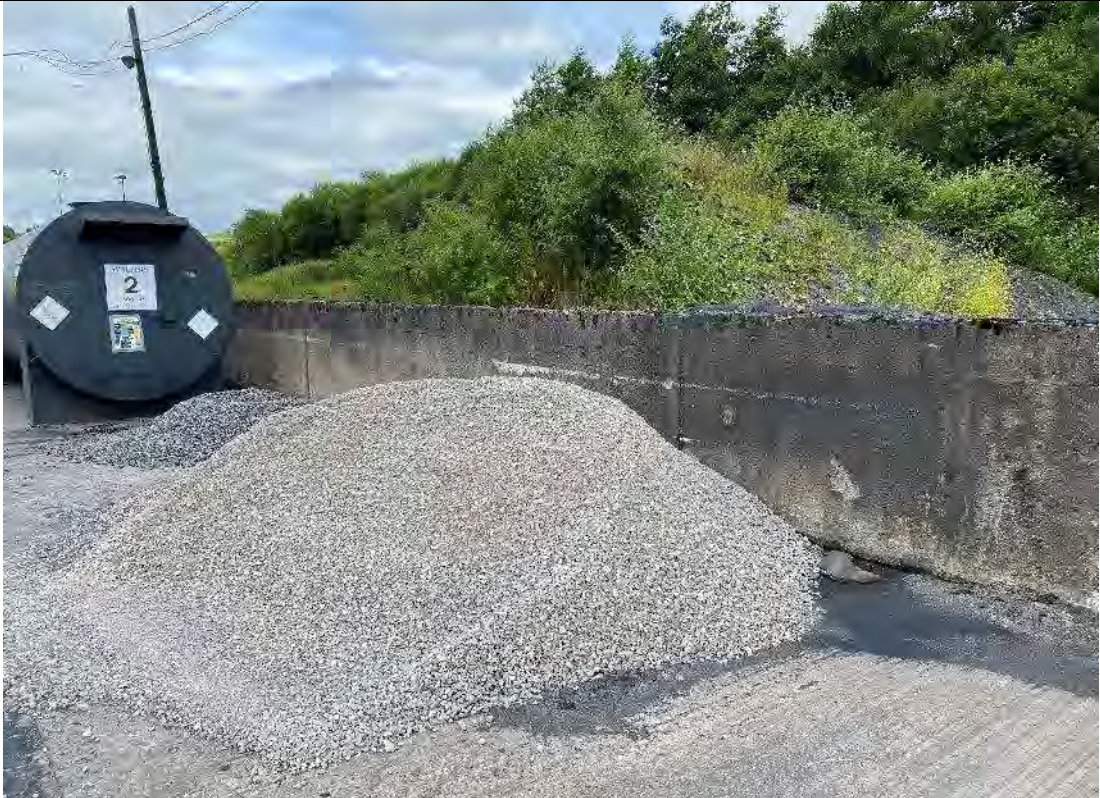
| <b>Photo No.</b><br>55 | <b>Date:</b><br>6 July 2022 | |

| <b>Loading Bays (026)</b><br><br>View of loading bay and stockpiled gravel and empty AST beyond.<br><br>The photograph aspect is west. | | |

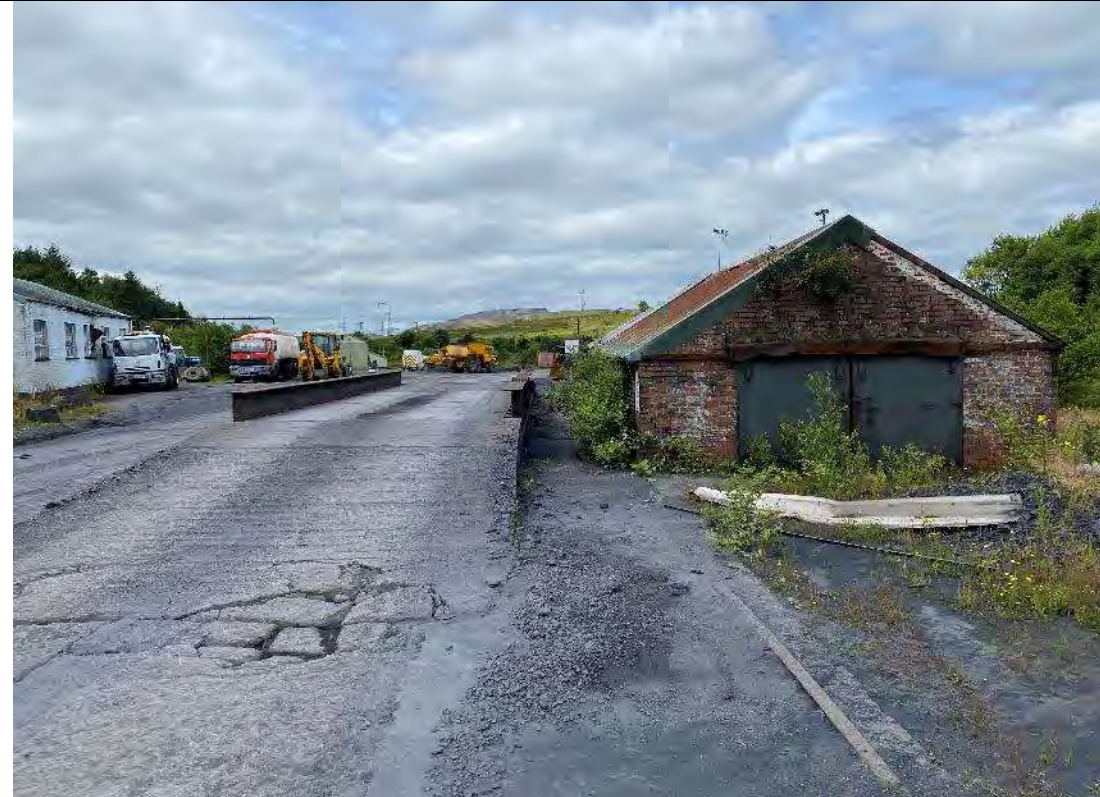
| <b>Photo No.</b><br>56 | <b>Date:</b><br>6 July 2022 | |

| <b>Plant Parking (027)</b><br><br>View of area used for plant parking, former weighbridge and building of unknown use to right.<br><br>The photograph aspect is west. | | |

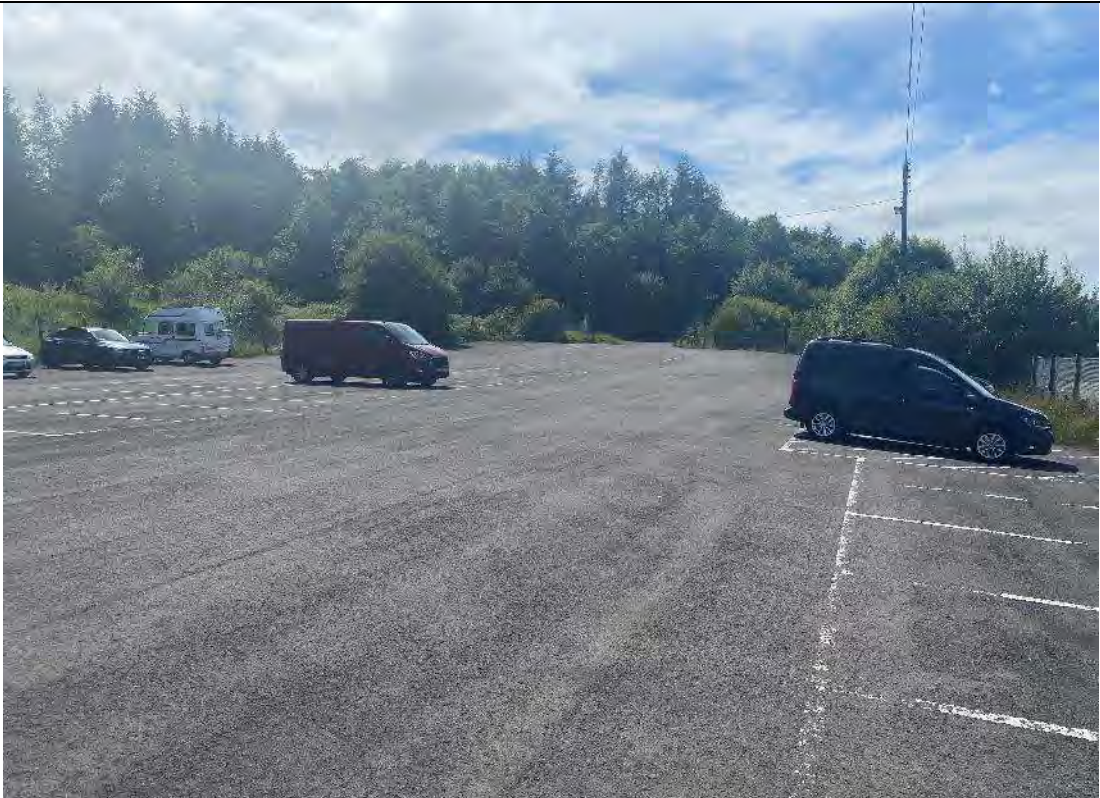
| <b>Photo No.</b><br>57 | <b>Date:</b><br>6 July 2022 | |

| <b>Washery Car Parking (028)</b><br><br>View of staff/visitors car park in Washery.<br><br>The photograph aspect is west. | | |
