GCRE

## **Appendix D. Site Walkover**

**Client Name: Global Centre of  
Rail Excellence**
**Site: GCRE (Onllywyn Washery)**
**Project No.  
5209796**

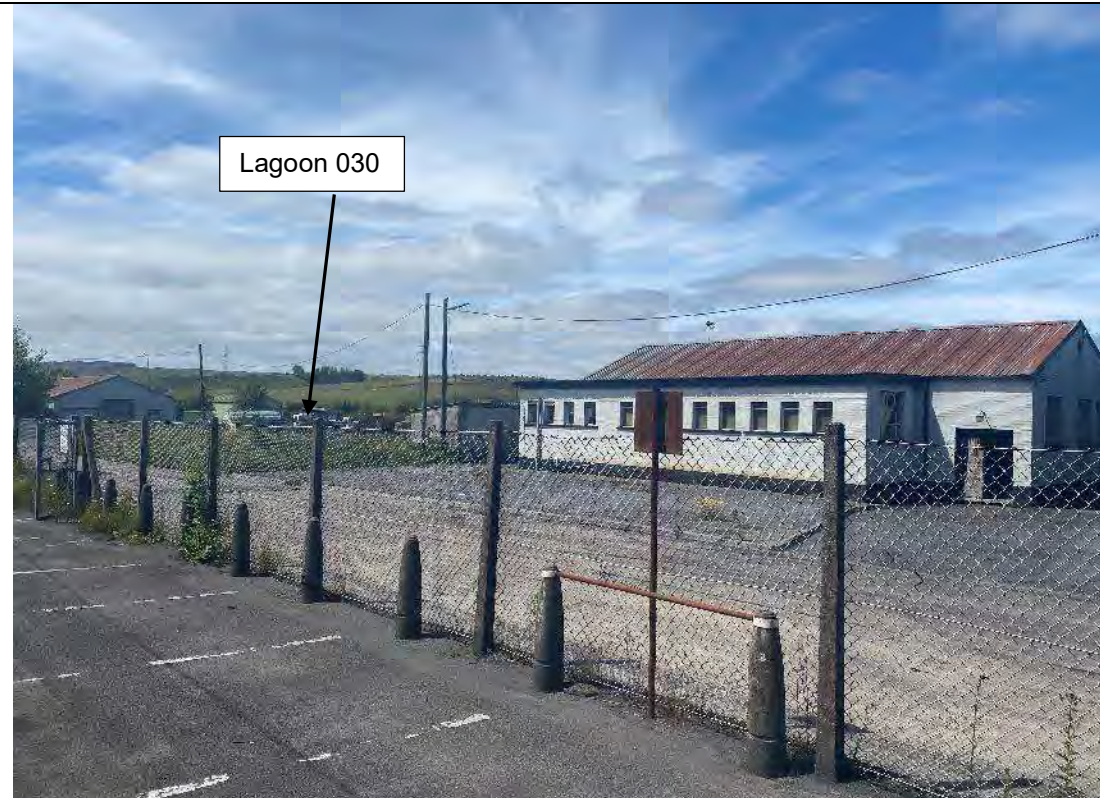
| <b>Photo No.</b><br>58 | <b>Date:</b><br>6 July 2022 | |

| <b>Welfare building (029)</b><br><br>View of bath house / boiler room from former colliery use. Lagoon (030) to left.<br><br>Asphalt and concrete lightly cracked and stained in places.<br><br>The photograph aspect is north-west. | | |

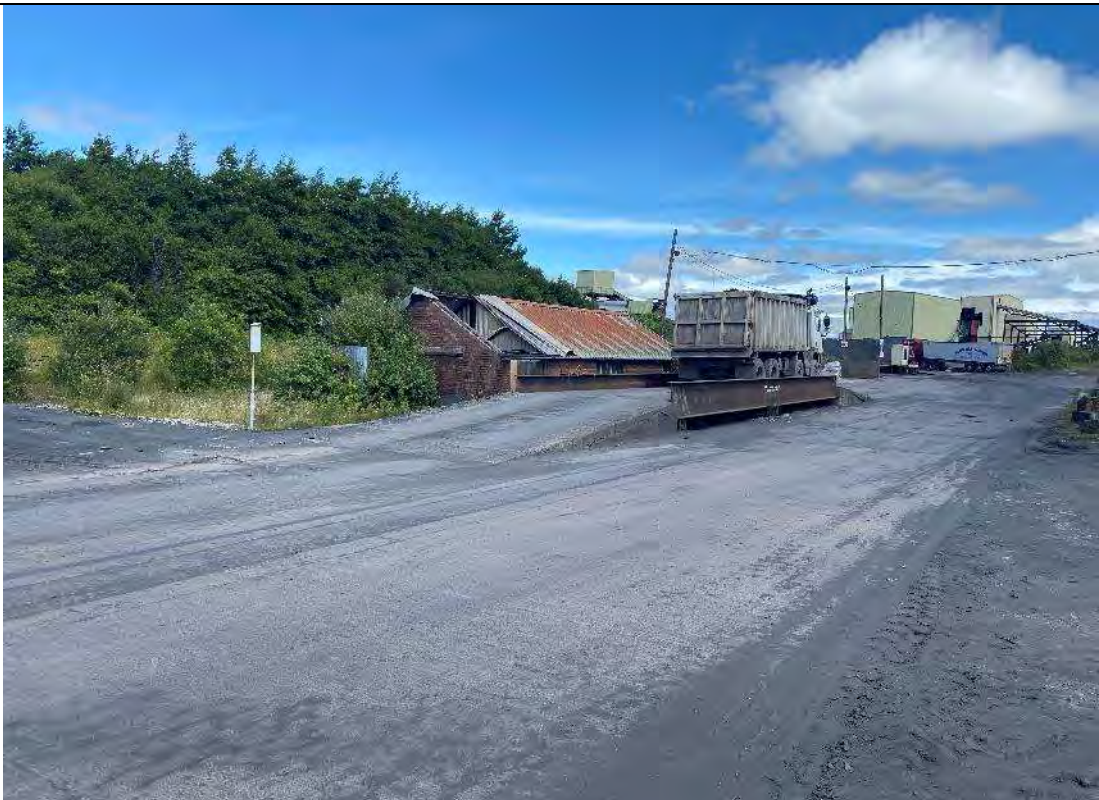
| <b>Photo No.</b><br>61 | <b>Date:</b><br>6 July 2022 | |

| <b>Plant Parking area<br/>(027)</b><br><br>View of the site boundary fence and the reduction in ground level in the adjacent Tesco delivery yard.<br><br>The photograph aspect is east-north-east. | | |

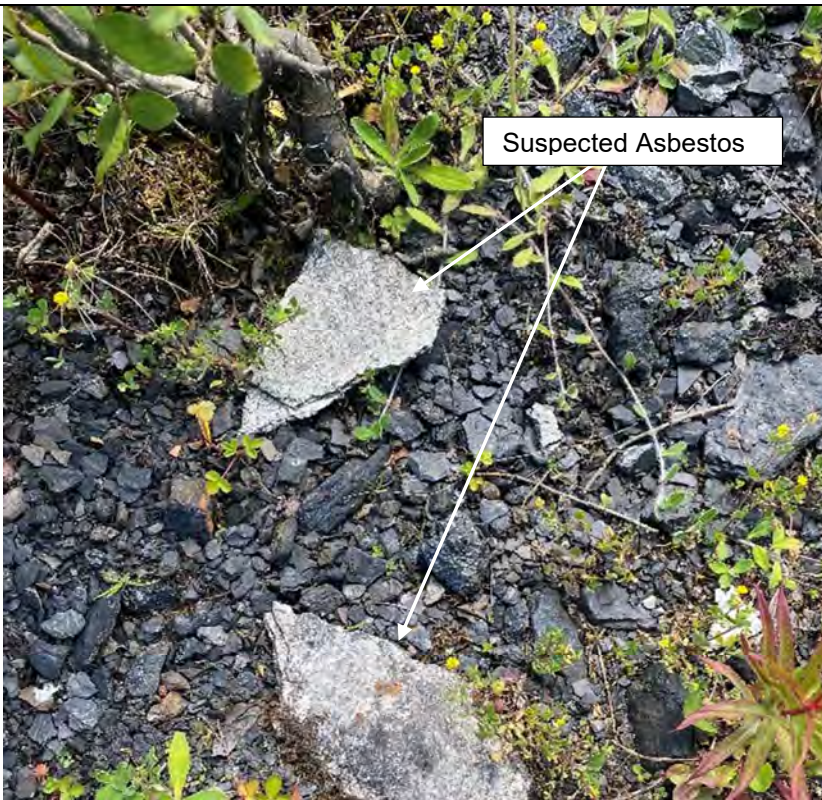
| <b>Photo No.</b><br>62 | <b>Date:</b><br>6 July 2022 | |

| <b>Suspected Asbestos<br/>Containing Material<br/>(033)</b><br><br>Fragments of cement with visible fibres observed on surface of land to north of Plant Parking (027) and south of lagoon (025). Suspected chrysotile asbestos. | | |

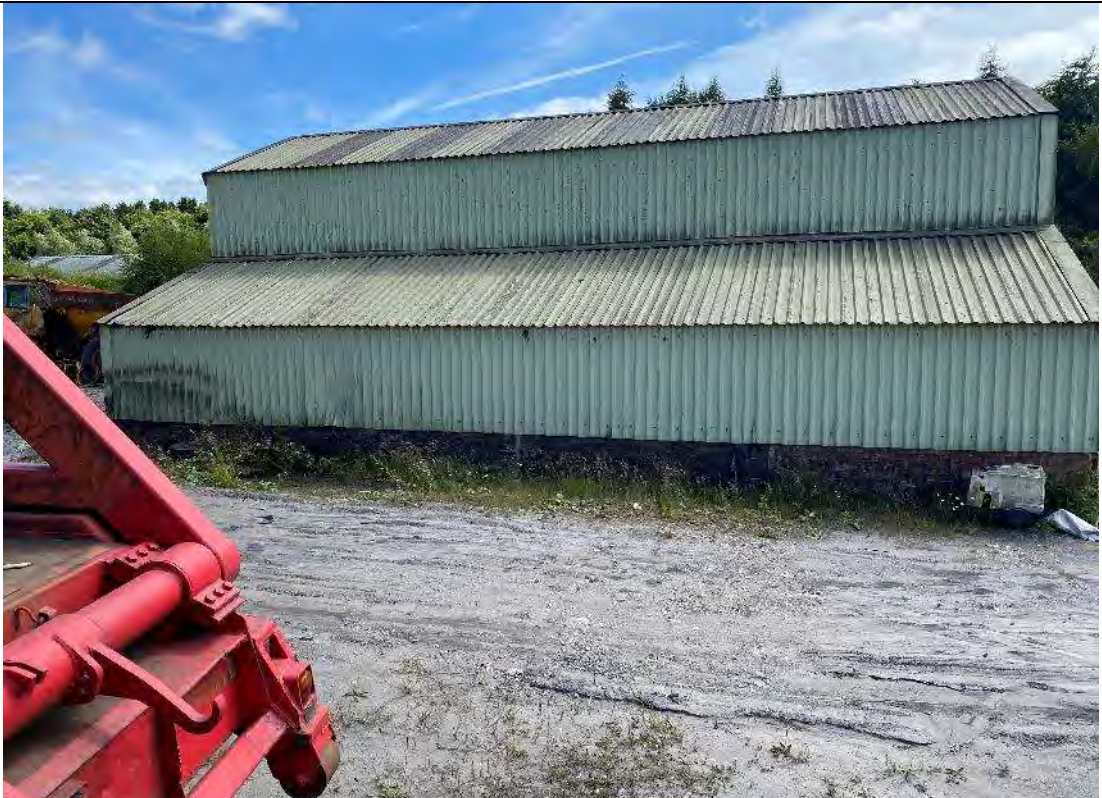
| <b>Photo No.</b><br>63 | <b>Date:</b><br>6 July 2022 | |

| <b>Vehicle Repair Garage (034)</b><br><br>View of vehicle repair garage, building locked. Yard area used for parking plant and scrapyard (035) of vehicle parts.<br><br>The photograph aspect is south. | | |

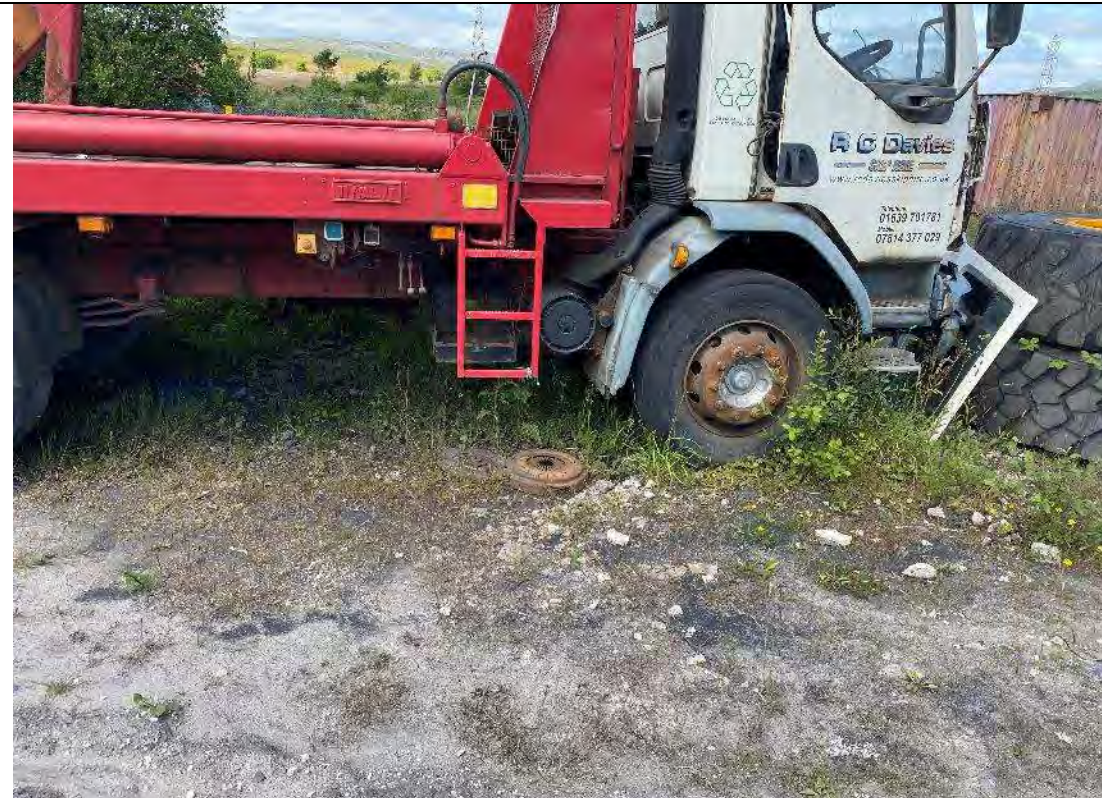
| <b>Photo No.</b><br>64 | <b>Date:</b><br>6 July 2022 | |

| <b>Scrapyard (035)</b><br><br>View of abandoned skip lorry, tyres etc.<br><br>The photograph aspect is north. | | |

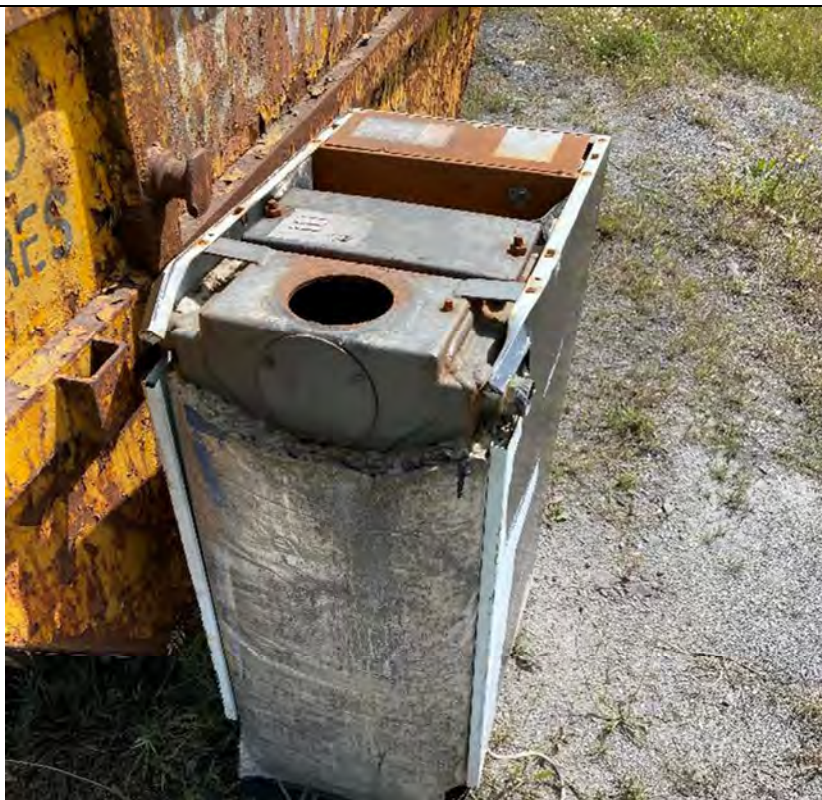
| <b>Photo No.</b><br>65 | <b>Date:</b><br>6 July 2022 | |

| <b>Scrapyard (035)</b><br><br>View of waste skips and boiler. Boiler contains fibrous white insulation (suspected ACM). | | |

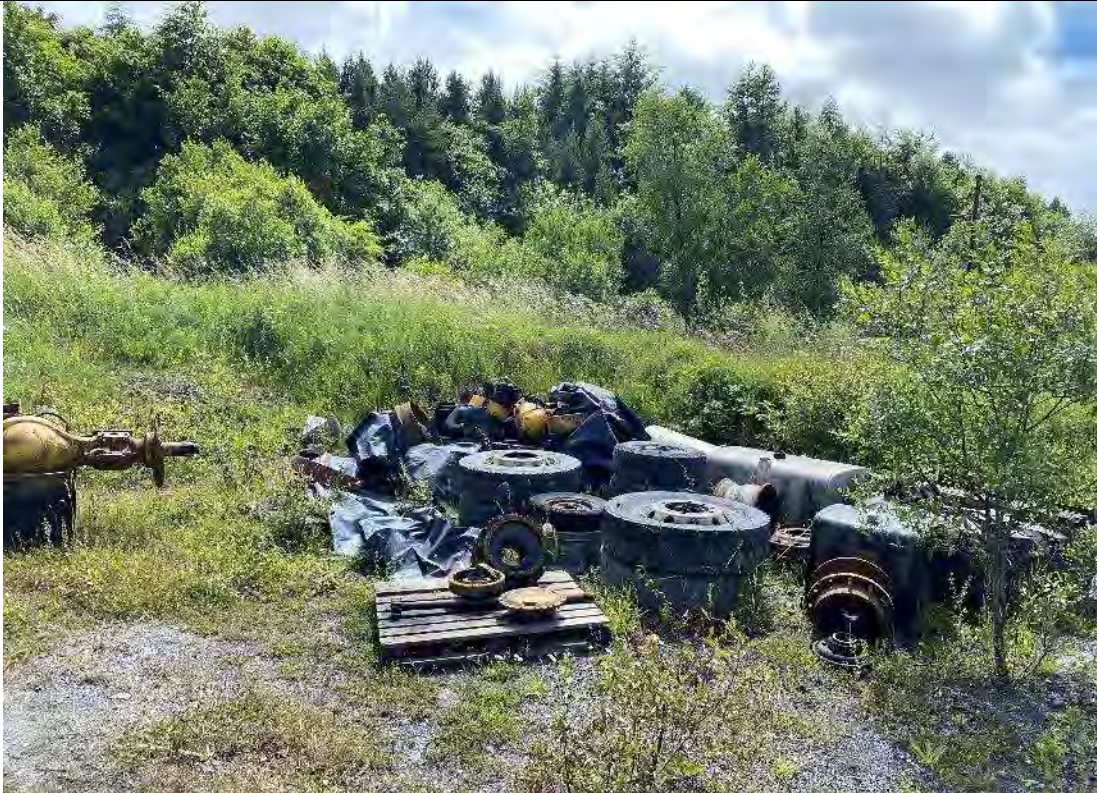
| <b>Photo No.</b><br>66 | <b>Date:</b><br>6 July 2022 | |

| <b>Scrapyard (035)</b><br><br>View of scrapyard area, holds wheels, tyres, vehicle parts, bund of made ground (C&D material).<br><br>The photograph aspect is south-west. | | |

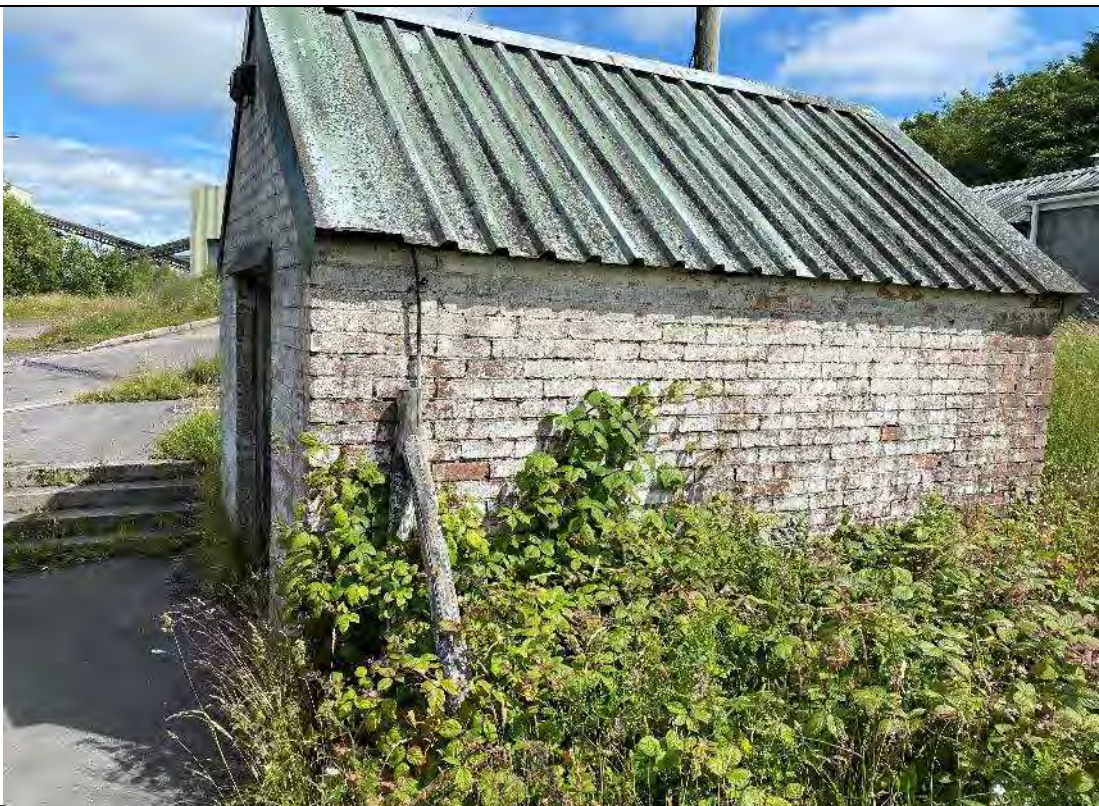
| Photo No. | Date: | |
|---|---|---|
| 69 | 7 July 2022 | |

| Photo No. | Date: | |
|---|---|---|
| <b>Chemical Store (036)</b> | | |
| View of chemical store used by site laboratory. | | |

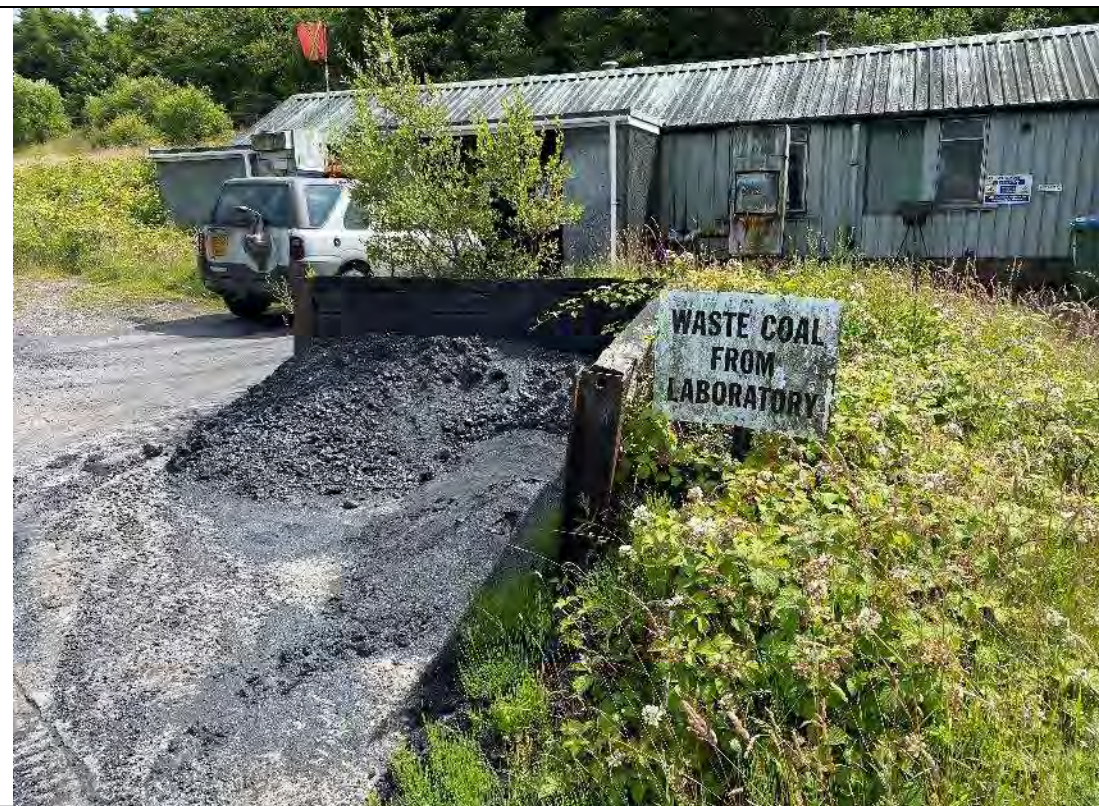
| Photo No. | Date: | |
|---|---|---|
| 70 | 7 July 2022 | |

| Photo No. | Date: | |
|---|---|---|
| <b>Laboratory (037)</b> | | |
| View of site laboratory used to assess quality and composition of coal. | | |

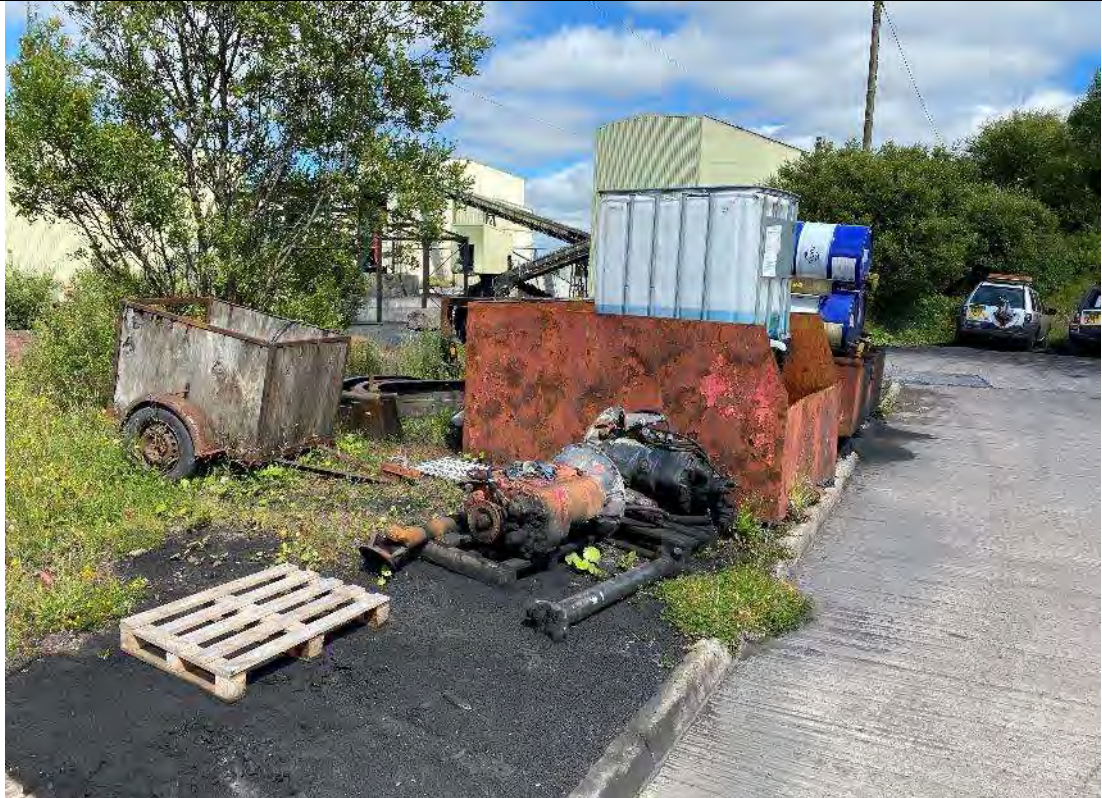
| <b>Photo No.</b><br>72 | <b>Date:</b><br>7 July 2022 | |

| <b>Vehicle Repair Garage (038)</b><br><br>View of AdBlue (039) and lube oil (040) and oil barrel bundled storage (041). Engine parts, tyres and scrap material in foreground and surrounds.<br><br>The photograph aspect is east. | | |

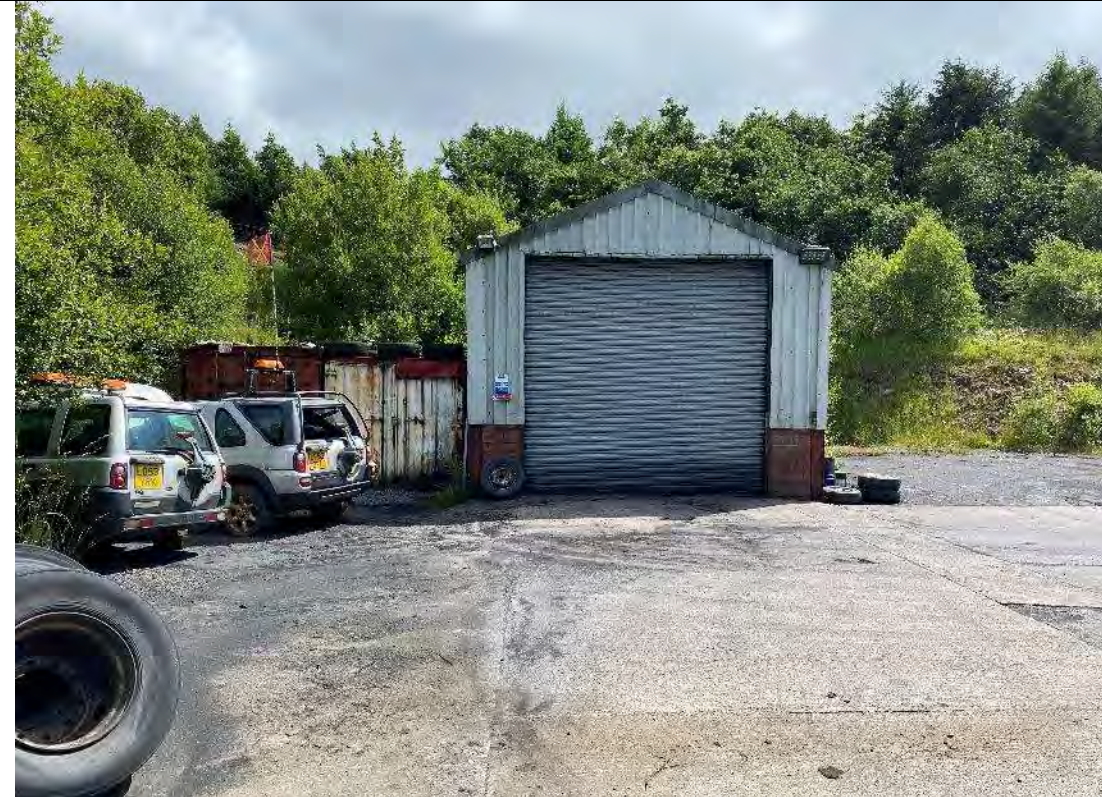
| <b>Photo No.</b><br>73 | <b>Date:</b><br>7 July 2022 | |

| <b>Vehicle Repair Garage (038)</b><br><br>View vehicle repair garage and land rovers being repaired / stripped for parts. Heavy staining on concrete from coal dust.<br><br>The photograph aspect is south. | | |

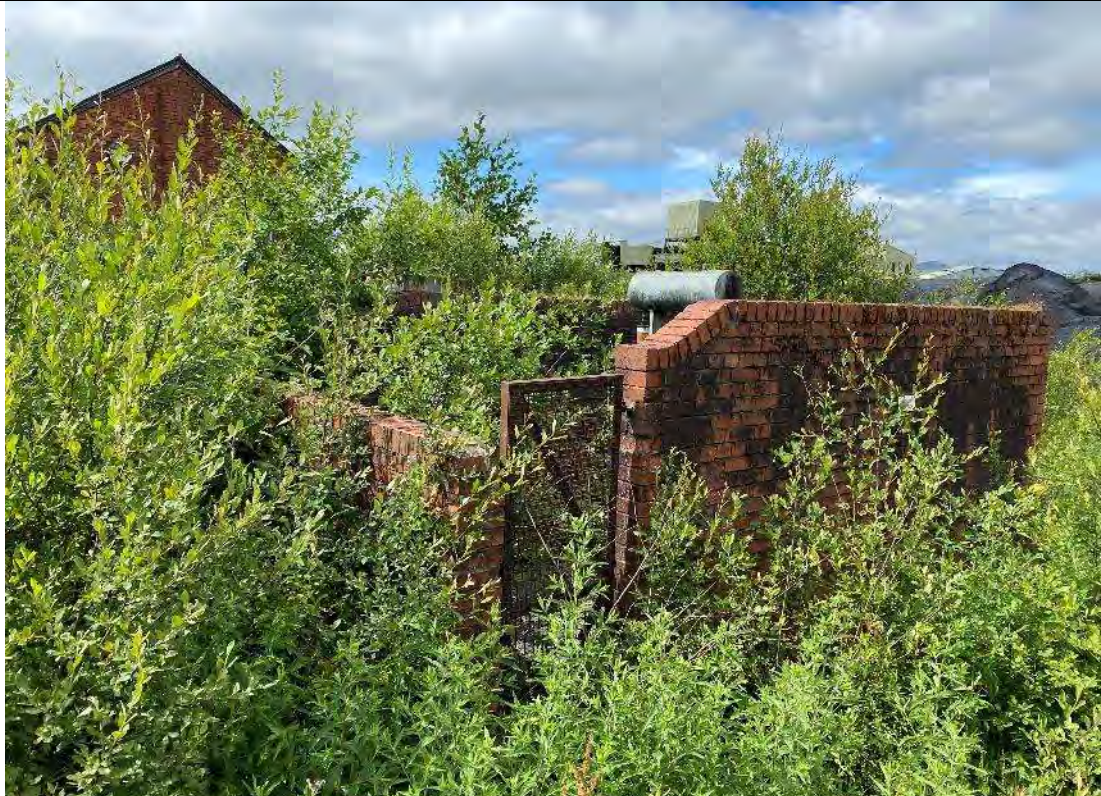
| <b>Photo No.</b><br>74 | <b>Date:</b><br>7 July 2022 |

| <b>Electrical Substation<br/>(042)</b><br><br>View of substation.<br><br>The photograph aspect<br>is north-west. | |

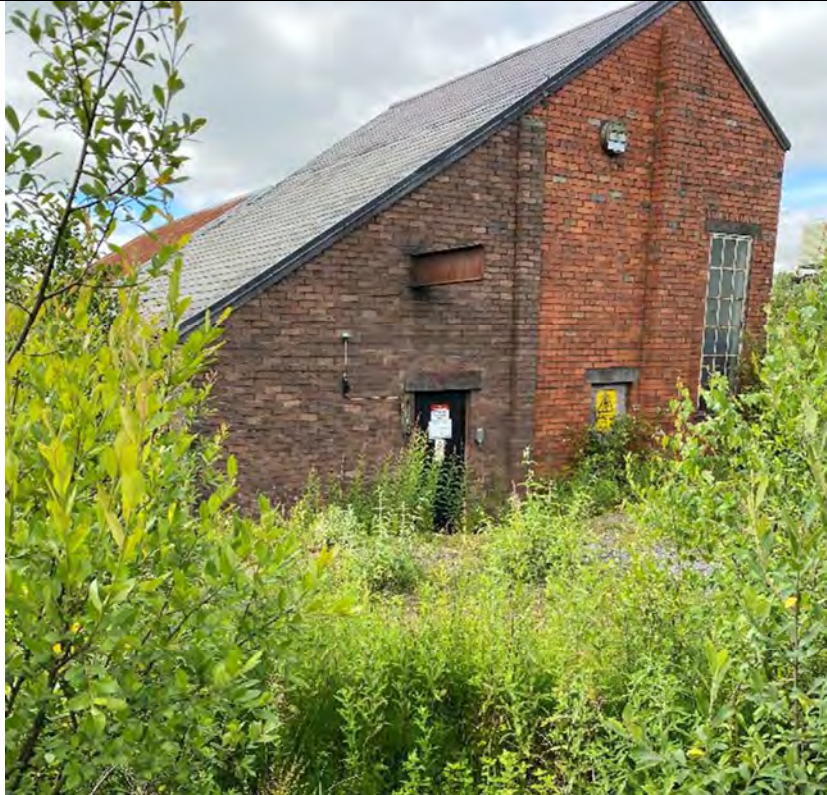
| <b>Photo No.</b><br>75 | <b>Date:</b><br>7 July 2022 | |

| <b>Electrical Substation<br/>(043)</b><br><br>View of substation.<br><br>The photograph aspect<br>is north-west. | | |

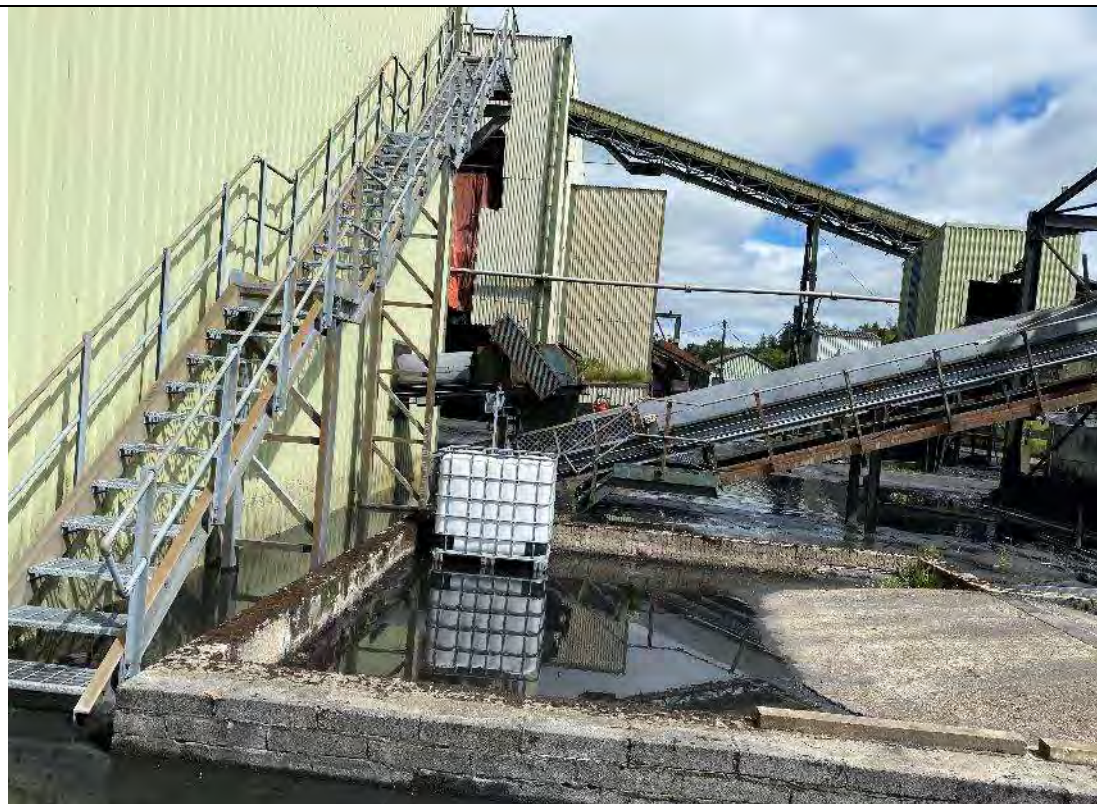
**Client Name: Global Centre of  
Rail Excellence**
**Site: GCRE (Onllywyn Washery)**
**Project No.  
5209796**
**Photo No.**  
78

**Washery Structure  
(045)**

View of washery building  
045, building 014 to rear.  
Empty IBC in middle  
ground.

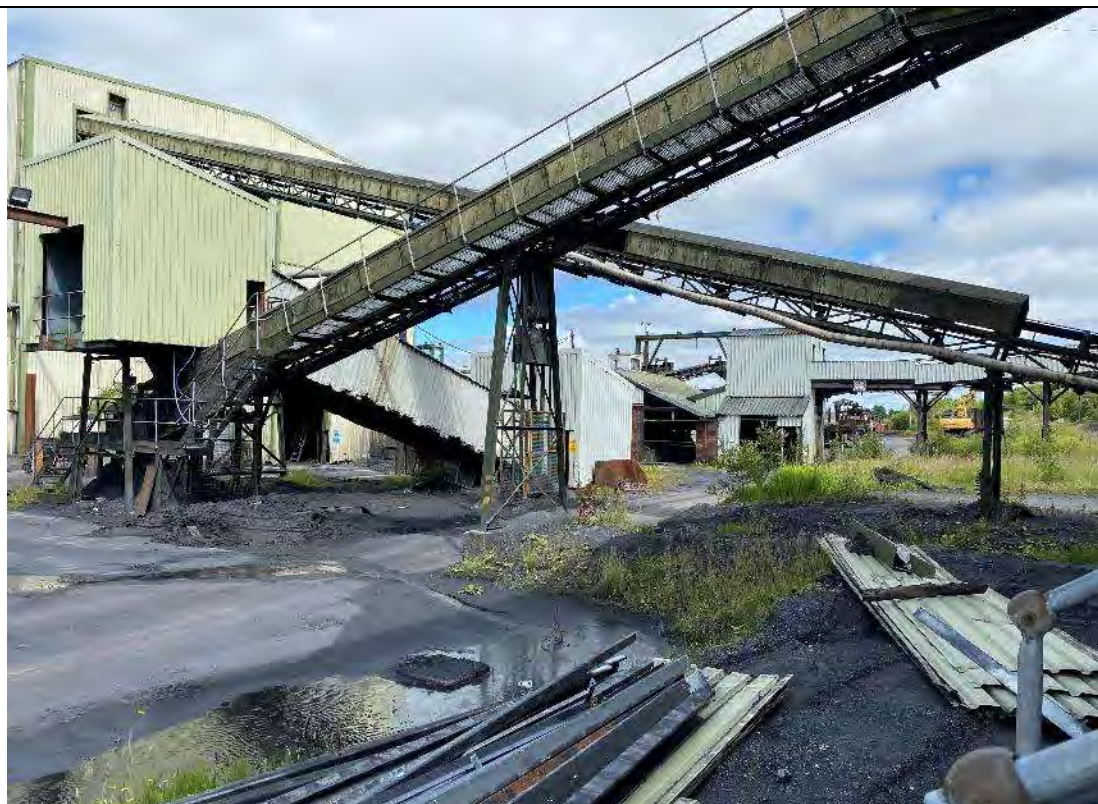
**Photo No.**  
79

**Washery Structures  
(046)**

View of washery  
structure 046. Structure  
047 to rear of  
photograph aspect

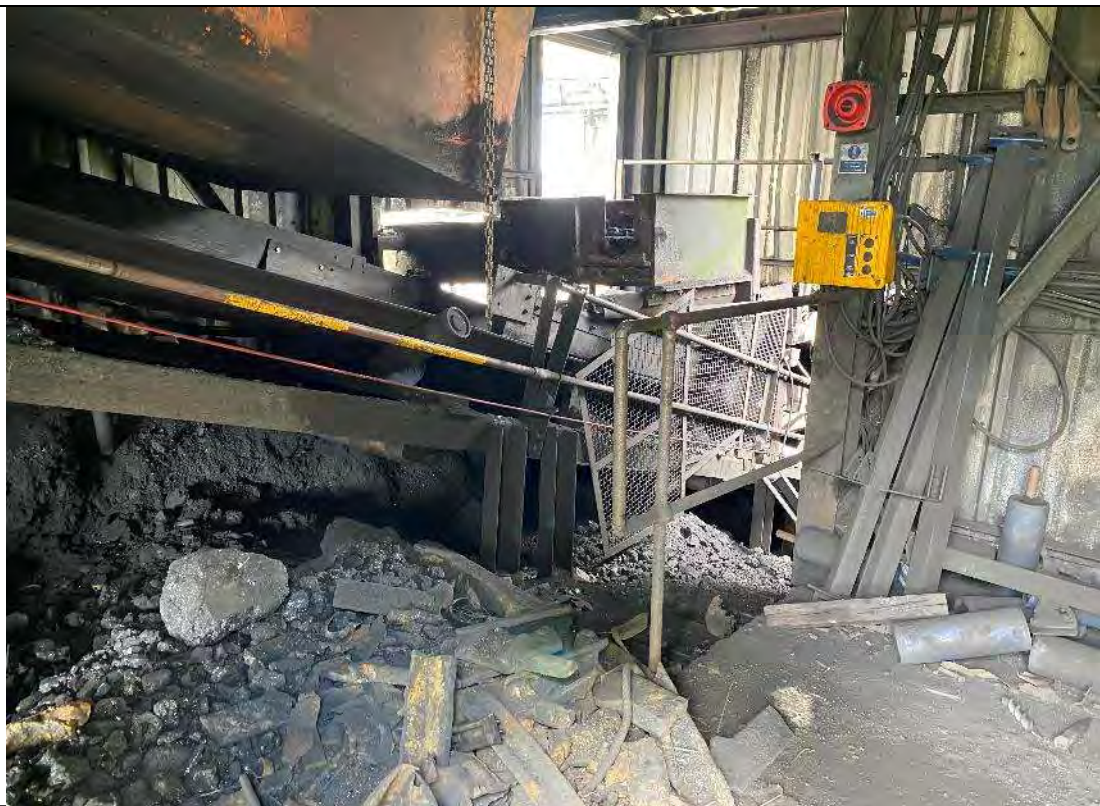
**Photo No.**  
80

**Washery Structure (047)**

View of interior of structure 047.

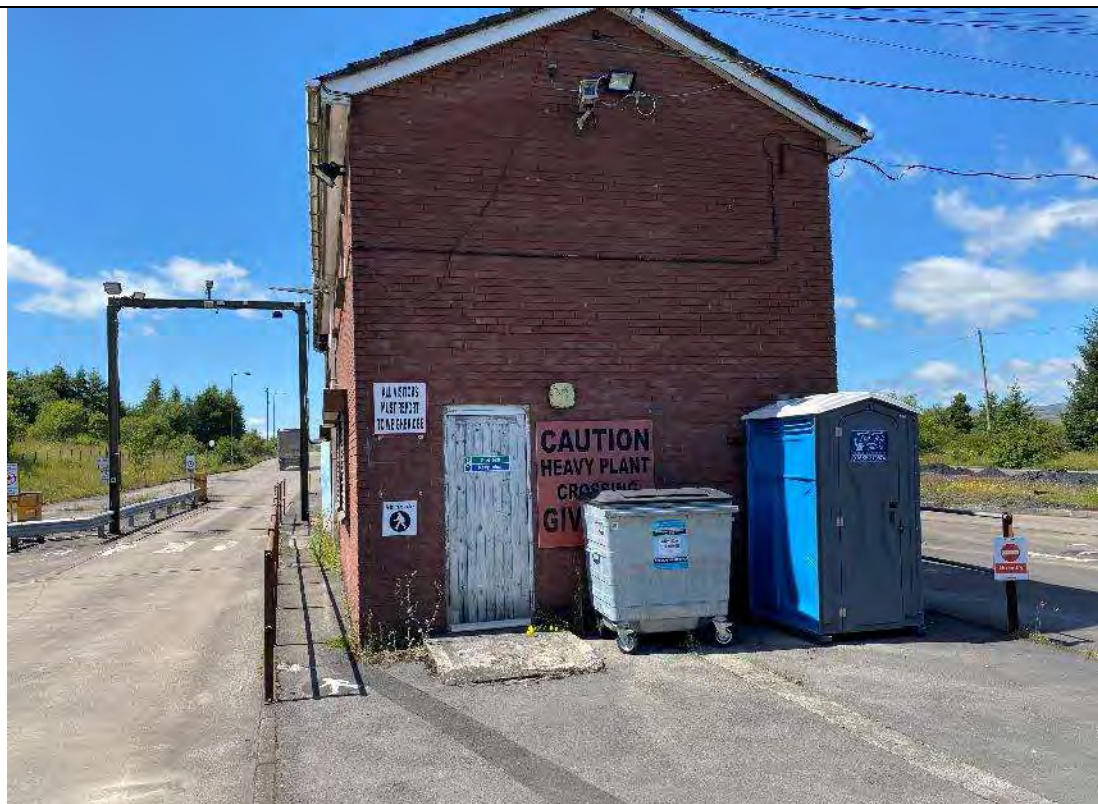
**Photo No.**  
81

**Weighbridge (048)**

View of HGV site entrance and office. Weighbridge to left.

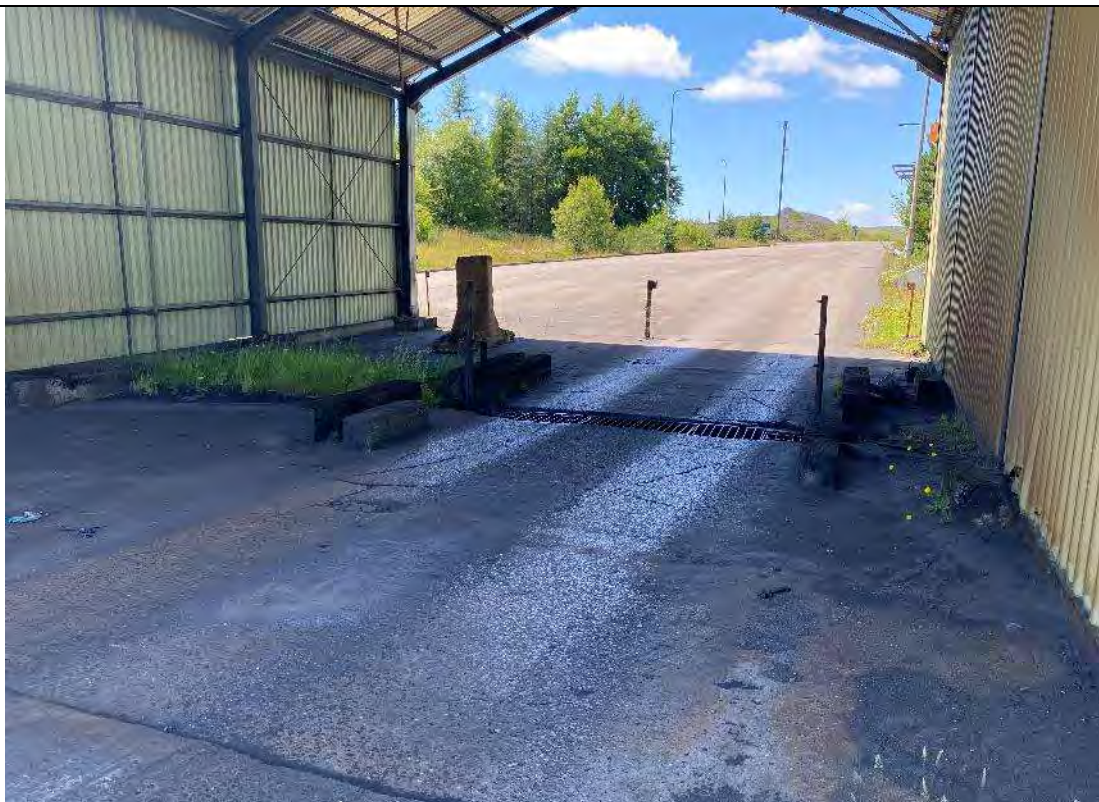
| <b>Photo No.</b><br>82 | <b>Date:</b><br>7 July 2022 | |

| <b>Wheel Wash (049)</b><br><br>View of wheel wash, lagoon (050) located to right hand side supplying water for its use.<br><br>The photograph aspect is west. | | |

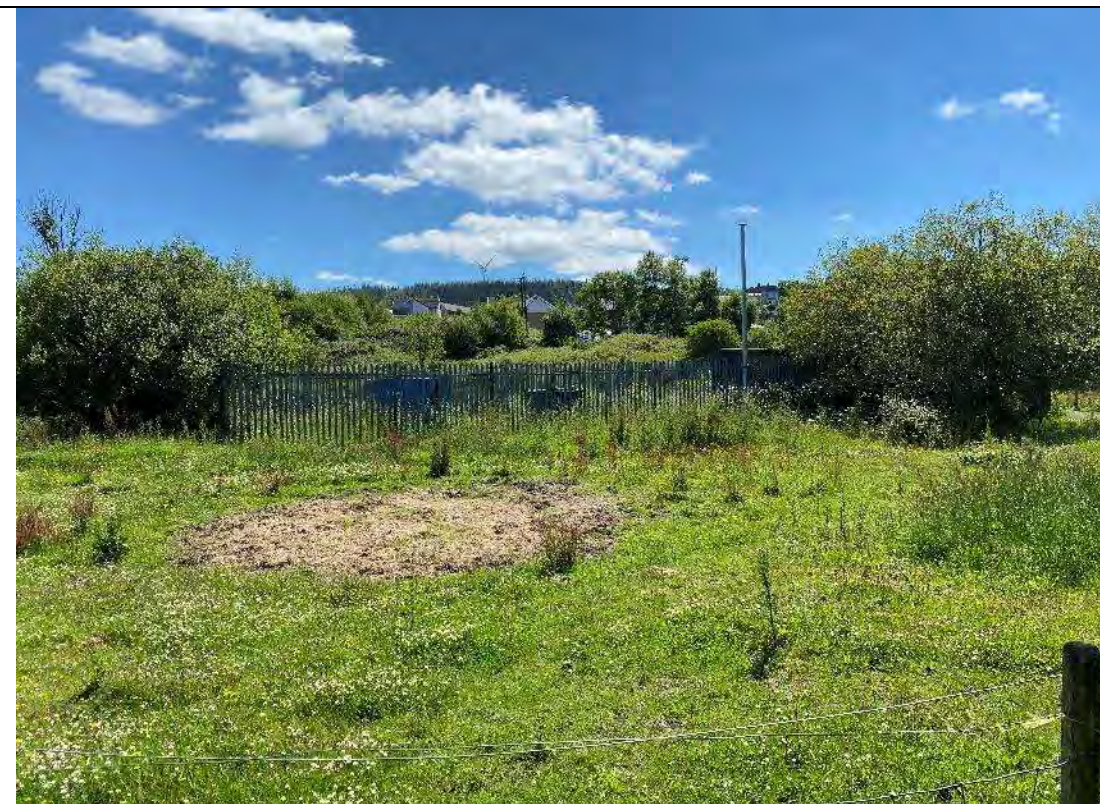
**Photo No.**  
85

**South of Washery**

View of area of colliery spoil in south of site.
