Figure 6-1: Washery Geological Sections - Section A (Imagery copyright AtkinsRéalis)

Figure 6-7: Formation Level Plan (Imagery copyright AtkinsRéalis)

# GLOBAL CENTRE OF RAIL EXCELLENCE

## GROUND INVESTIGATION:

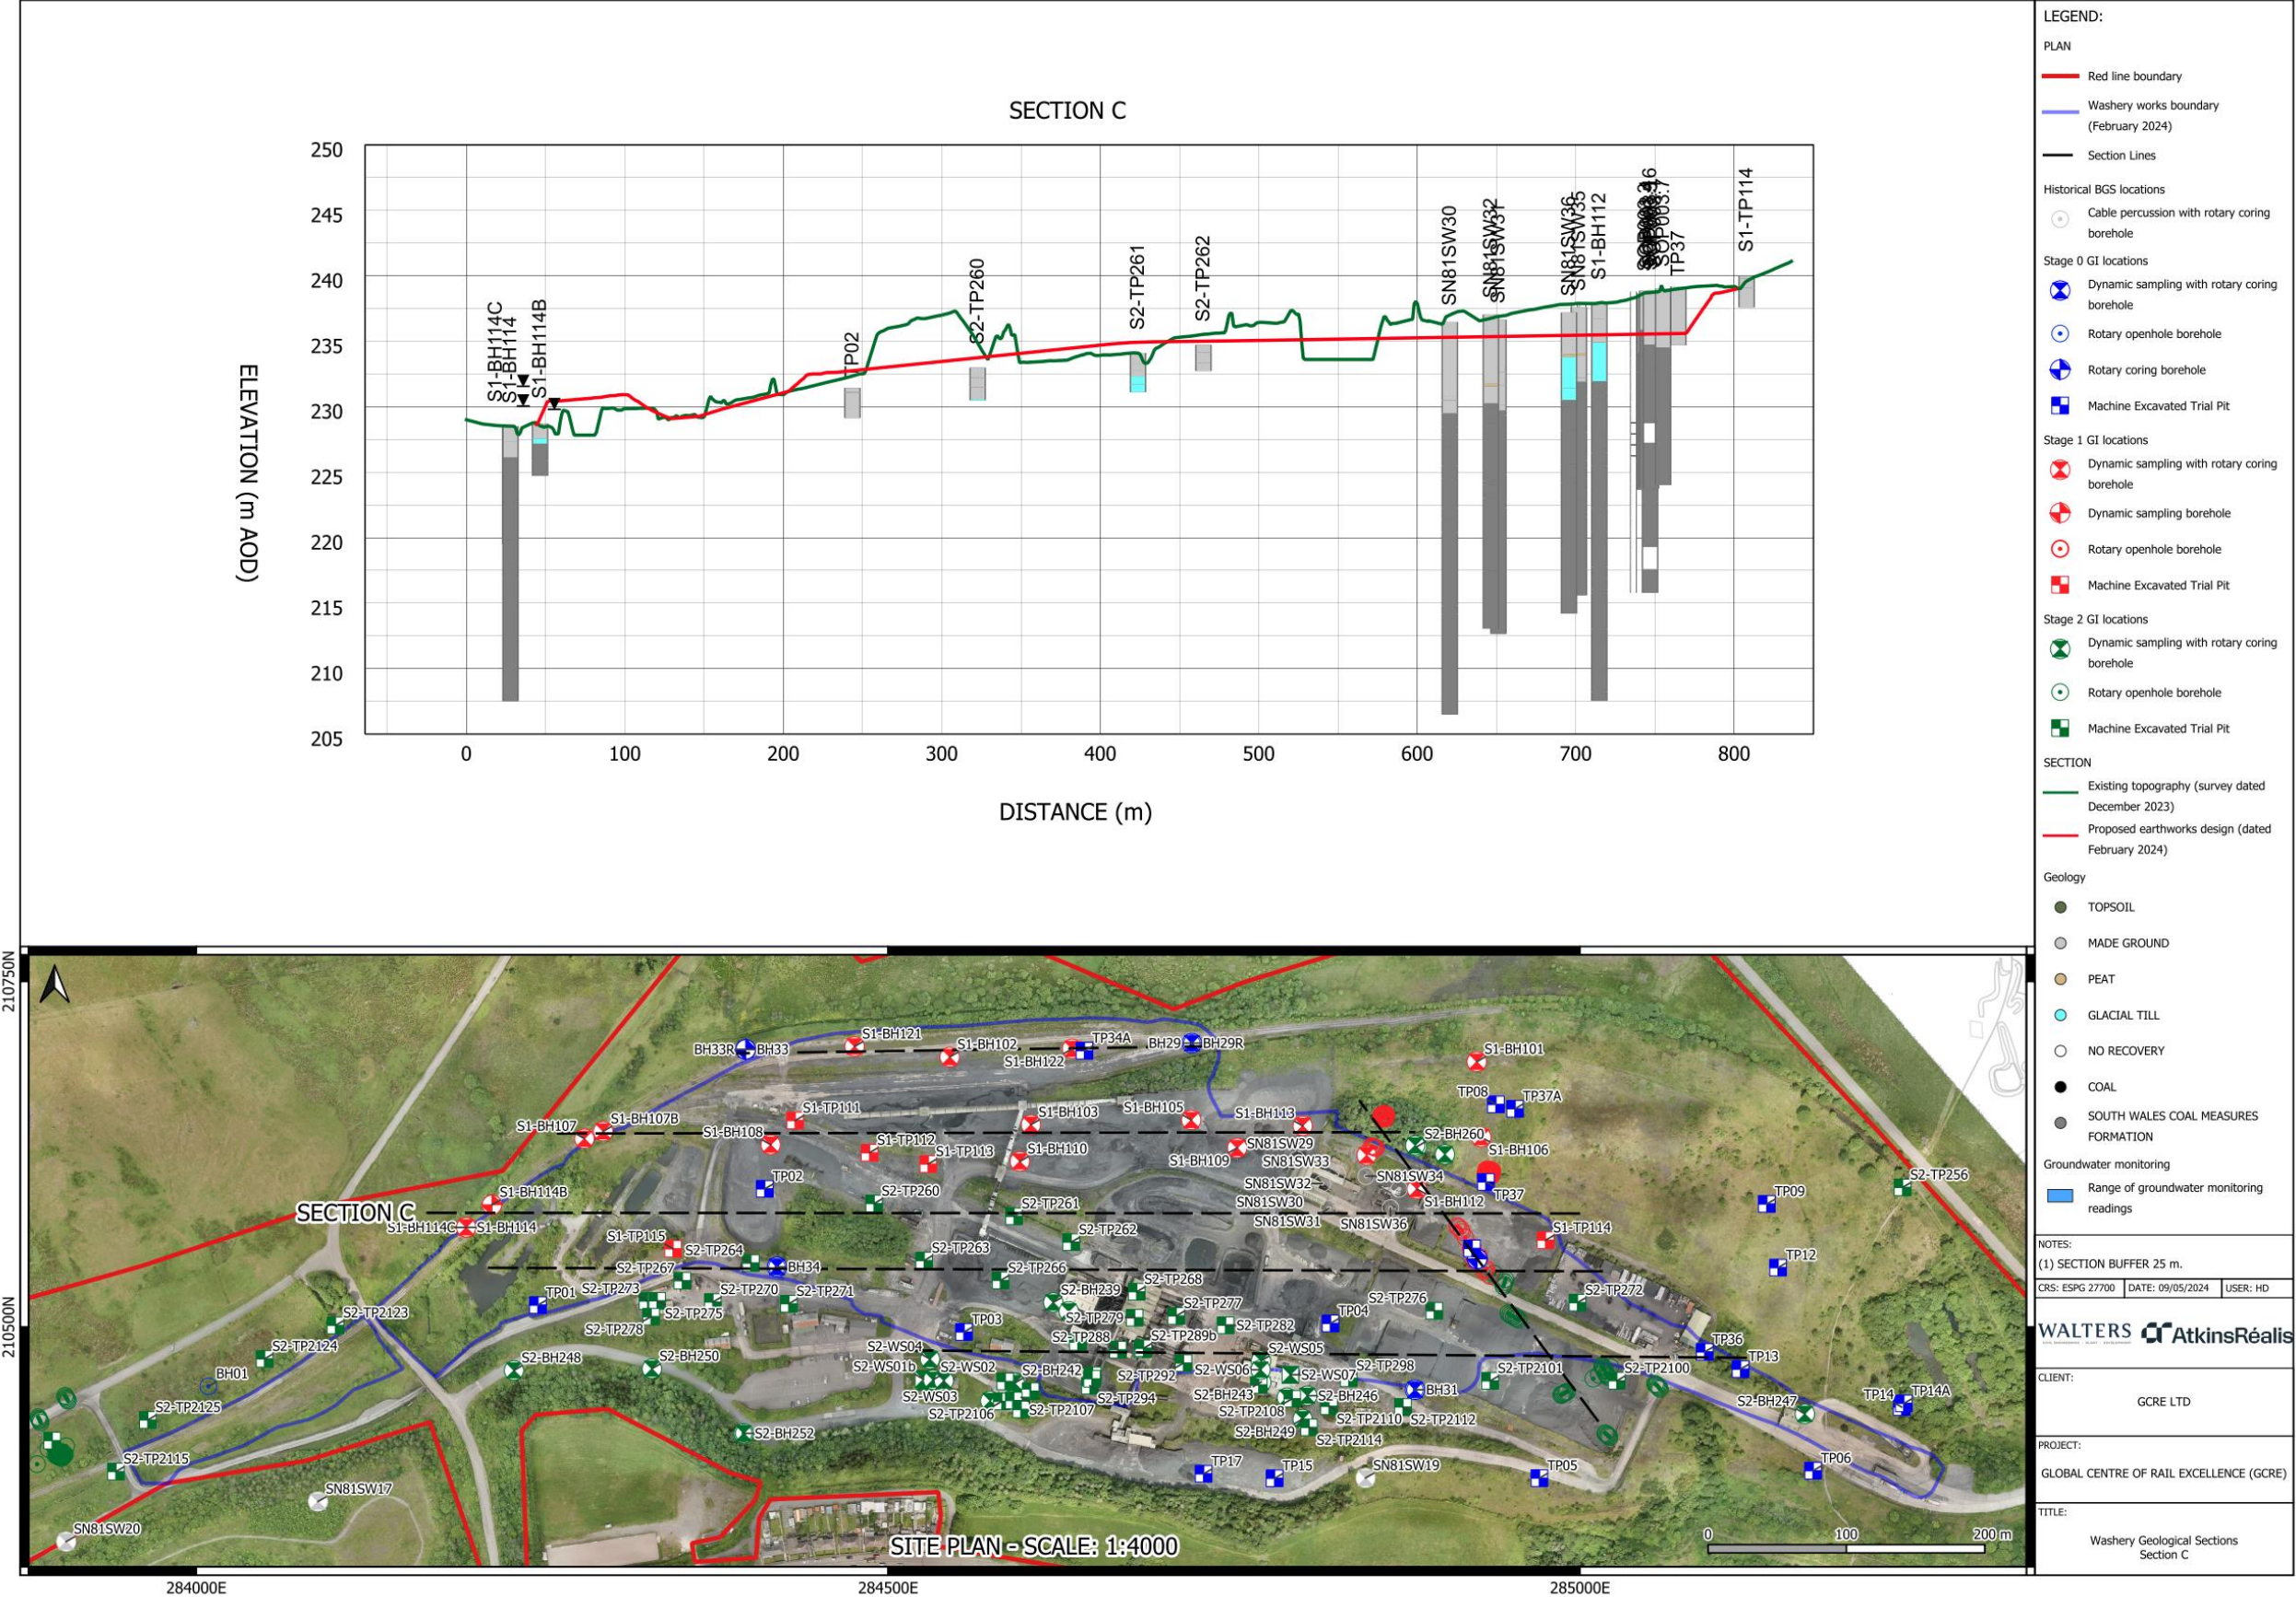
Figure 6-3: Washery Geological Sections - Section C (Imagery copyright AtkinsRéalis)
