**HEOL CRWYS, CWMAVON**

**Supplemental Site Investigation Report**

14023/LW/24/SSI/RevC

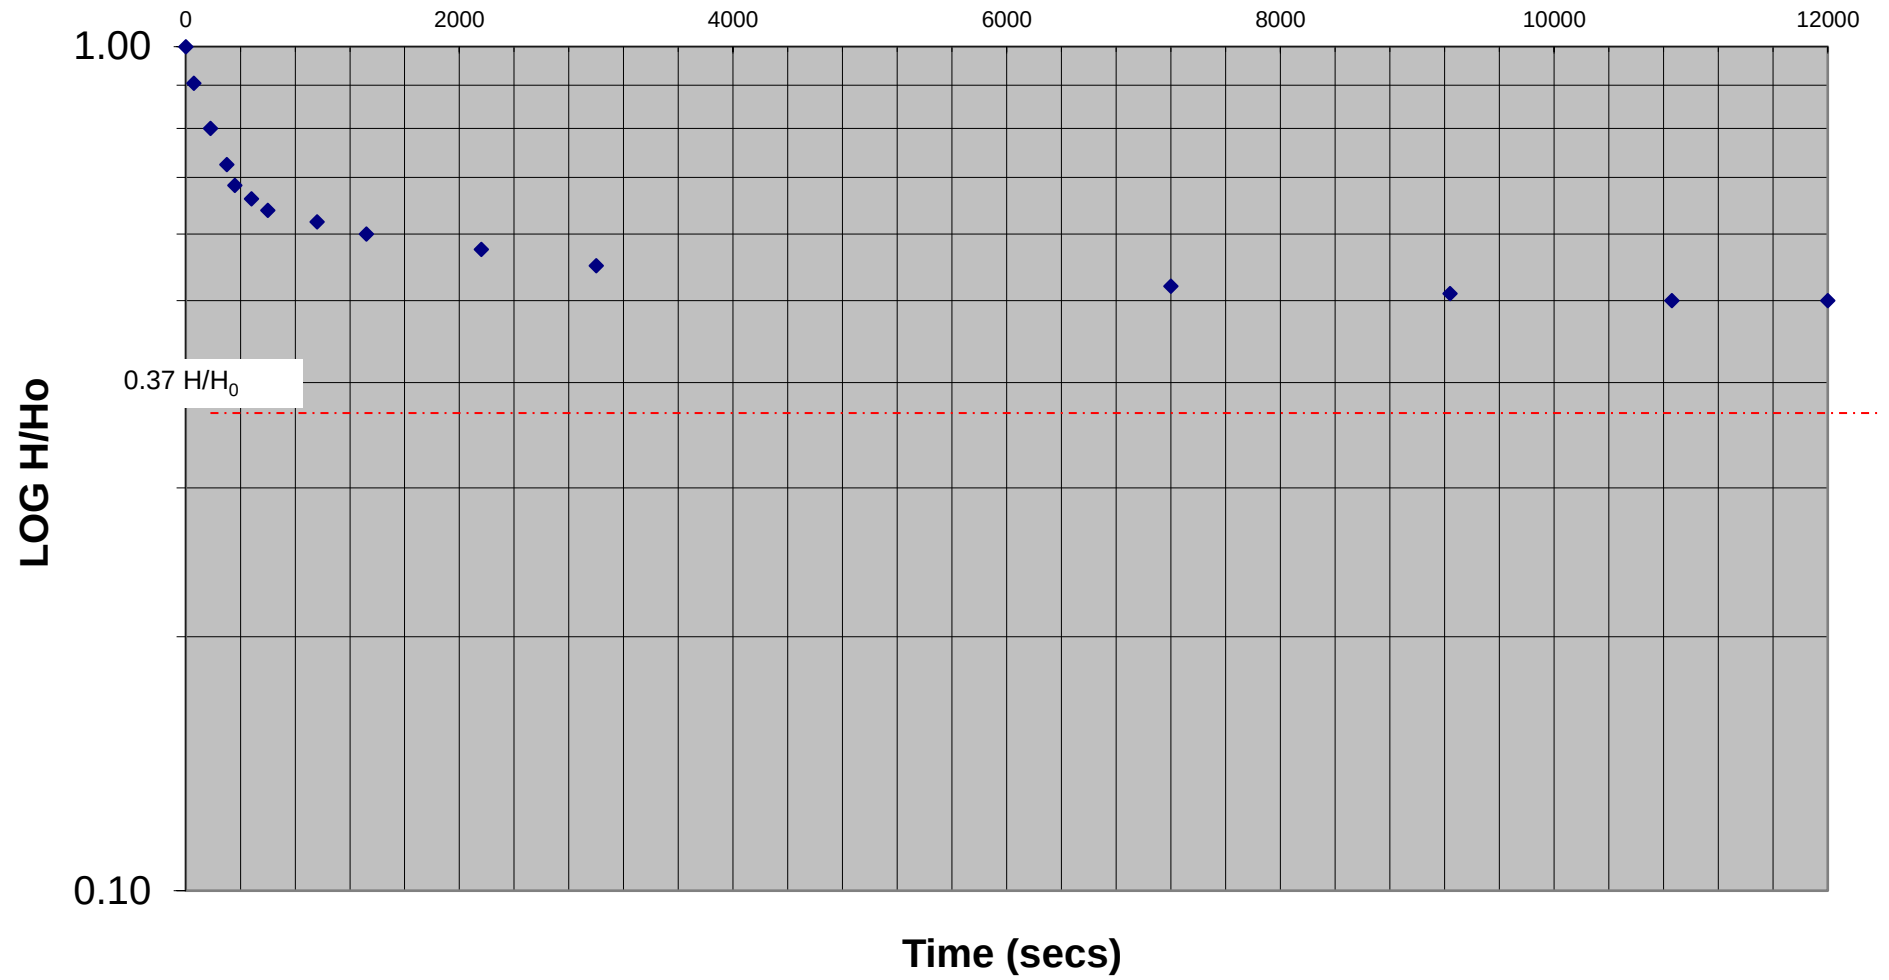
# Borehole WS03

Infiltration stalled after 200 minutes. Insufficient infiltration to derive permeability value.  
Test undertaken primarily within granular made ground deposits.

Within windowless sample borehole WS03 and WS09, the infiltration stalled at a depth of 1.0m and 1.72m respectively and therefore no infiltration could be calculated for either location.

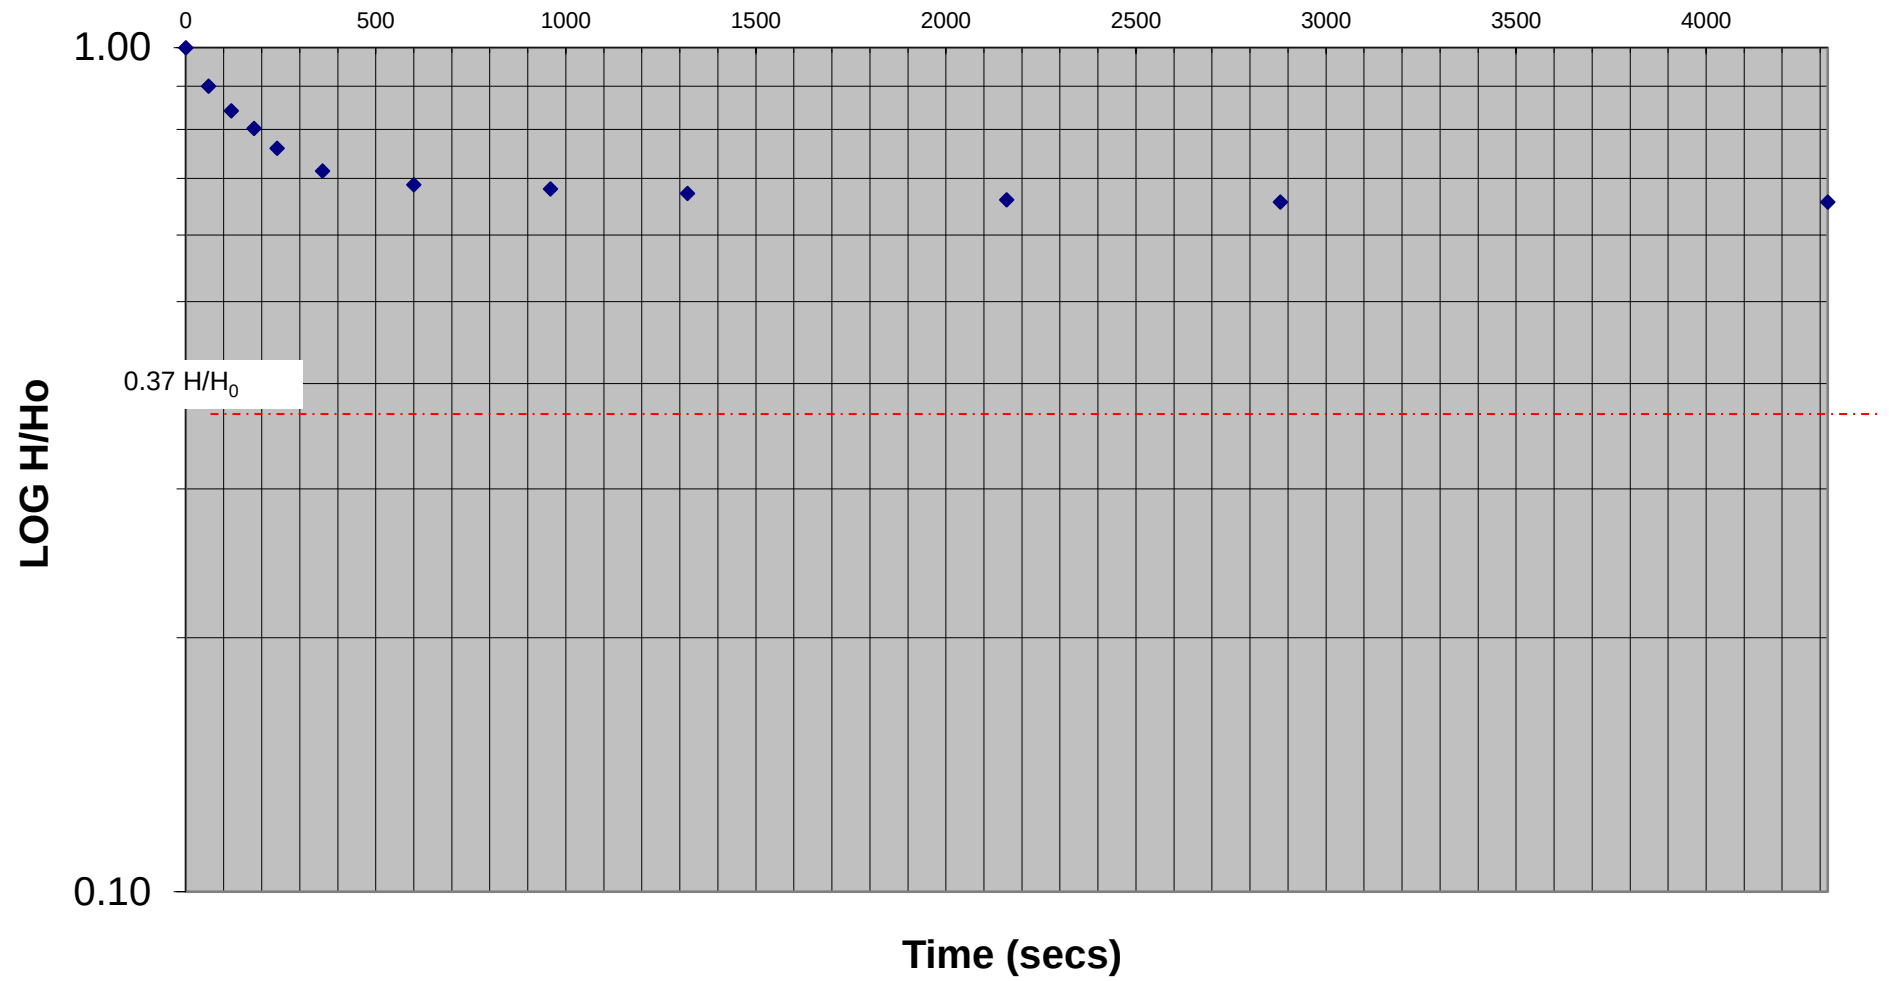
## Borehole WS09

| COMMENTS | Infiltration stalled after 48 minutes. Insufficient infiltration to derive permeability value.<br>Test undertaken primarily within granular made ground deposits. |

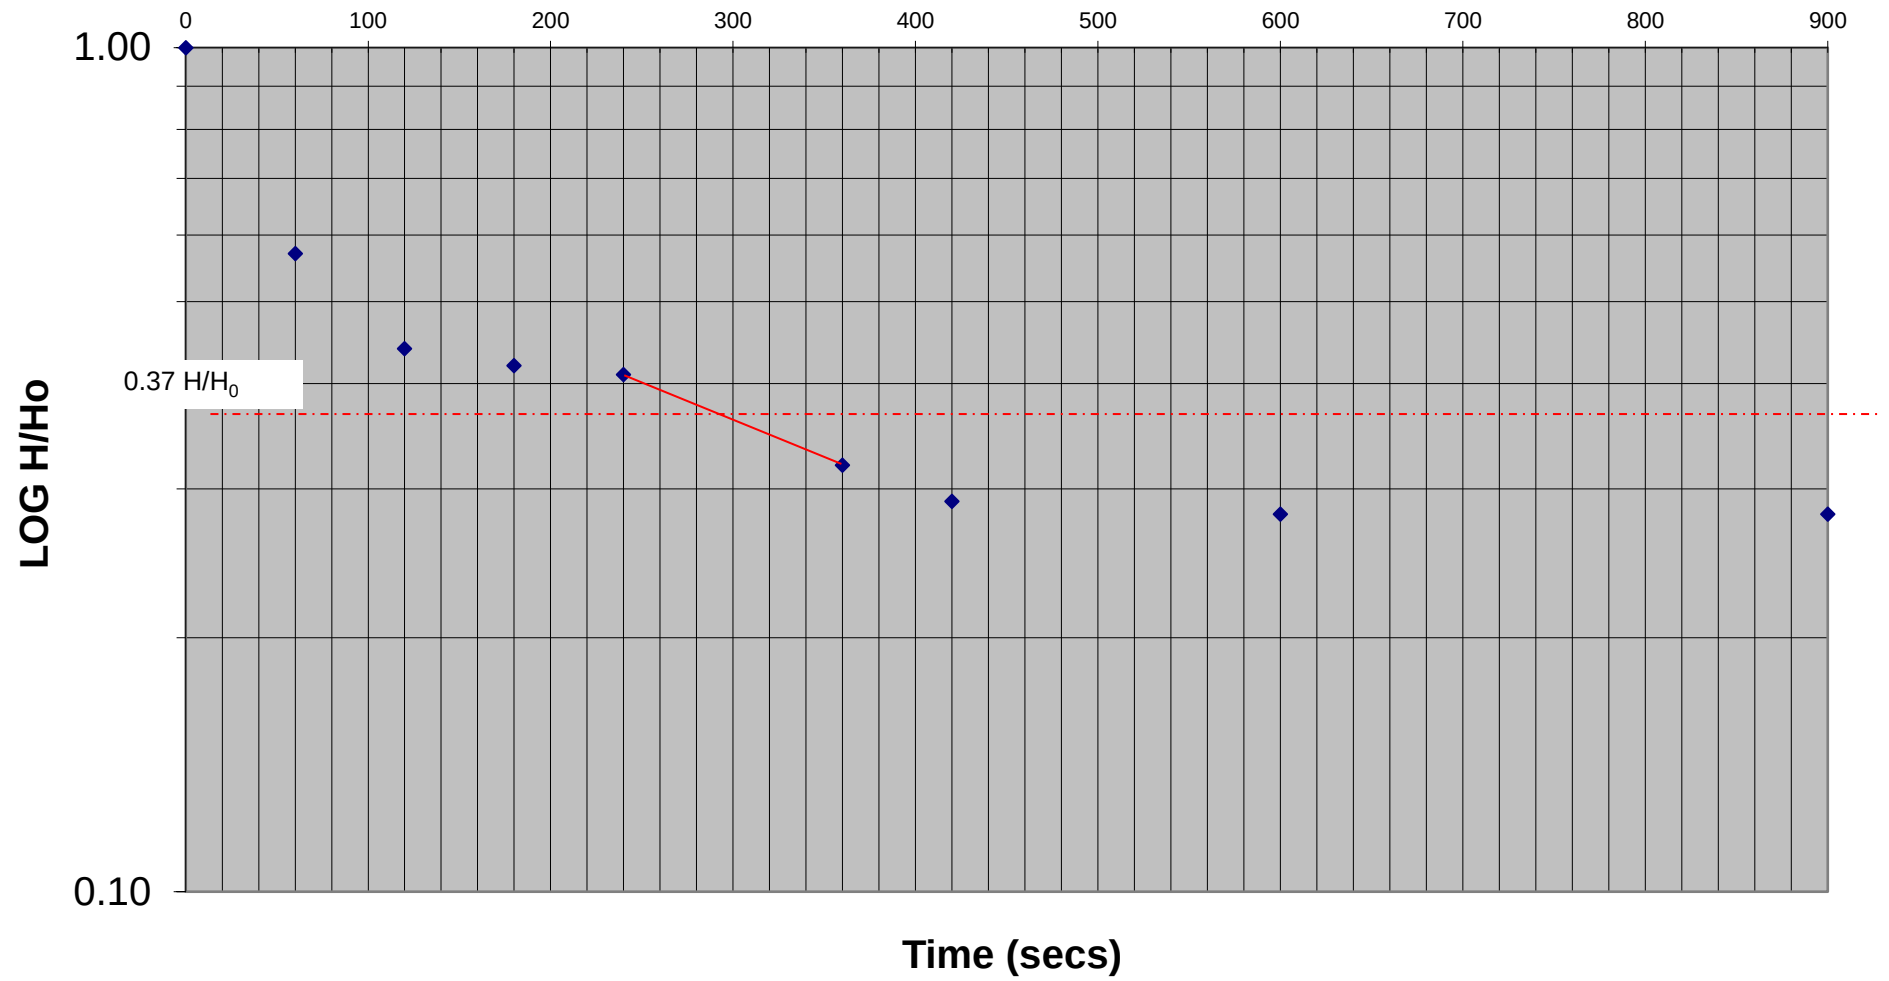
## Borehole WS05

COMMENTS Test undertaken within variable made ground deposits. Permeability value to be used with caution.

Within windowless sample borehole WS05, an infiltration rate of  $4.74 \times 10^{-4} \text{m/s}$  was calculated.

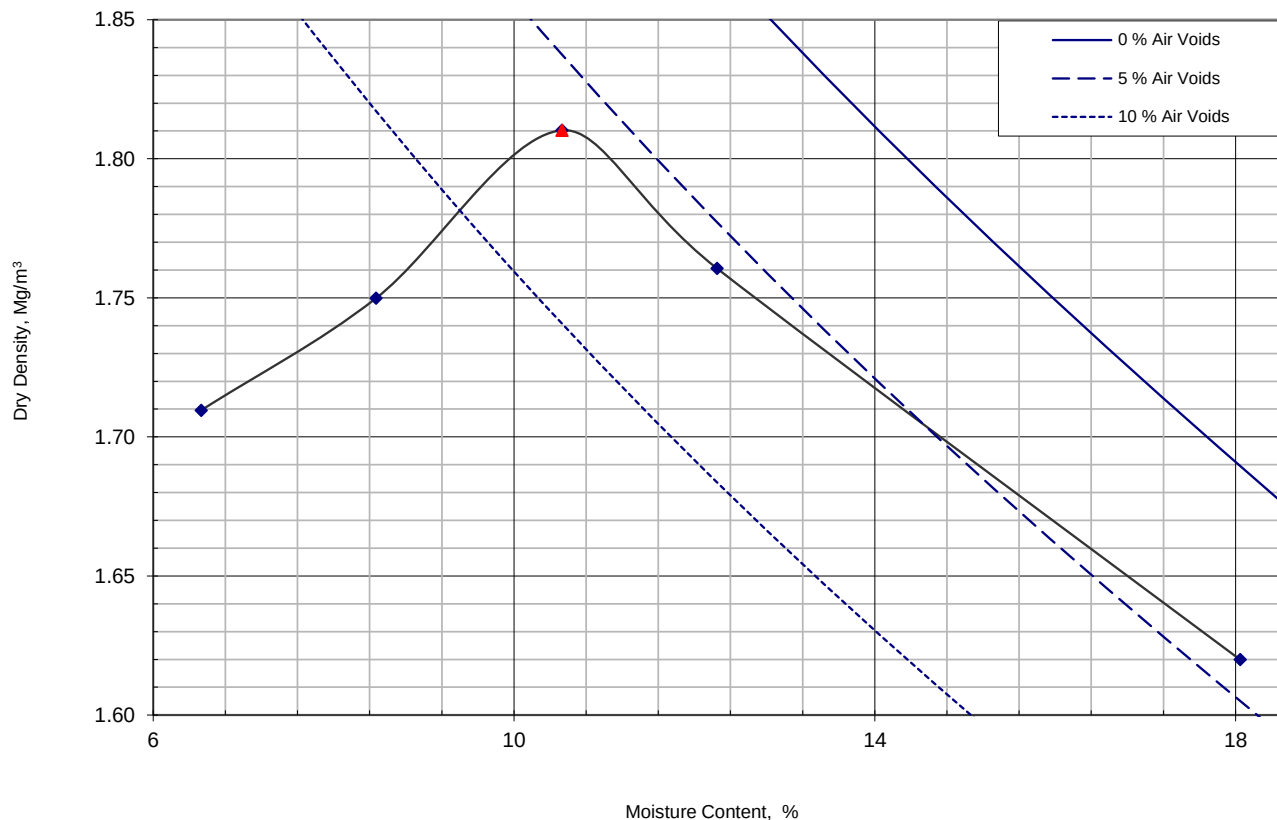
**Dry Density / Moisture Content Relationship  
BS 1377:Part 4:1990**

Sample Description Grey/ black fine to coarse GRAVEL

| Compaction Point | 1 | 2 | 3 | 4 | 5 | | | | | | | |
|---|---|---|---|---|---|--|--|--|--|--|--|--|
| Moisture Content | 6.5 | 8.5 | 11 | 12 | 18 | | | | | | | |

| Optimum Moisture Content | 11 | % |

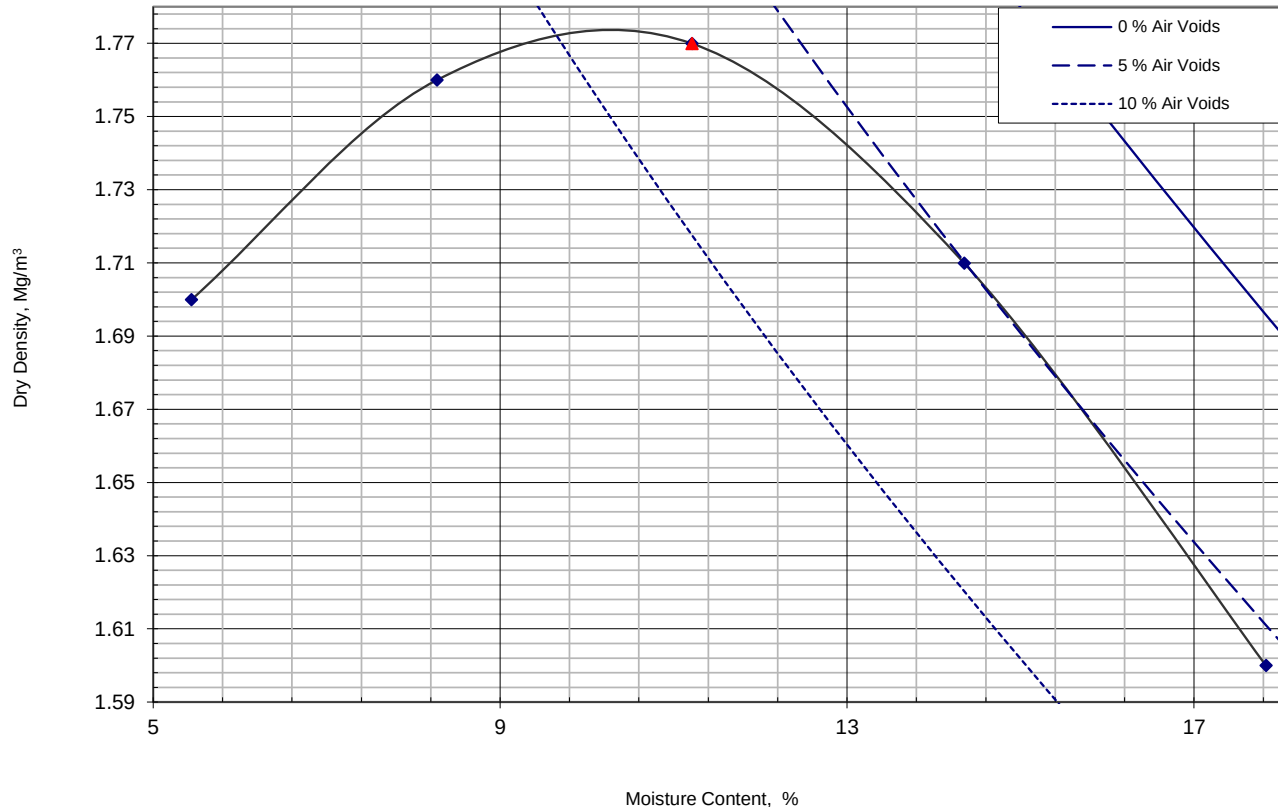
**Dry Density / Moisture Content Relationship  
BS 1377:Part 4:1990**

Sample Description Grey fine to coarse GRAVEL

| Compaction Point | 1 | 2 | 3 | 4 | 5 | | | | | | | |
|---|---|---|---|---|---|--|--|--|--|--|--|--|
| Moisture Content | 5.4 | 8.3 | 11 | 14 | 18 | | | | | | | |

| Optimum Moisture Content | 11 | % |

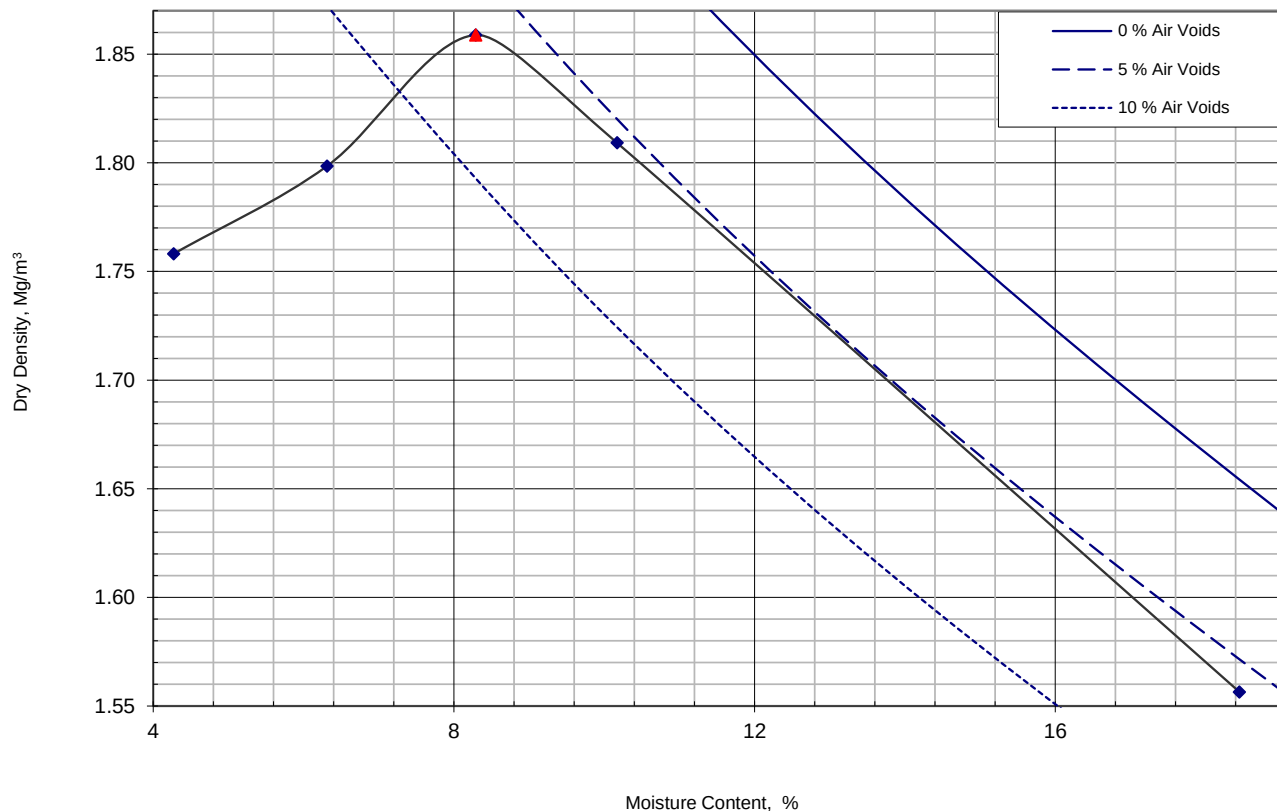
**Dry Density / Moisture Content Relationship  
BS 1377:Part 4:1990**

Sample Description Grey fine to coarse GRAVEL

| Compaction Point | 1 | 2 | 3 | 4 | 5 | | | | | | | |
|---|---|---|---|---|---|--|--|--|--|--|--|--|
| Moisture Content | 4.3 | 6.3 | 8.3 | 10 | 18 | | | | | | | |

| Optimum Moisture Content | 8.3 | % |

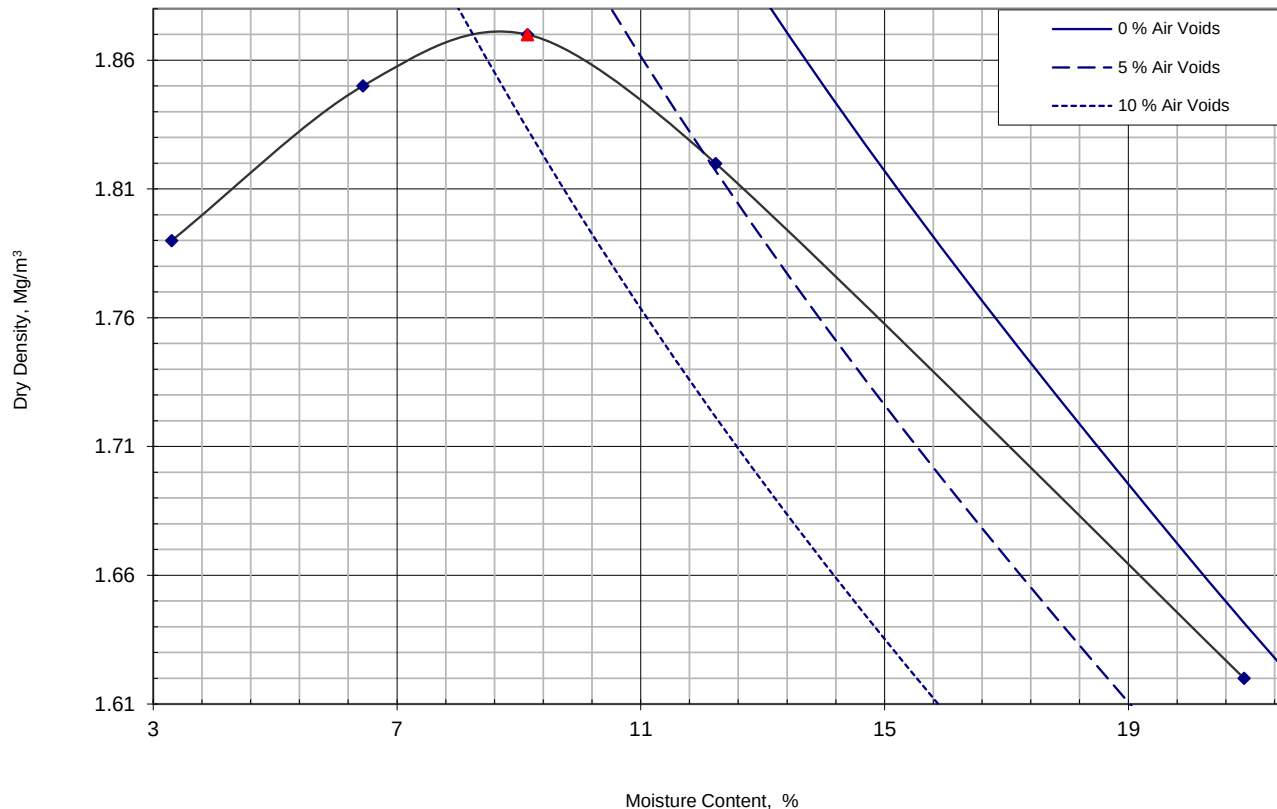
**Dry Density / Moisture Content Relationship  
BS 1377:Part 4:1990**

Sample Description Black slightly clayey sandy GRAVEL

| Compaction Point | 1 | 2 | 3 | 4 | 5 | | | | | | | |
|---|---|---|---|---|---|--|--|--|--|--|--|--|
| Moisture Content | 3.3 | 6.4 | 9.1 | 12 | 21 | | | | | | | |

| Optimum Moisture Content | 9.1 | % |

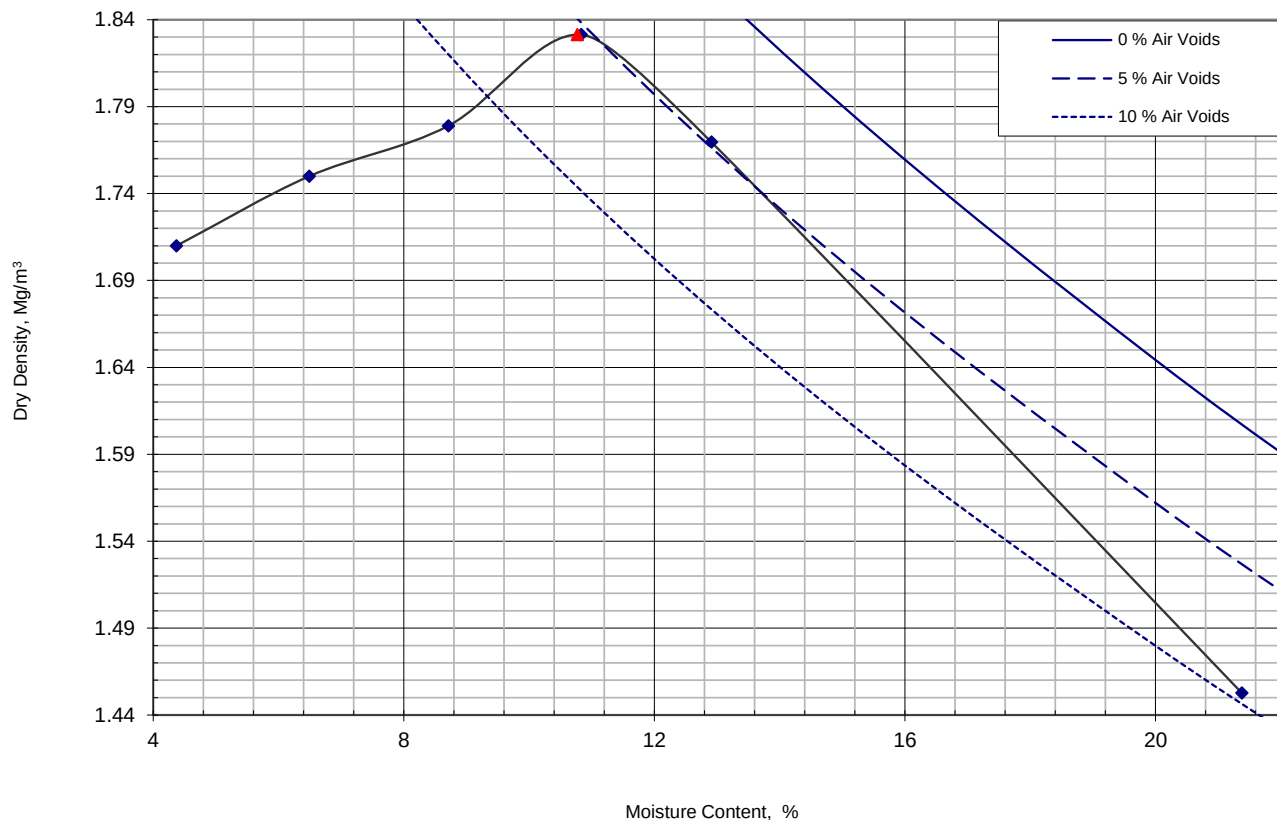
**Dry Density / Moisture Content Relationship  
BS 1377:Part 4:1990**

Sample Description Grey fine to coarse GRAVEL

| Compaction Point | 1 | 2 | 3 | 4 | 5 | 6 | | | | | | |
|---|---|---|---|---|---|---|--|--|--|--|--|--|
| Moisture Content | 4.4 | 6.5 | 8.7 | 11 | 13 | 21 | | | | | | |

| Optimum Moisture Content | 11 | % |

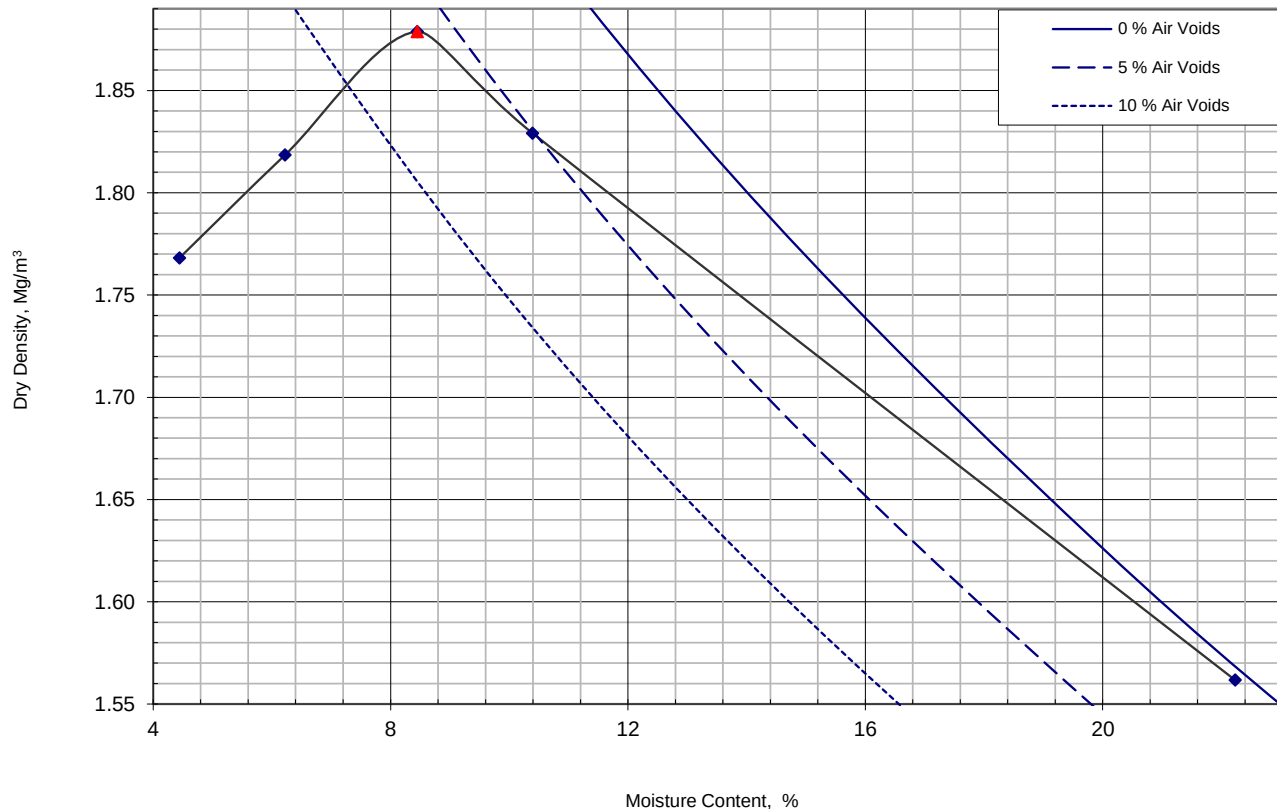
**Dry Density / Moisture Content Relationship  
BS 1377:Part 4:1990**

Sample Description Grey sandy silty clayey GRAVEL

| Compaction Point | 1 | 2 | 3 | 4 | 5 | | | | | | | |
|---|---|---|---|---|---|--|--|--|--|--|--|--|
| Moisture Content | 4.4 | 6.2 | 8.5 | 10 | 22 | | | | | | | |

| Optimum Moisture Content | 8.5 | % |

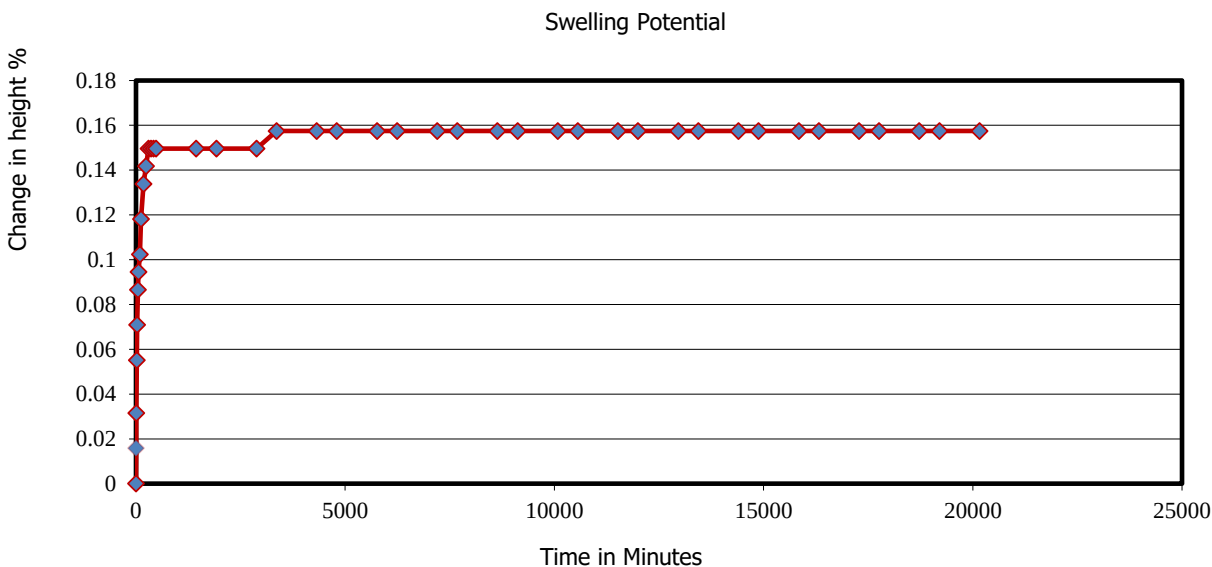
Initial Height - mm: 127.00  
Moisture Content - %: 20.5  
Bulk Density - Mg/m3: 1.90  
Dry Density - Mg/m3: 1.57

Final Height - mm: 127.20  
Moisture Content - %: 22  
Bulk Density - Mg/m3: 1.91  
Dry Density - Mg/m3: 1.57

**Swelling after 336 Hours -%**  
**0.16**

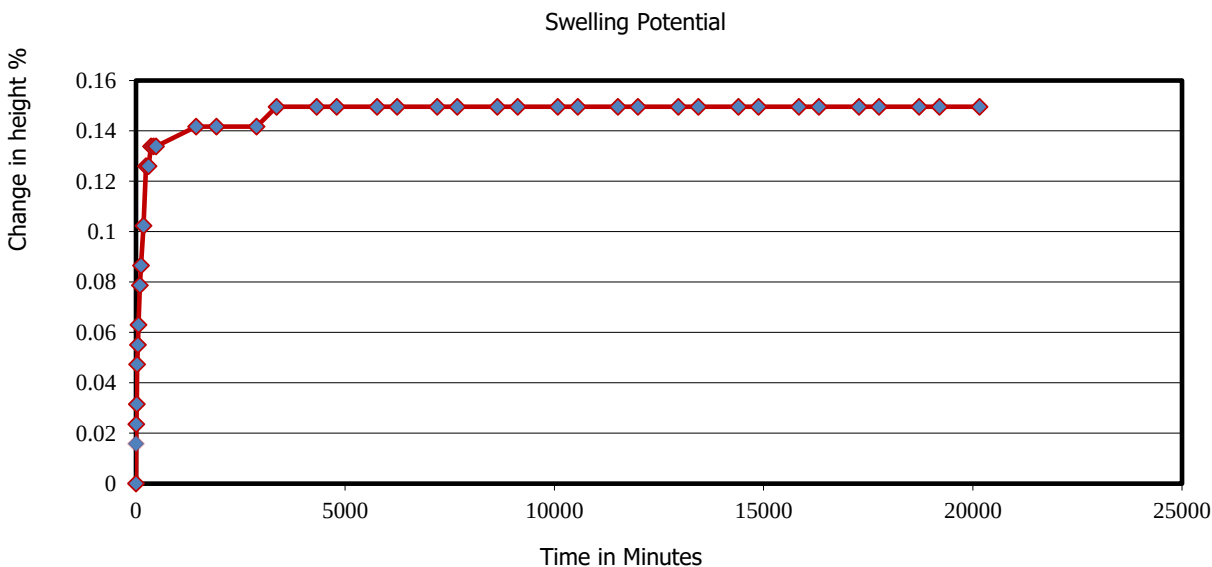
Initial Height - mm: 127.00  
Moisture Content - %: 21.8  
Bulk Density - Mg/m3: 1.77  
Dry Density - Mg/m3: 1.45

Final Height - mm: 127.19  
Moisture Content - %: 23  
Bulk Density - Mg/m3: 1.78  
Dry Density - Mg/m3: 1.45

**Swelling after 336 Hours -%**  
**0.15**

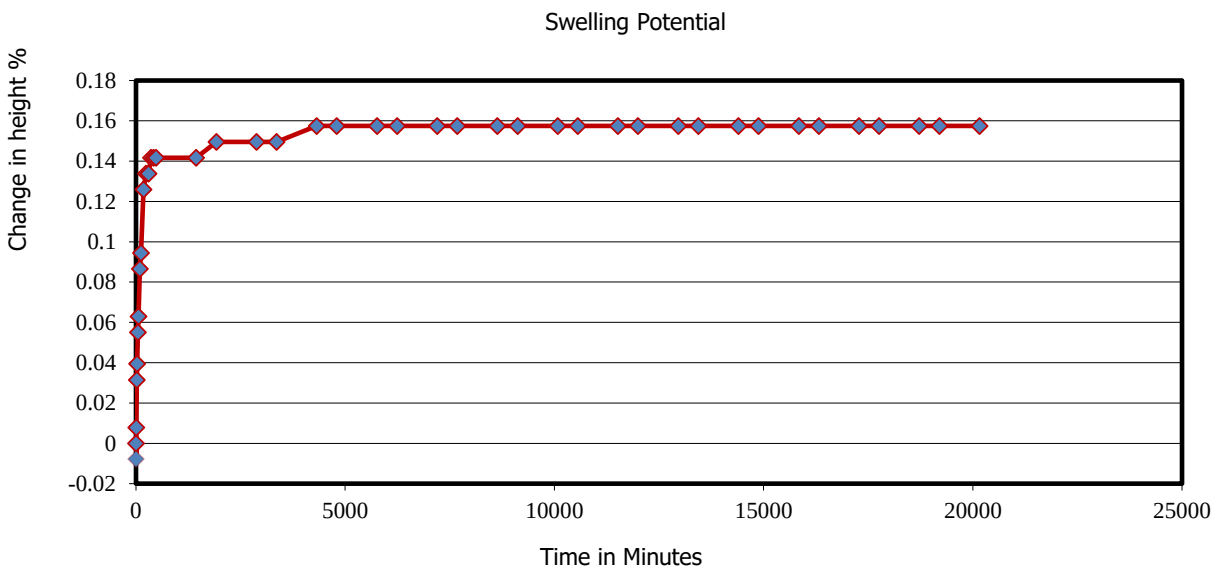
Initial Height - mm: 127.00  
Moisture Content - %: 19.1  
Bulk Density - Mg/m3: 1.84  
Dry Density - Mg/m3: 1.54

Final Height - mm: 127.20  
Moisture Content - %: 22  
Bulk Density - Mg/m3: 1.86  
Dry Density - Mg/m3: 1.54

**Swelling after 336 Hours -%**  
**0.16**

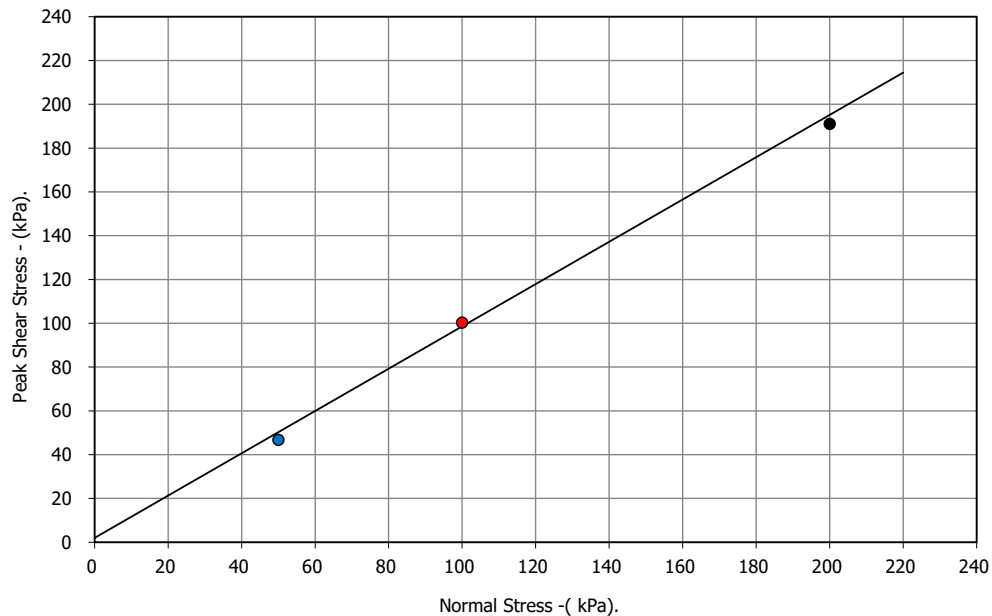
Angle of Shearing Resistance:( $\theta$ ) **44.0**  
 Effective Cohesion - kPa: **2.0**

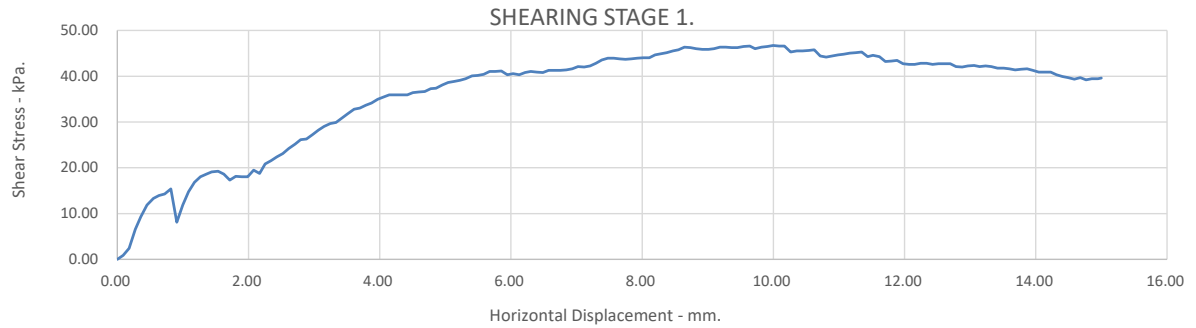
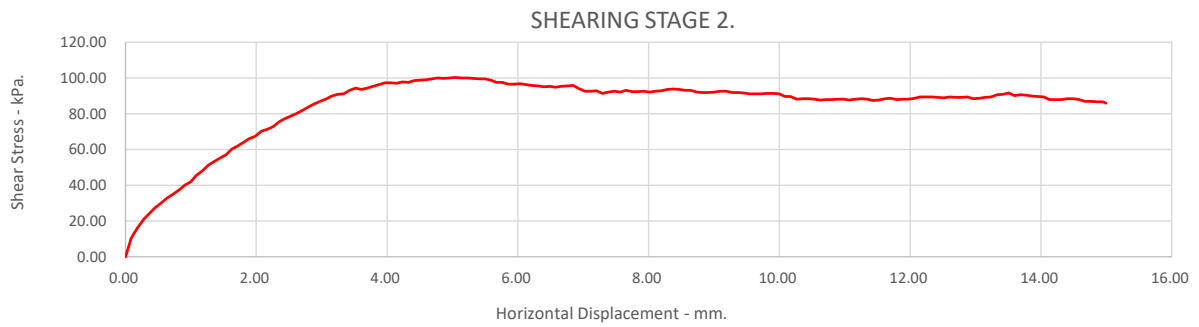
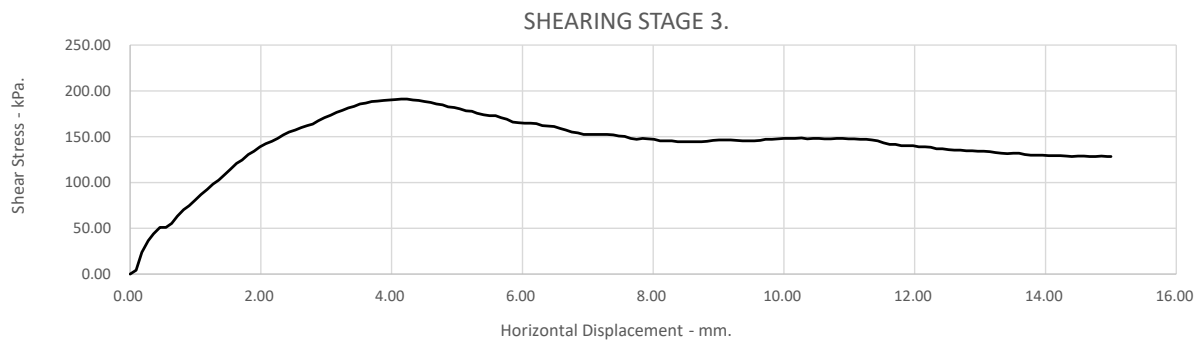
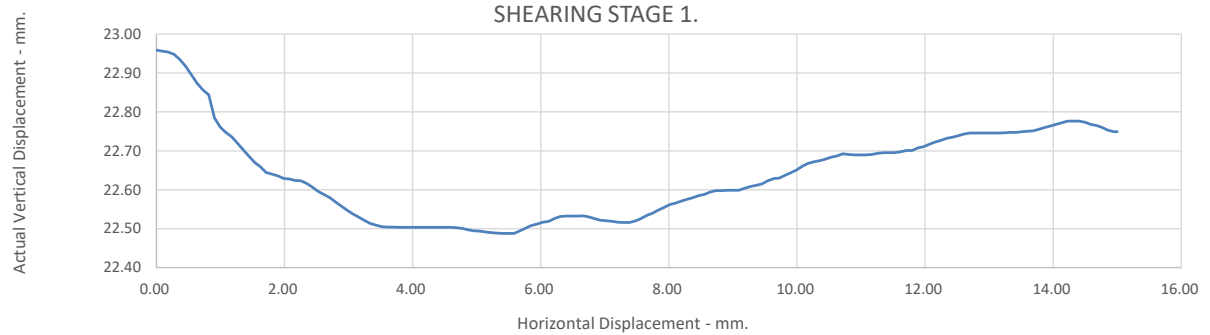
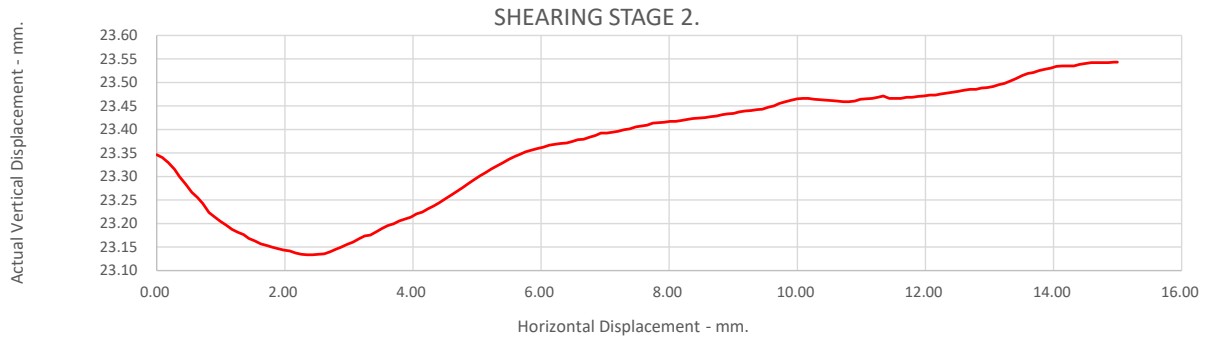
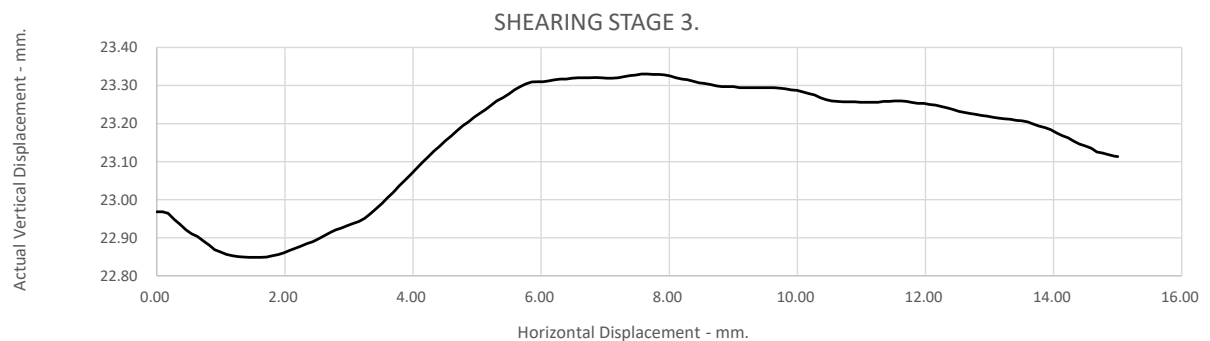
Borehole Number: TP02  
Sample Number : 2

Depth from (m): 1.50  
Depth to (m):

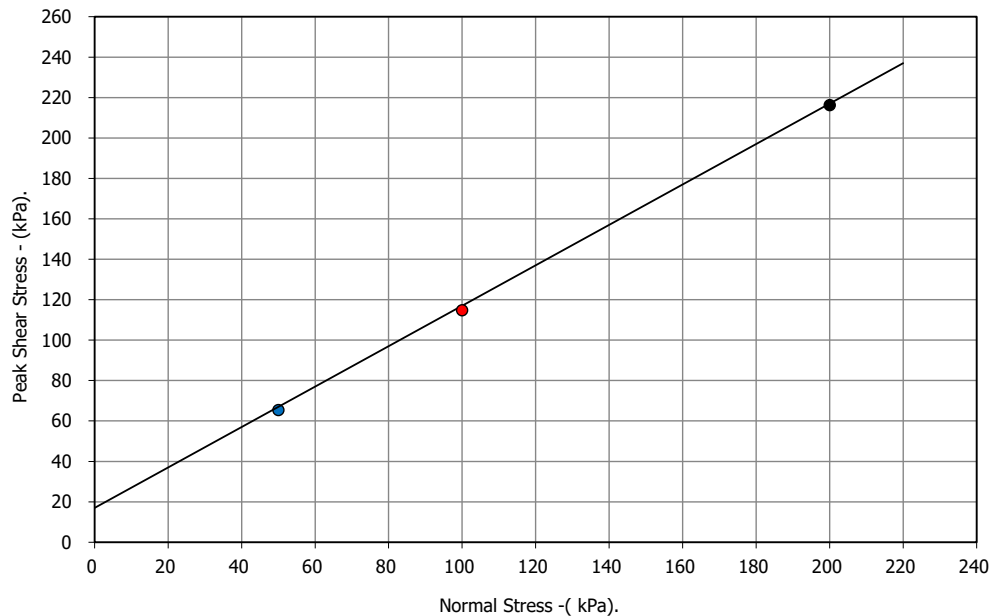
Angle of Shearing Resistance:( $\theta$ ) **45.0**  
 Effective Cohesion - kPa: **17**

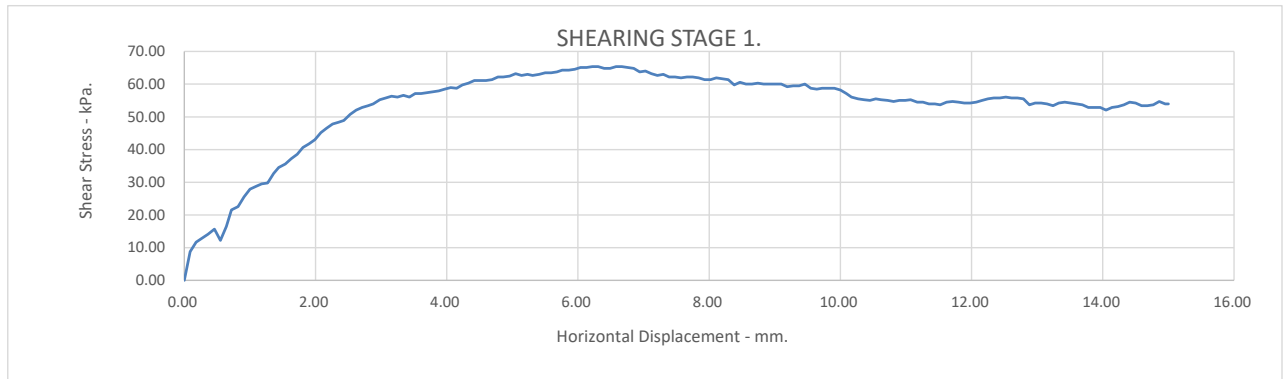
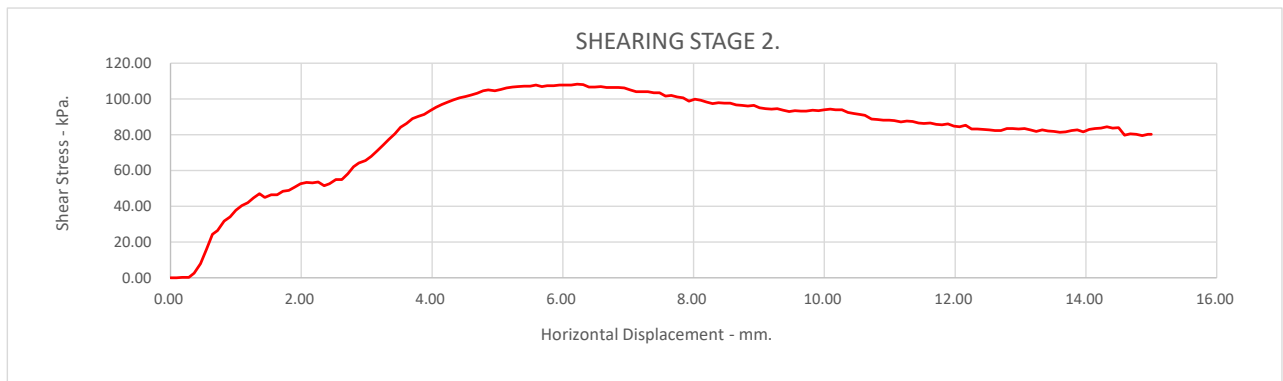
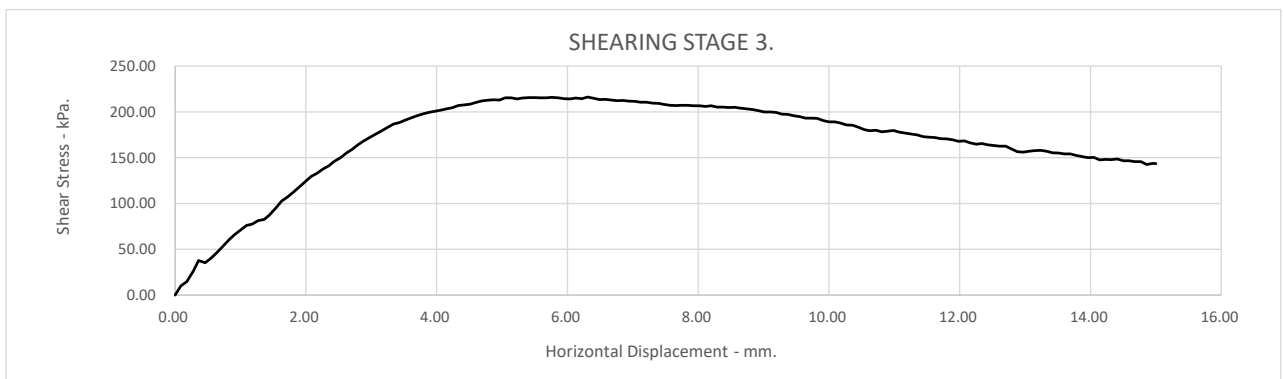
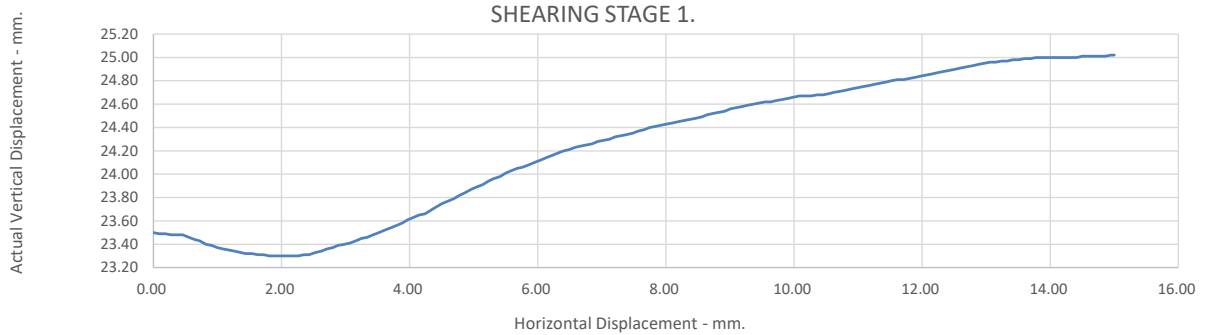
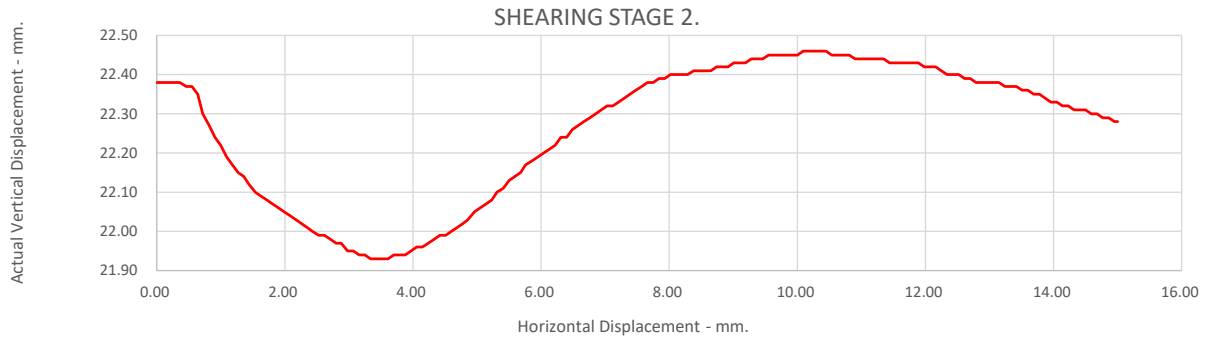
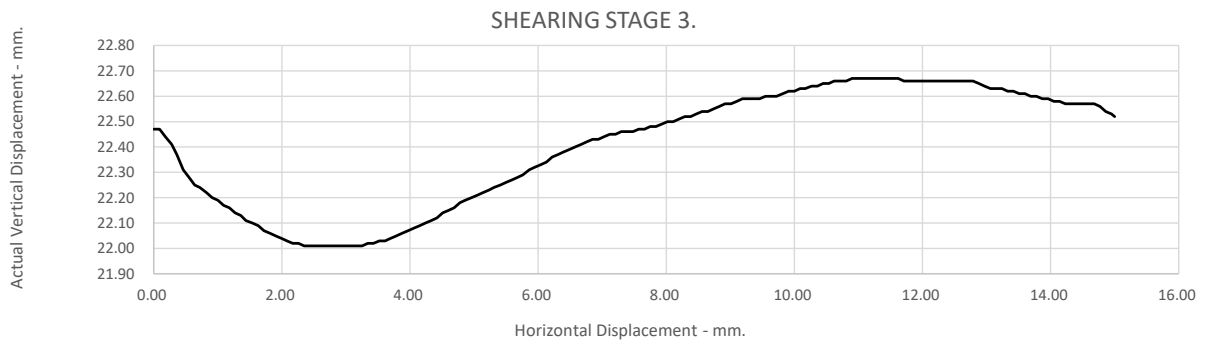
## Test Report: MS DIRECT SHEARBOX TEST.BS1377:Part 7:4.5 :1990.

Borehole Number: TP08      Depth from (m): 2.20  
 Sample Number : 2      Depth to (m):

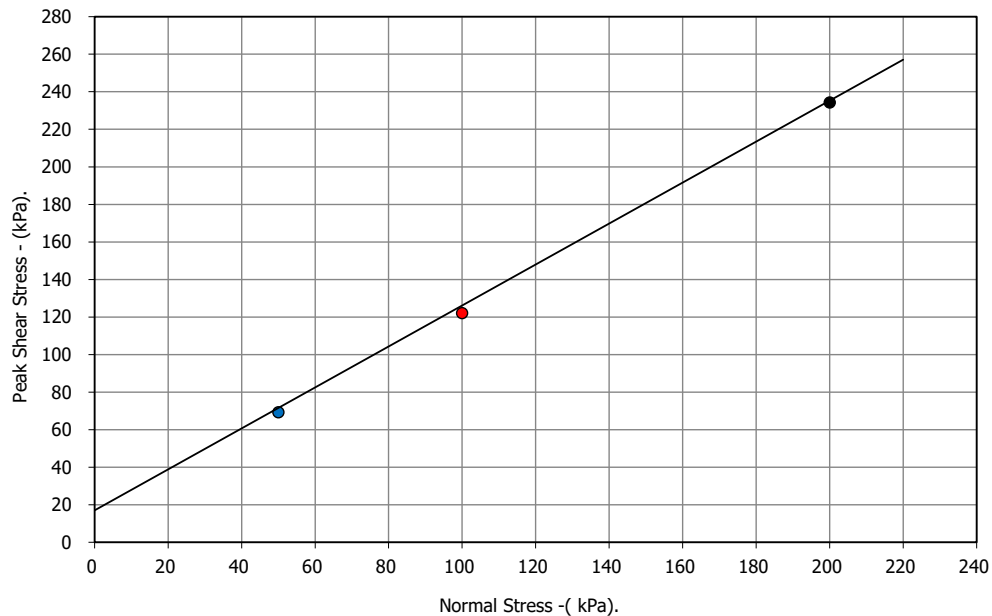
Angle of Shearing Resistance:( $\theta$ ) **47.5**  
 Effective Cohesion - kPa: **17**
