**HEOL CRWYS, CWMAVON**

**Supplemental Site Investigation Report**

14023/LW/24/SSI/RevC

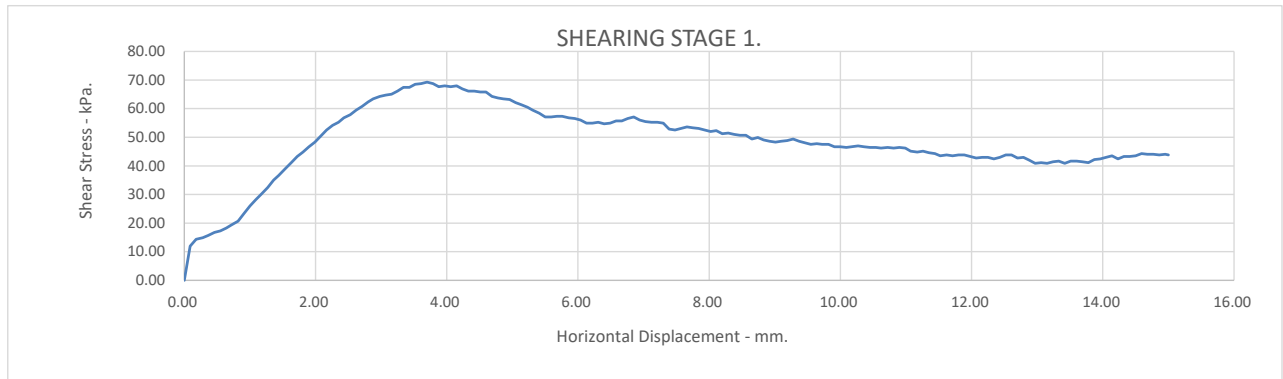
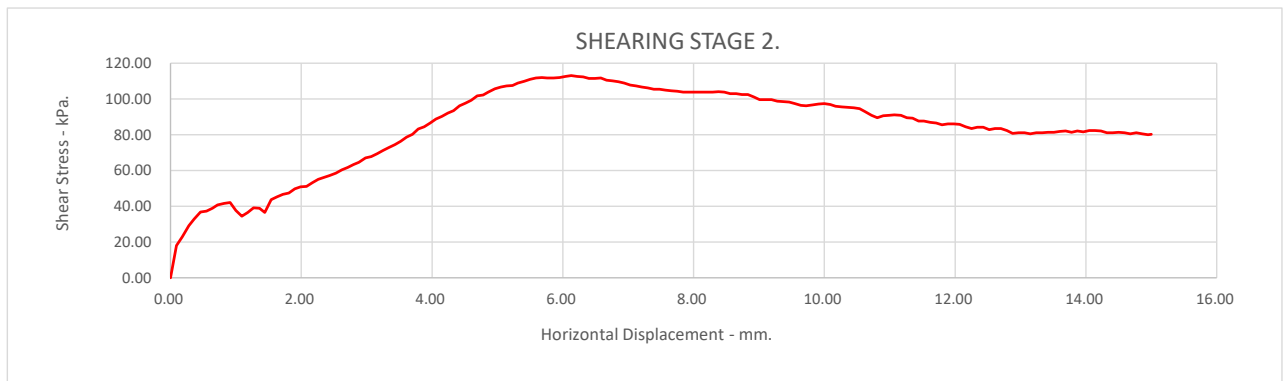
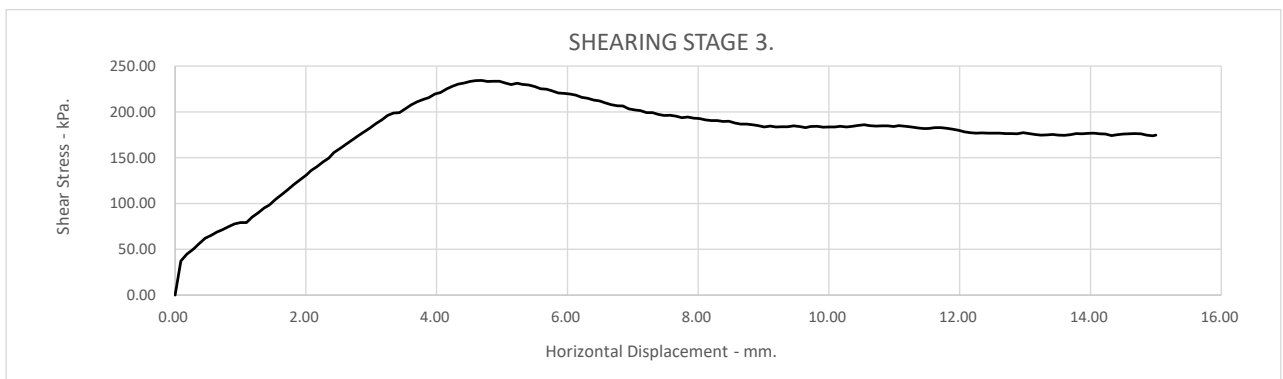
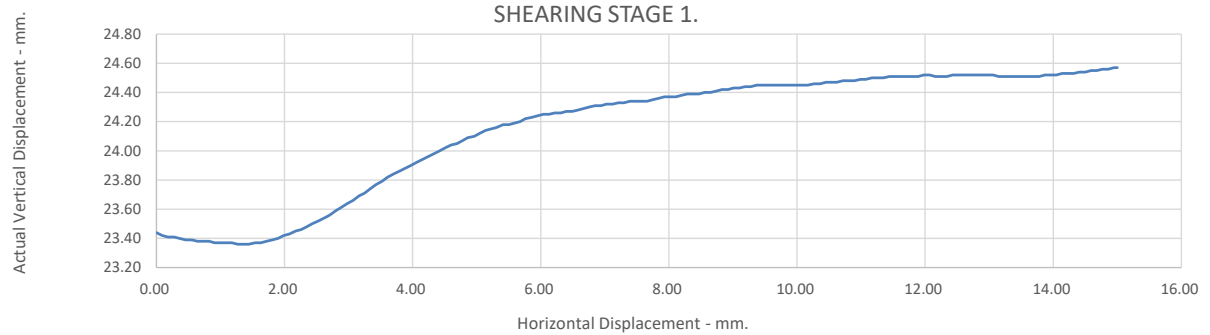
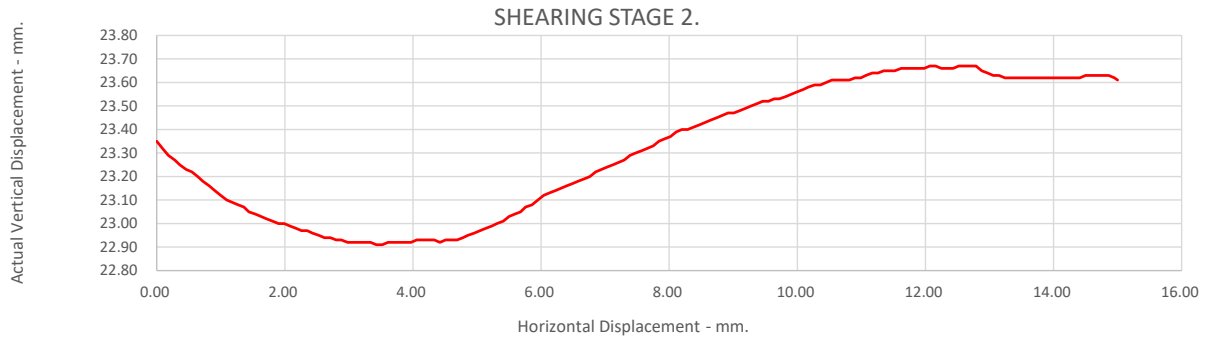
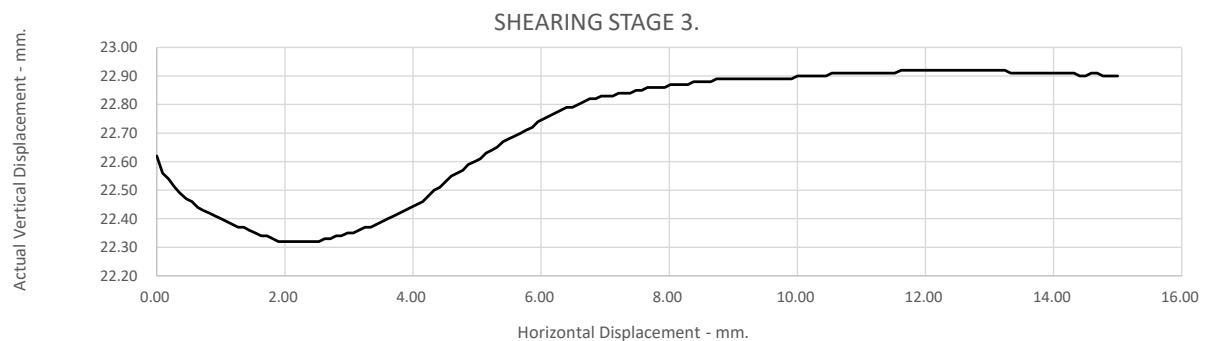
## Test Report: MS DIRECT SHEARBOX TEST.BS1377:Part 7:4.5 :1990.

Borehole Number: TP11      Depth from (m): 1.50  
 Sample Number : 2      Depth to (m):
