# HEOL TABOR, CWMAVON, PORT TALBOT, SA12 9PR

## Phase II:

## Ground Investigation Interpretative Report

Report No. Q1218/GIR

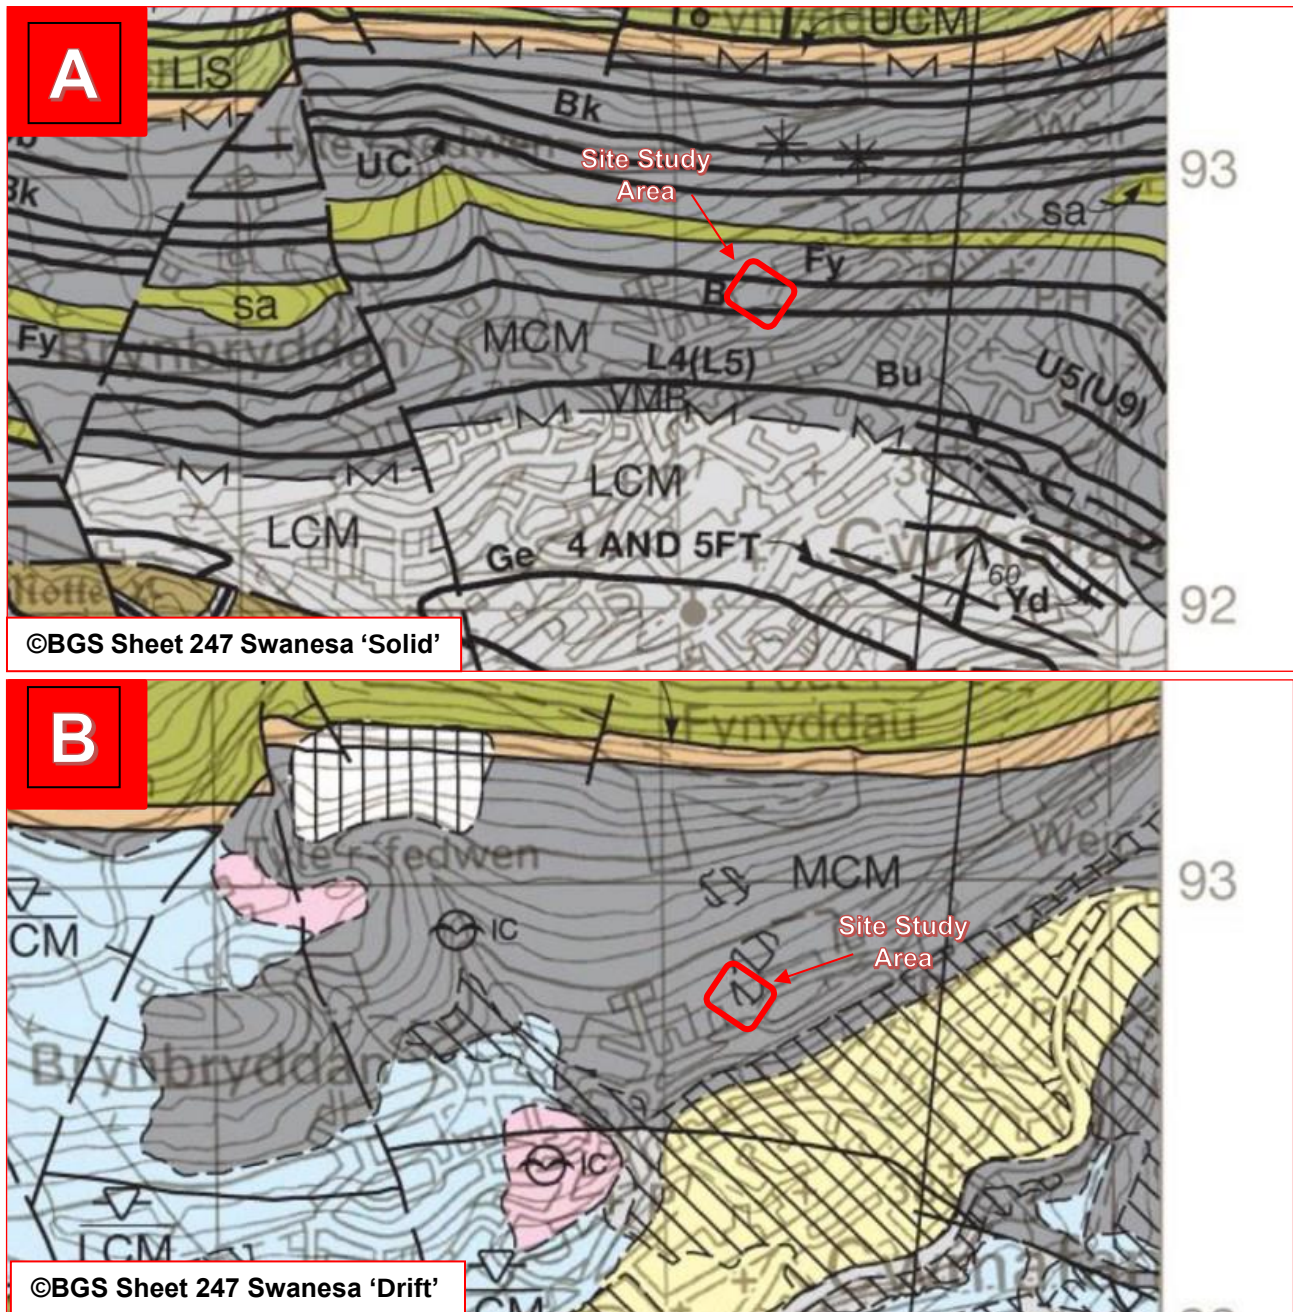
**Figure 2:** Illustration of the site study area 'Solid' and 'Drift' Geology using BGS Sheet 247

The geological mapping indicates the site to be underlain by strata from the South Wales Middle Coal Measures Formation. The lithology comprises grey, productive coal bearing mudstone/ siltstones with seat earths and minor sandstones. The dip angle/ direction of the strata is 35 degrees to the north. There is also one named fault (Gnoll Fault) 1.5km west of the site study area trending northwest-southeast with a downthrow of 200 yards to the west.

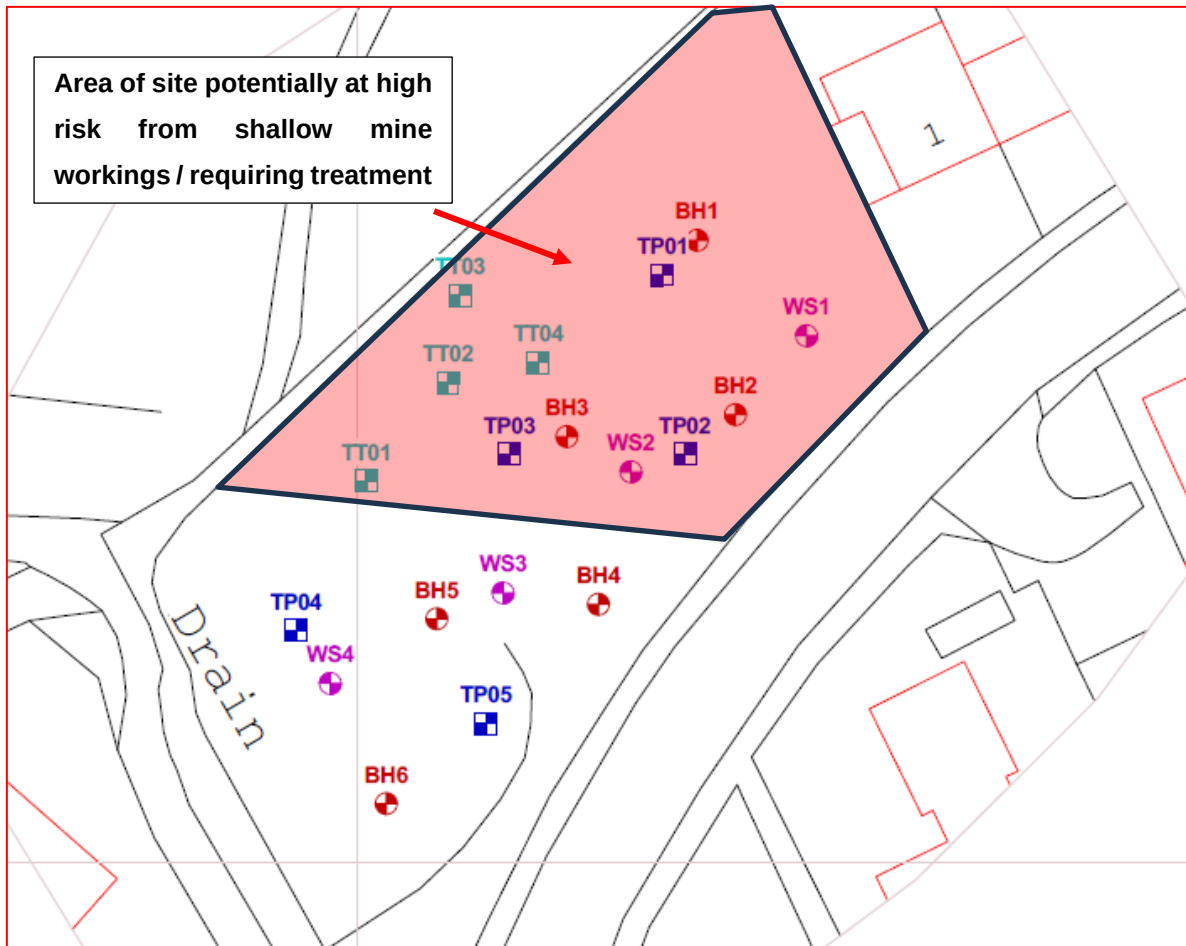
**Figure 3:** Indicative area of site potentially at risk from shallow mine workings.

Based on our assessment, an insufficient thickness of dependable strata is considered to exist above the identified voids and therefore, a risk of surface void migration from historic workings in the Big Seam below the northern area of the site exists. A negligible risk from shallow mine workings exists in the southern area of the site. An indicative drawing showing zones at high risk is presented in Figure 3.

Healy and Head (in CIRIA C758 Construction Over Abandoned Mineworkings) presented data that the extent to which a void may migrate from the roof of any workings is governed by the structure and form of deformation and disintegration of the roof material. The geometry of collapse they proposed, could be due to rectangular collapse, wedge collapse or conical collapse. The maximum height of potential collapse is then related to the bulking factor as discussed, for the three differing modes of failure. From the data presented in CIRCA C758, for the lowest bulking factor and the worst-case failure type (Conical), the height to which a void may migrate is 10 times the seam or working thickness. At the maximum seam thickness reported 1.75m, then collapse may migrate 17.5m above such a void before becoming arrested. Based on this theory, the void associated with suspected workings within the '**Big Seam**' may migrate to the surface across the northern area of the site.

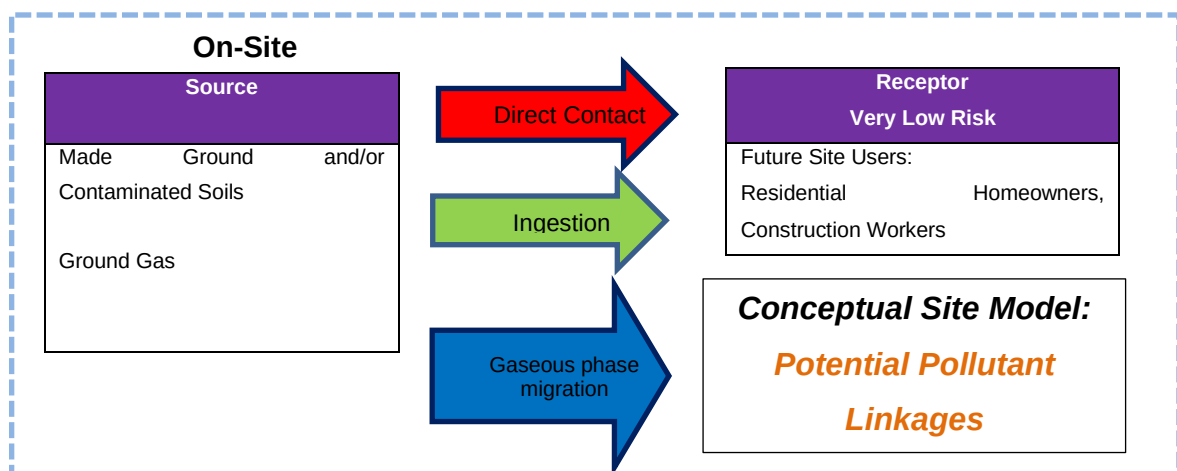
**Figure 4:** Conceptual Site Model: Pollutant Linkages

Considering sources and receptors on-site, a pathway exists: on-site to on-site. A visual representation of the complete model and each pollutant linkage is provided as Figure 4 below.

The remedial measures recommended within Section 7.5.1 and 7.6 would remove either the contamination source or contamination pathway and as such, remove the risk to future site users.

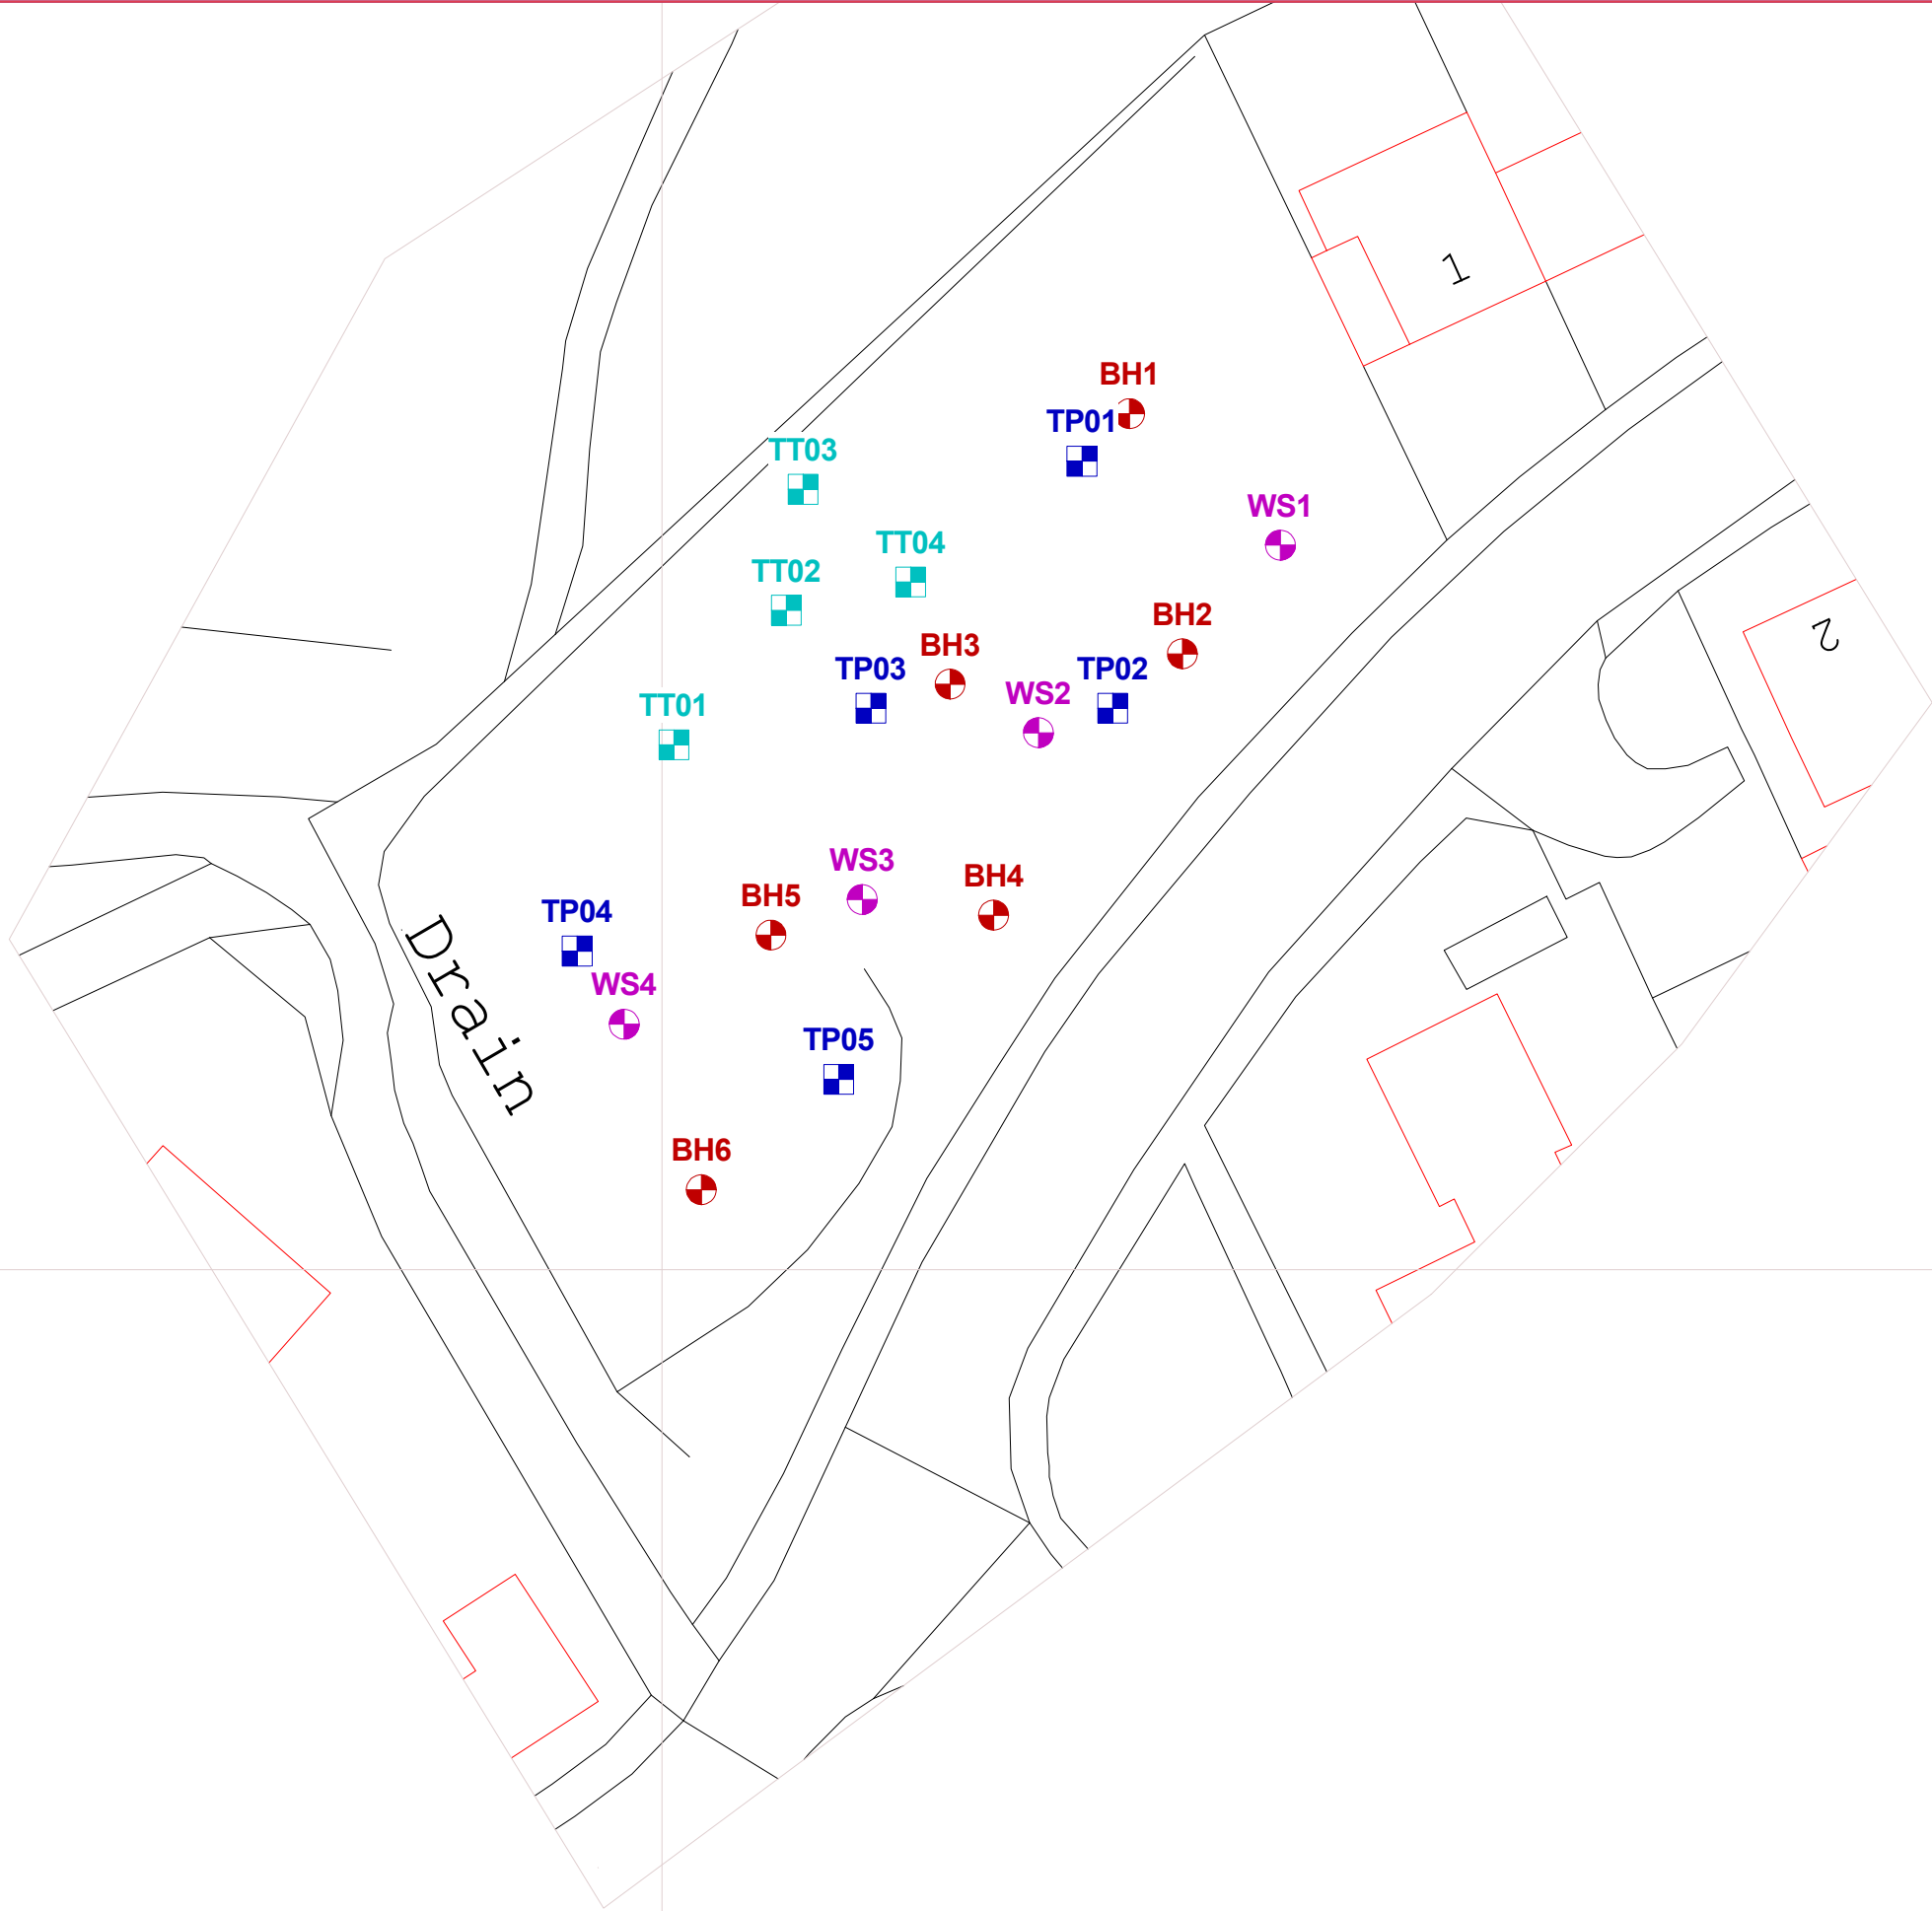
Indicative Cross Sections of the ground conditions below the site are presented in Appendix I.

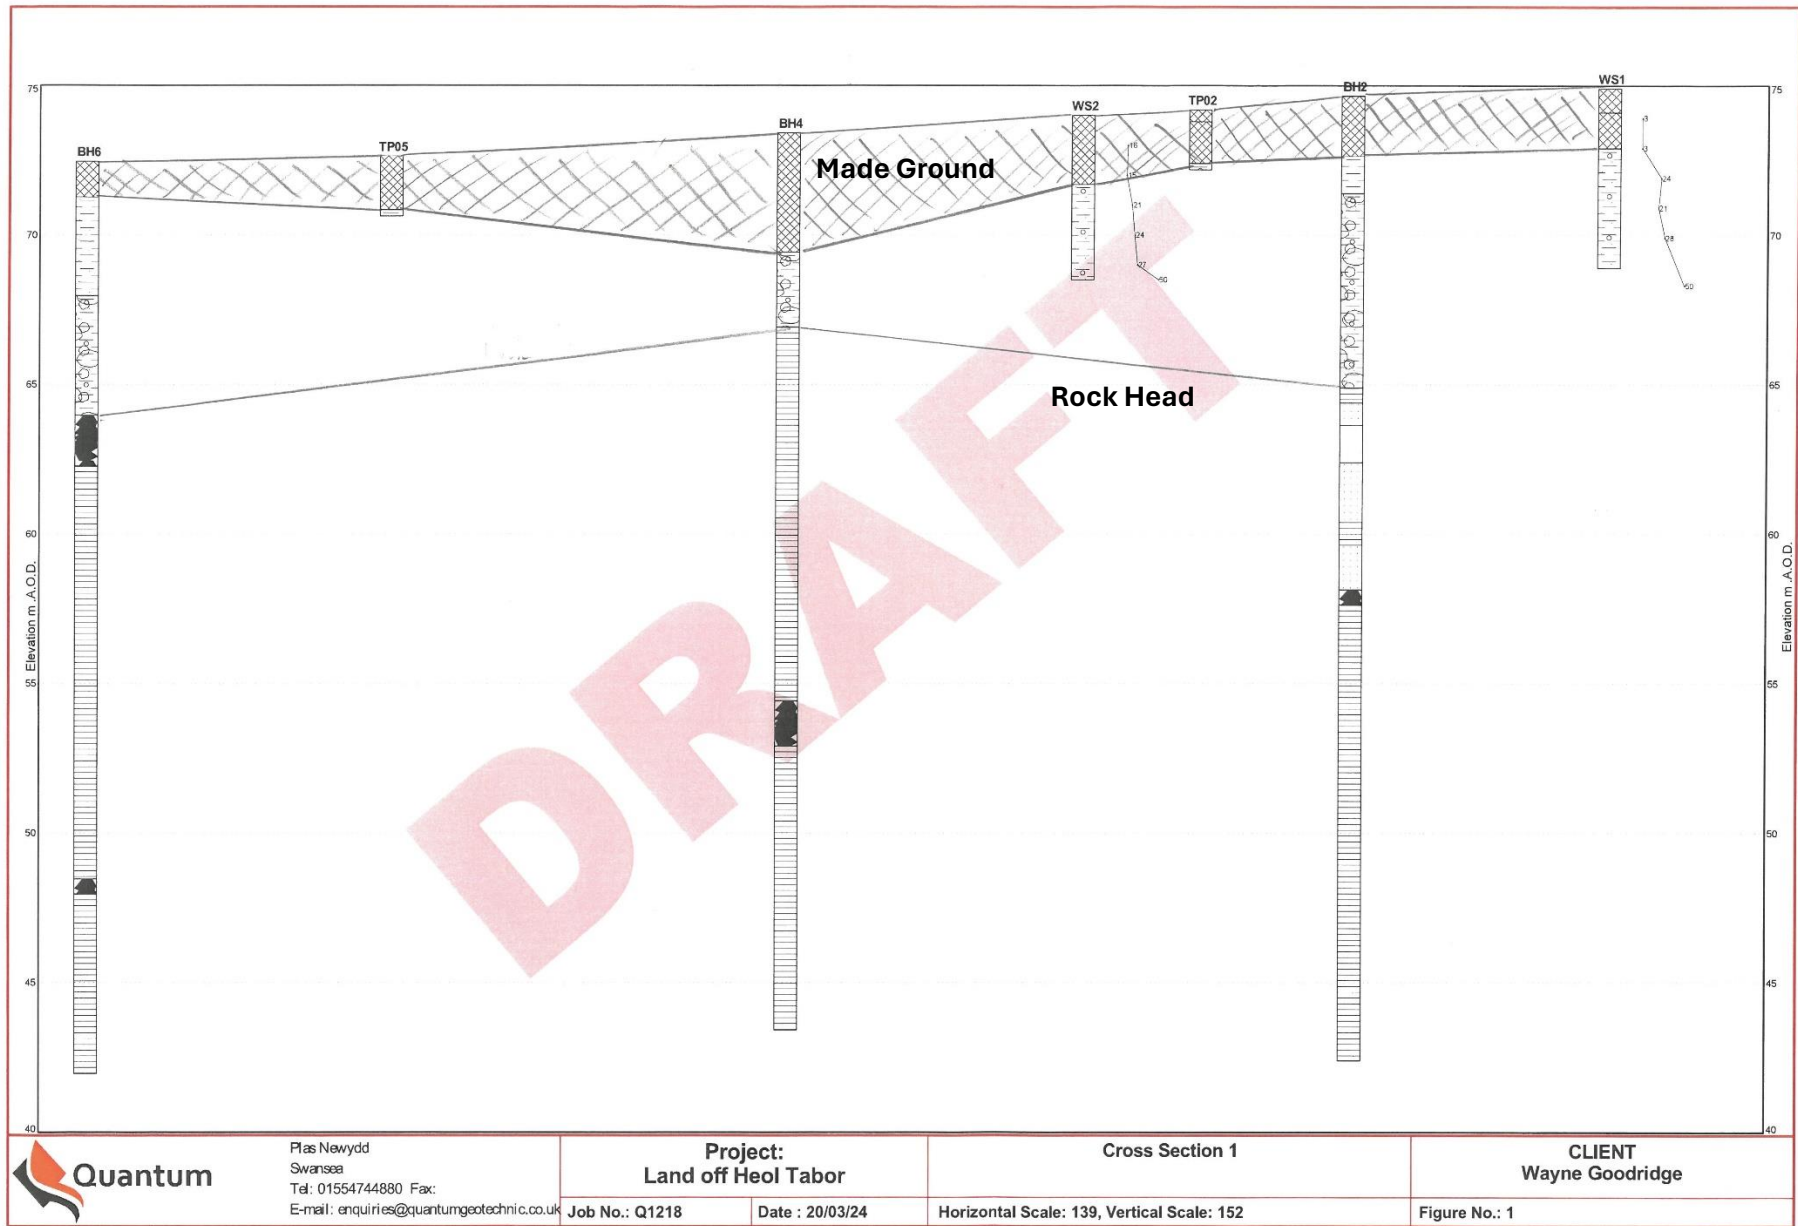
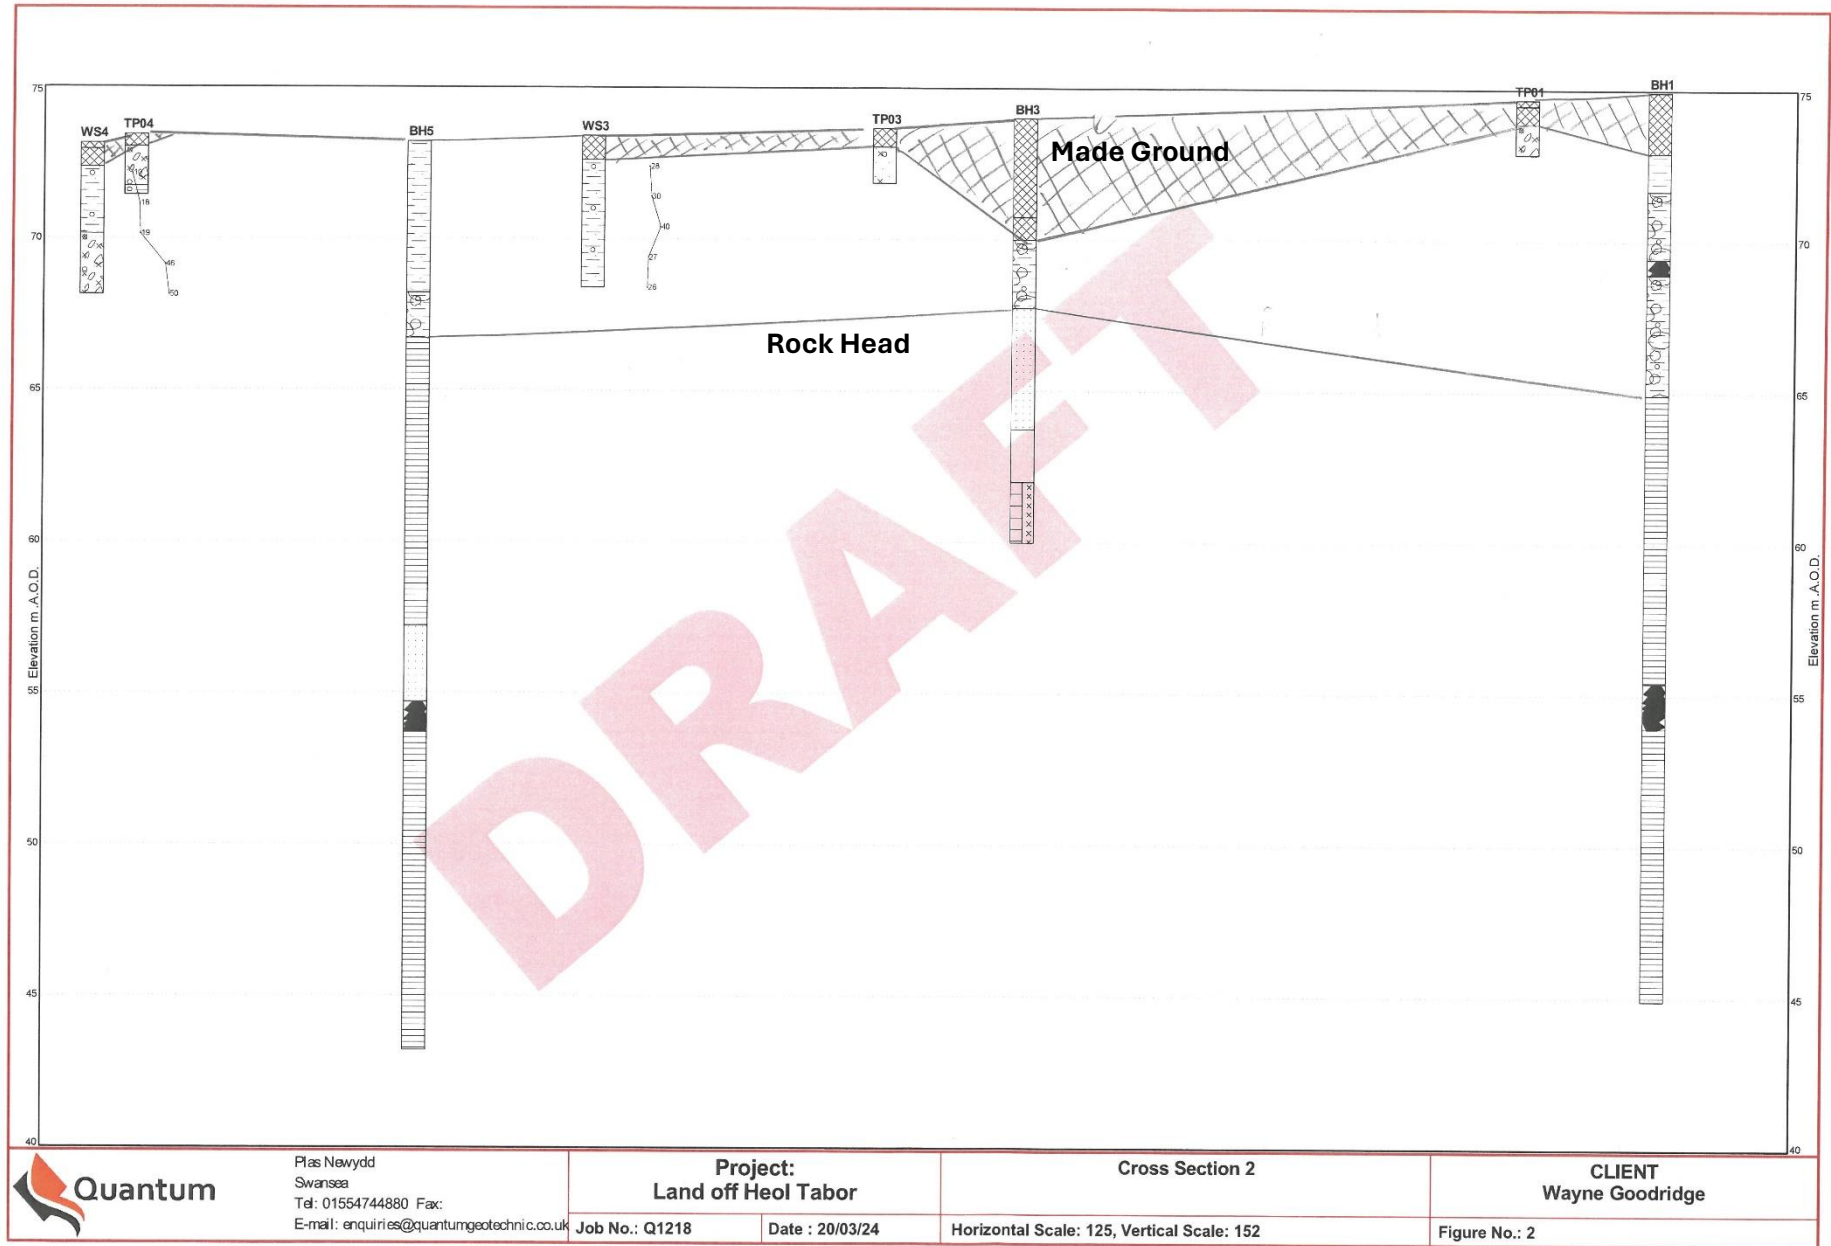
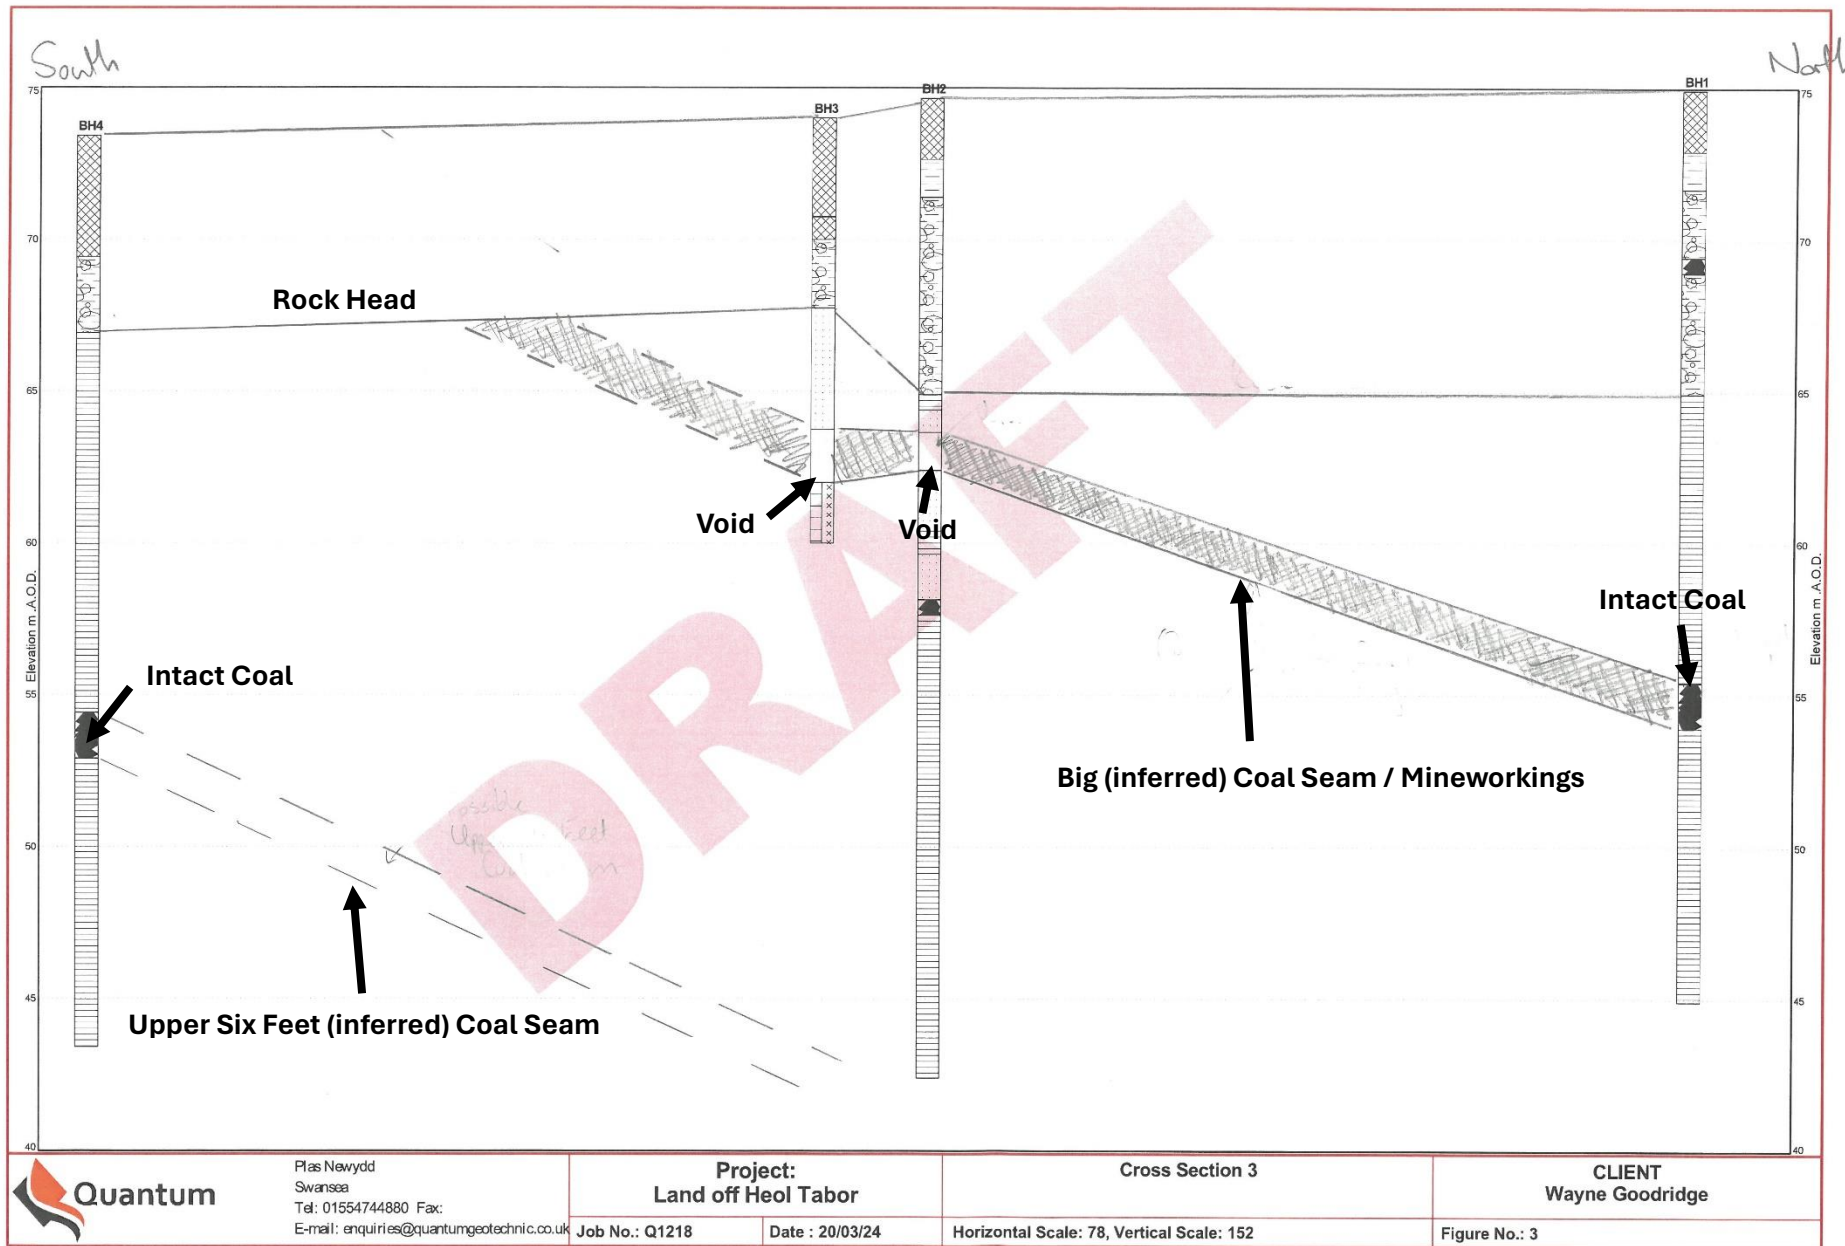
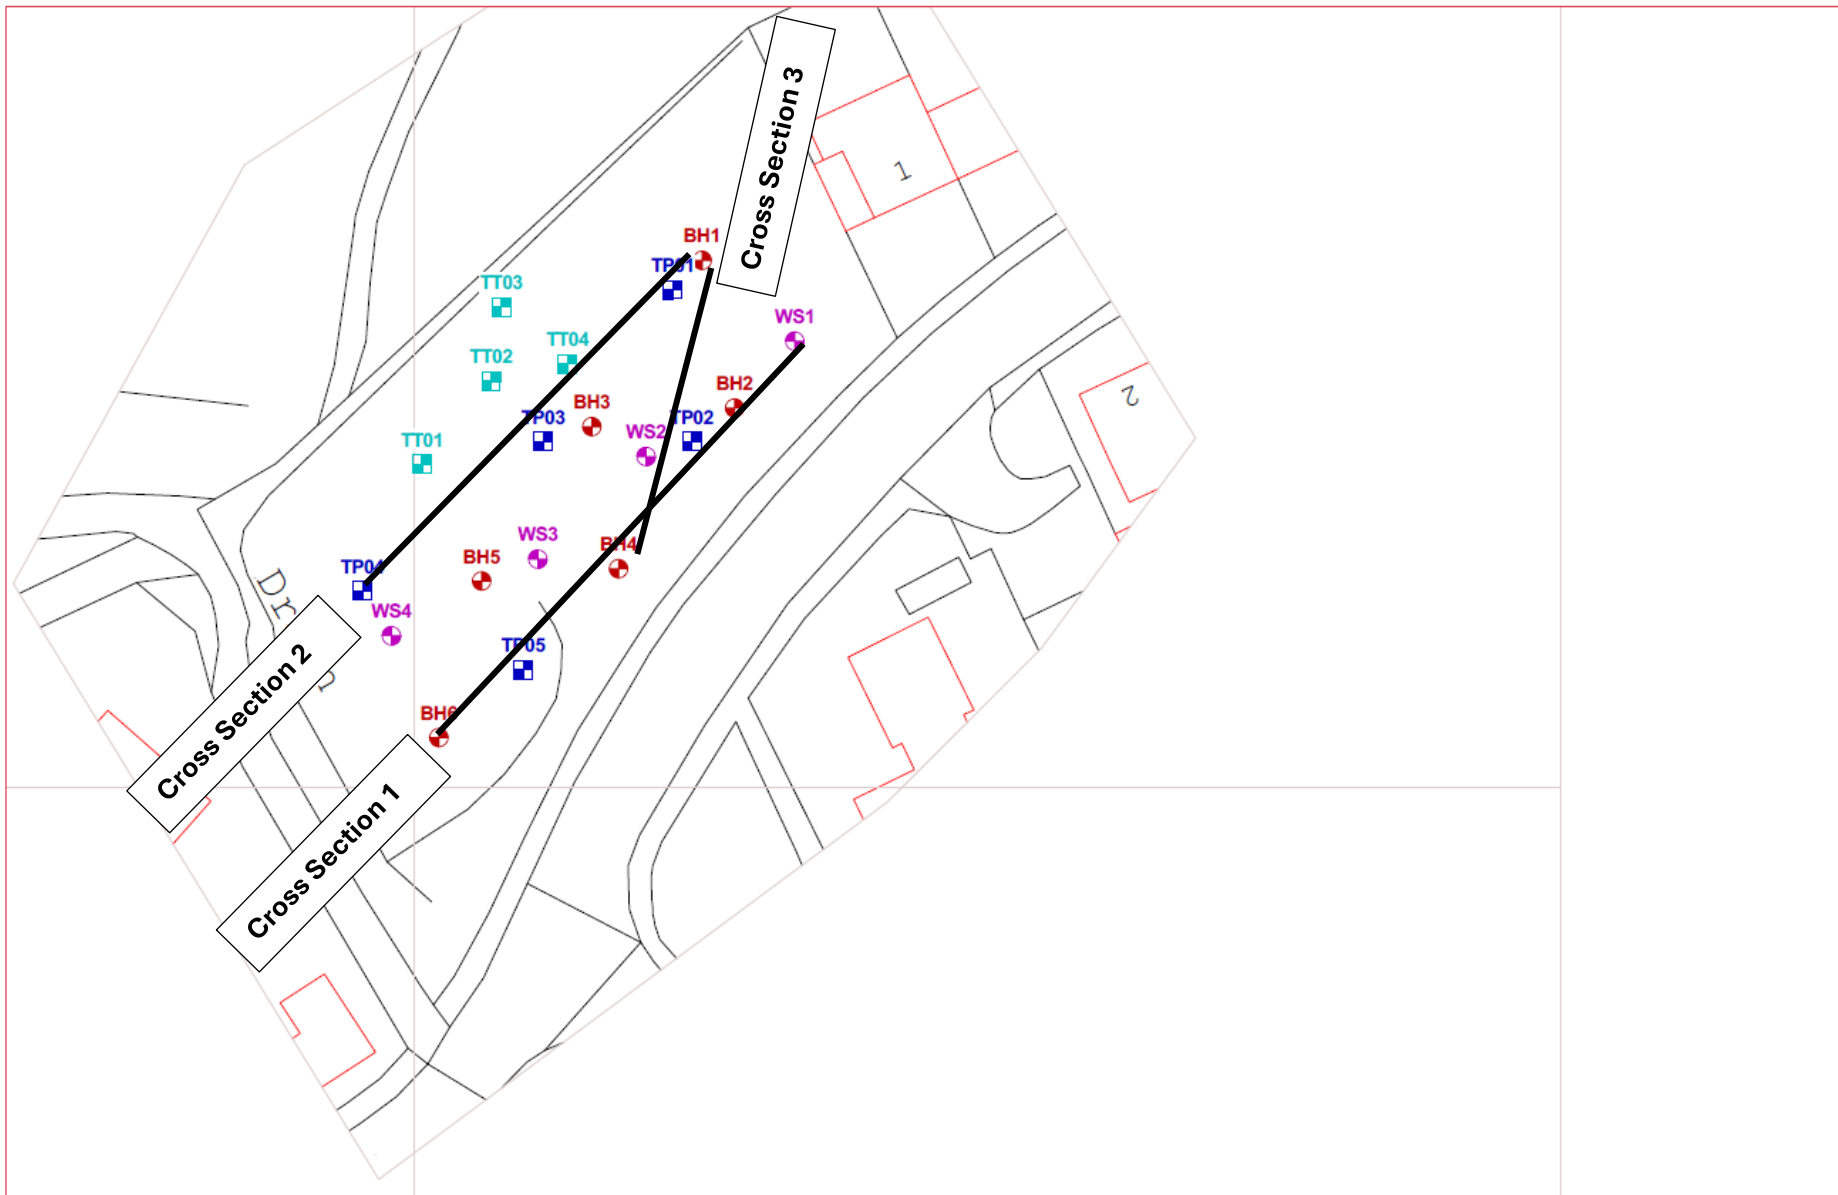
The exploratory hole locations were set out by a SQL Engineering Geologist at locations specified by SQL to obtain as best coverage of the site and where access could be gained with the investigation equipment. An Exploratory Hole Location Plan is presented as Figure 1 in Appendix I.
