**Parc Pelenna**

**Archaeological and  
Heritage Assessment**

Prepared by:  
**The Environmental Dimension  
Partnership Ltd**

Report Reference  
**edp6556\_r006b**

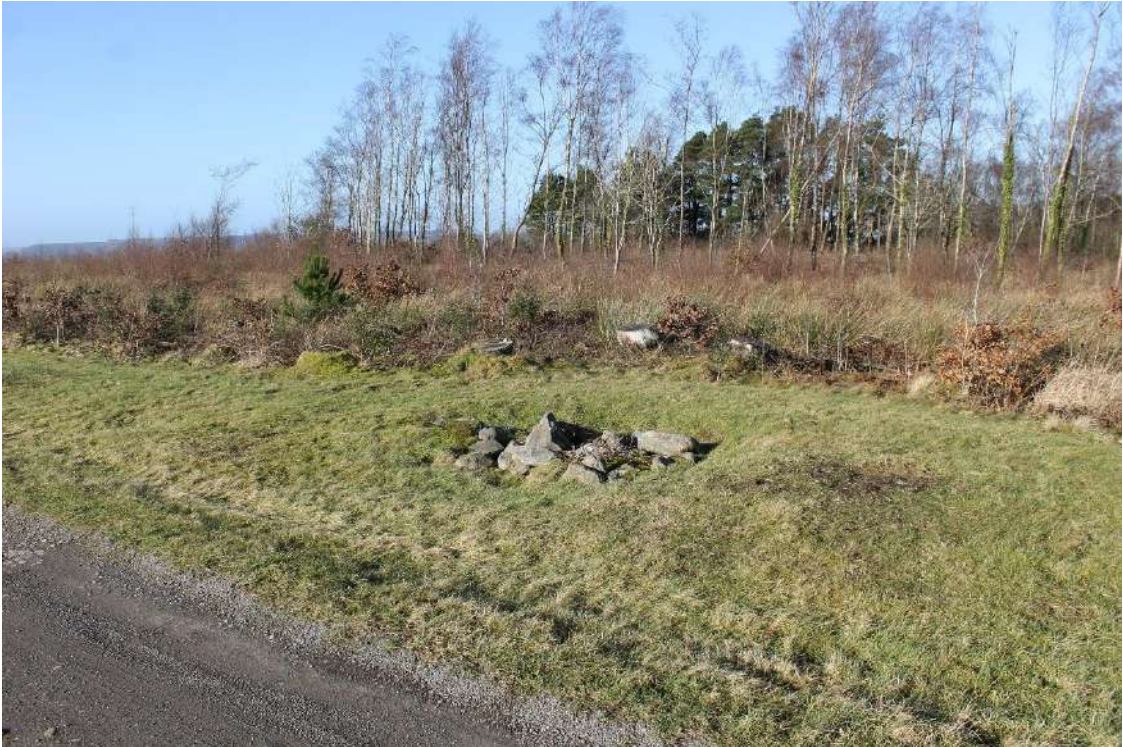
**Image EDP A1.1:** View north-west across the Pen-Rhiw Angharad Round Cairns Scheduled Monument illustrating the vegetation that covers most of the monument with the only clearly visible cairn in the foreground.

- 4.19 Whilst the majority of the monument's significance is contained in its physical fabric a lesser proportion is derived from its setting.
- 4.20 As noted above the monument is located within a small area of woodland (**Image EDP A1.1**) defined by young deciduous trees but with a dense understorey. This vegetation covers almost the whole monument with only the cairn (**307391**) located at the side of the adjacent track to the south not within it. The undergrowth obscures any visual appreciation of most of the cairns due to their low height and by restricting access through the monument on foot.

- 4.21 Whilst this restriction of access may protect the monument, the cairns are susceptible to damage from tree roots. Furthermore, the screening effect greatly reduces the degree to which the monument can be seen and understood. As such, the vegetation that covers the monument is a negative aspect of its setting that detracts from its significance to a low degree.

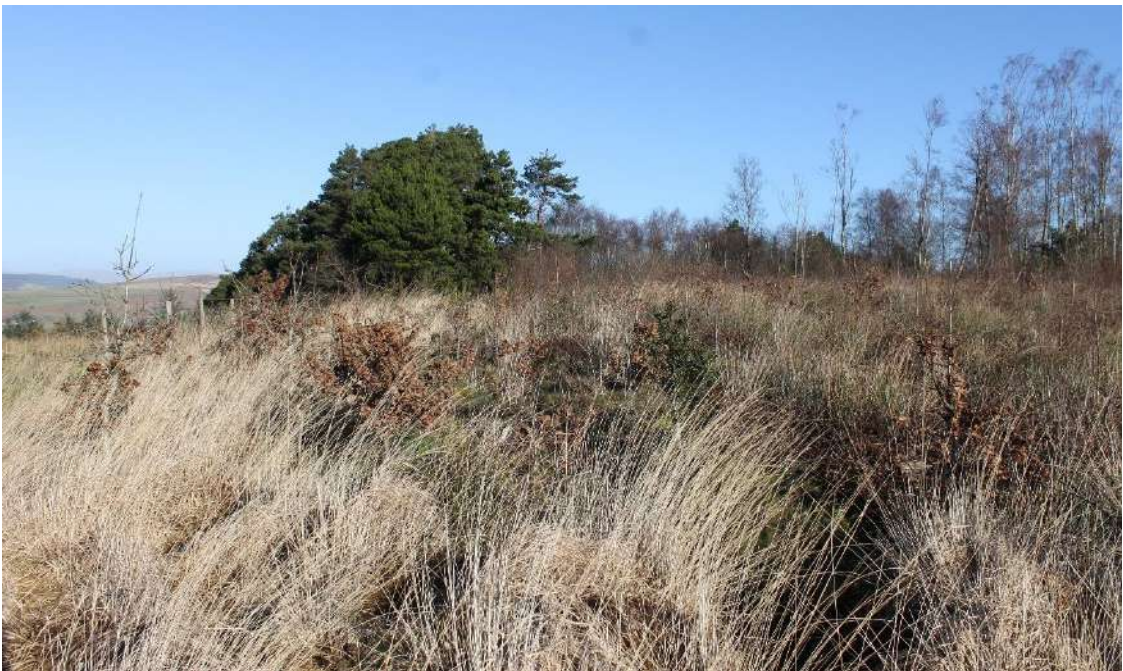
**Image EDP A1.2:** View of the distinct mound at the western end of the cairn group.

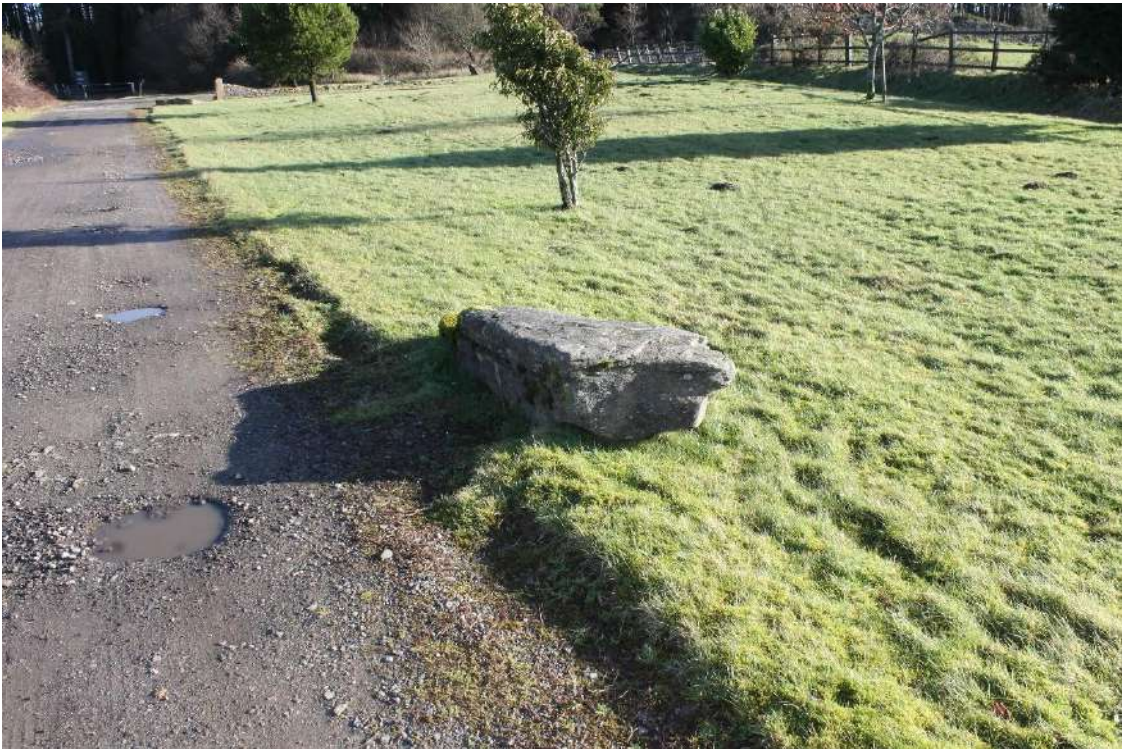
**Image EDP A1.3:** Stone slab located just outside of the scheduled cairn group.

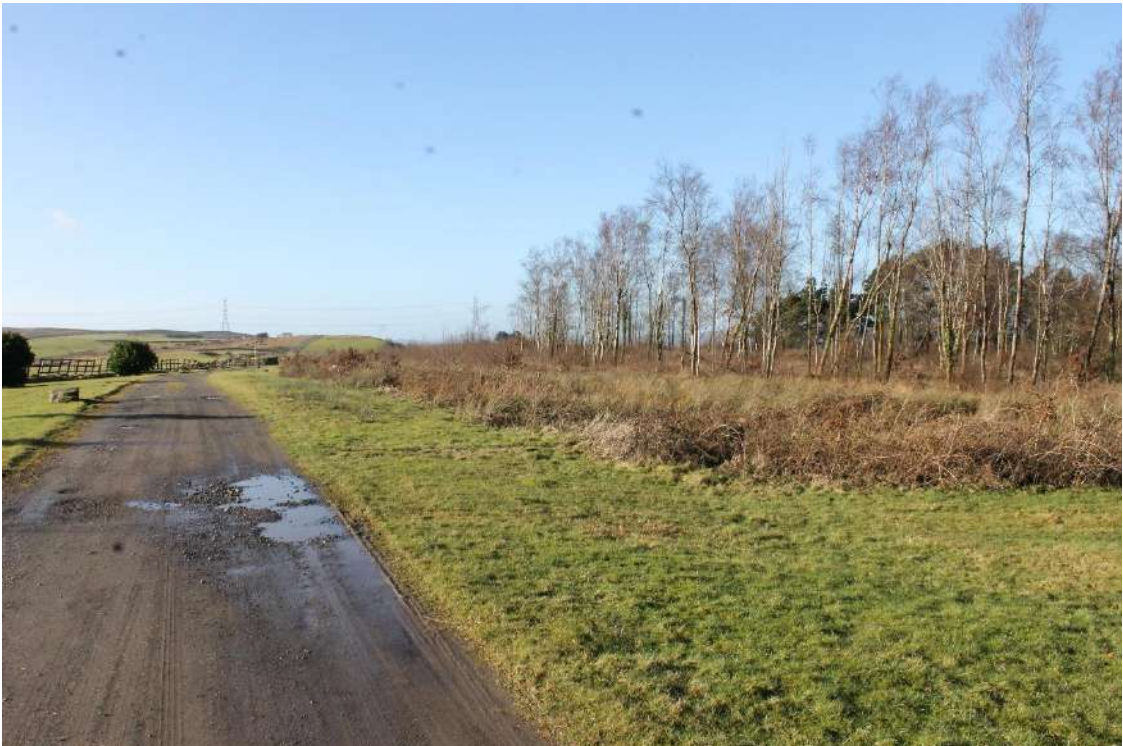
**Image EDP A1.4:** View illustrating the setting of the scheduled monument to the south, with the adjacent track, grassed spaces and ornamental trees visible.

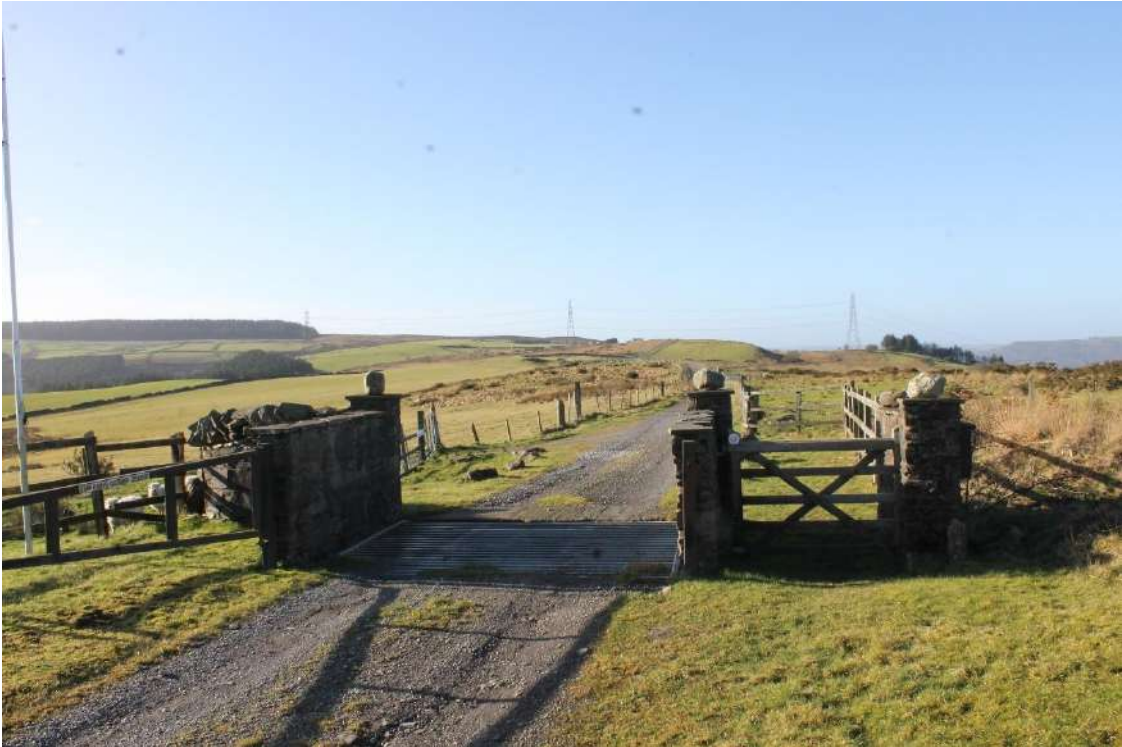
**Image EDP A1.5:** View to the west of the scheduled monument with stone gate piers in the foreground and the ridge beyond. Much of the view includes the extent of the Blaen-Cwmbach Camp with the low rise in the middle distance occupied by Blaen-Cwmbach Earthwork and, slightly nearer, the location of an additional Bronze Age cairn.

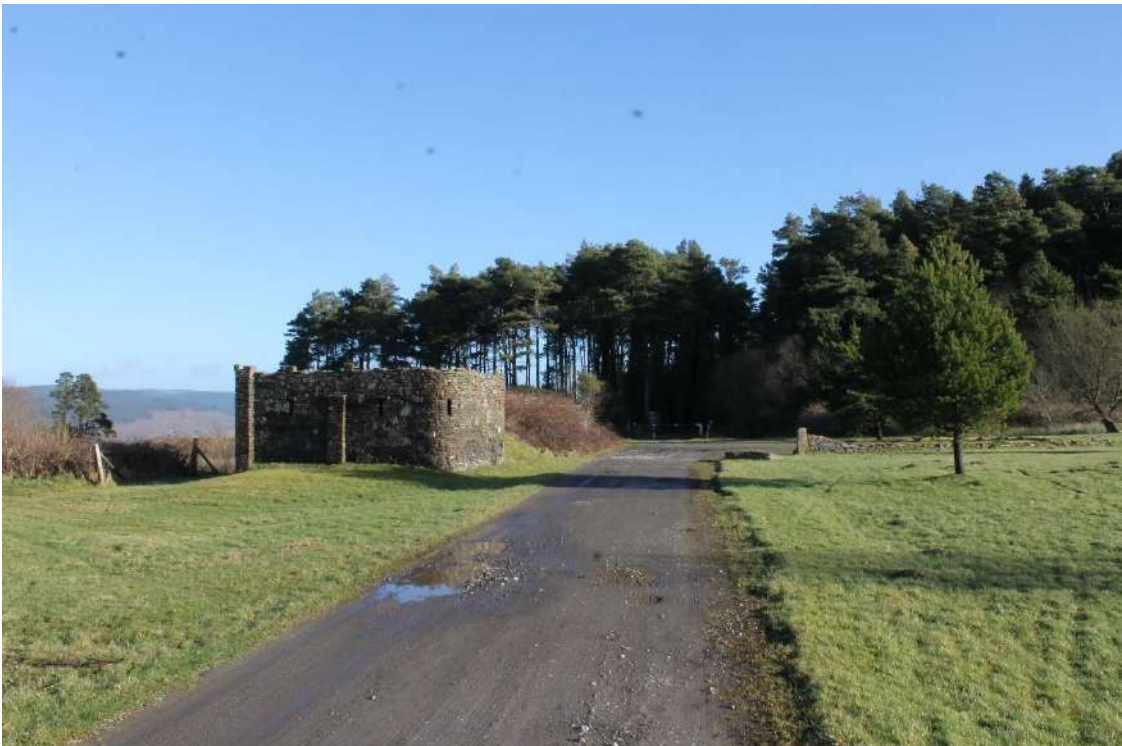
**Image EDP A1.6:** View to the east of the scheduled monument illustrating the stone walls that define the entrance to the estate and trees of Pelenna Forest beyond.

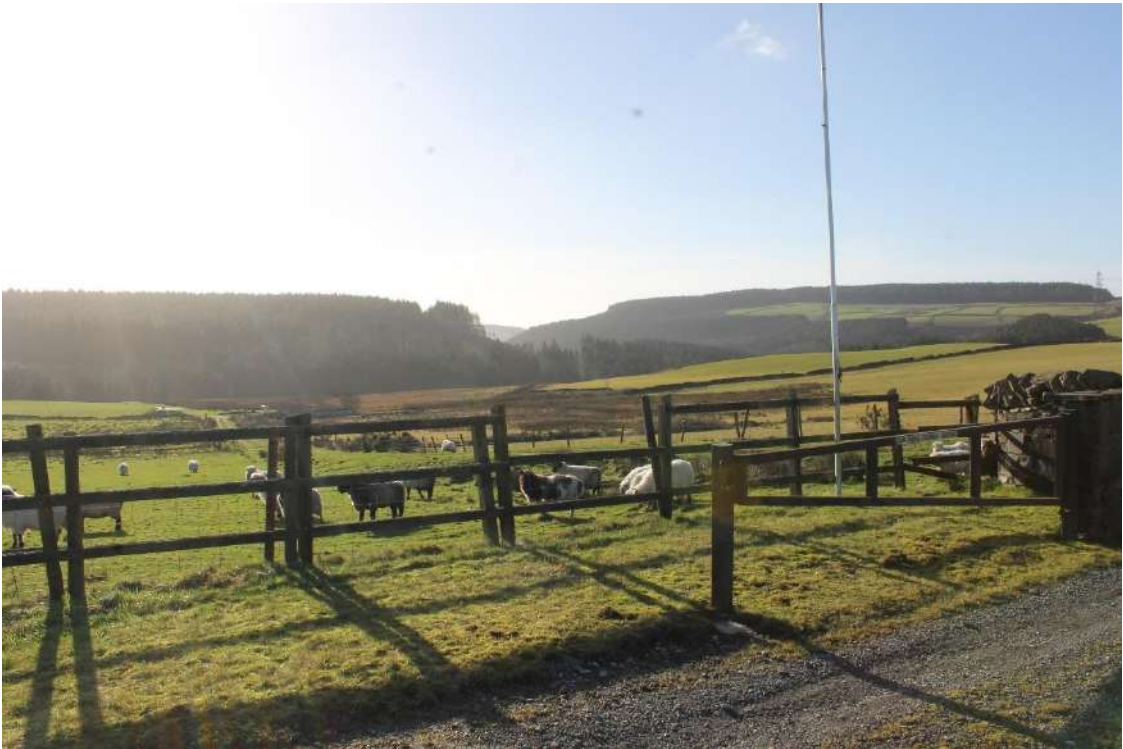
**Image EDP A1.7:** View to the south from the scheduled monument illustrating the extensive view.

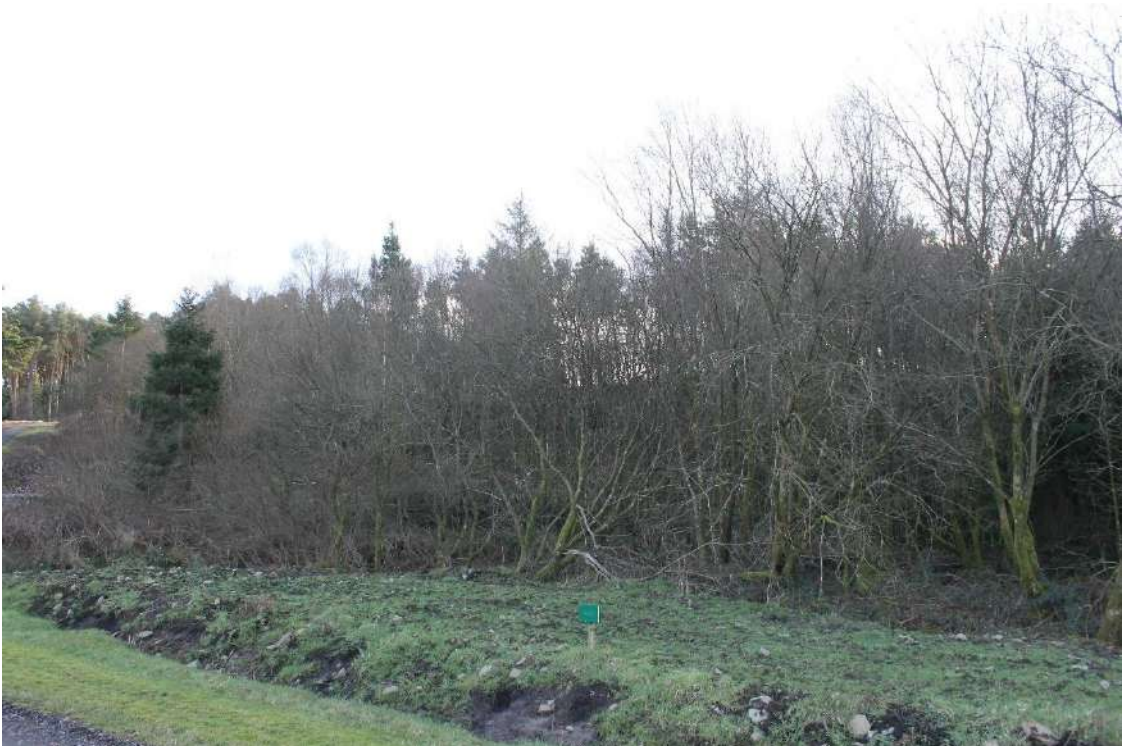
**Image EDP A1.8:** View towards the scheduled monument form the north-east, illustrating the dense stand of trees that screens view towards it from the part of the Site that is proposed for development.

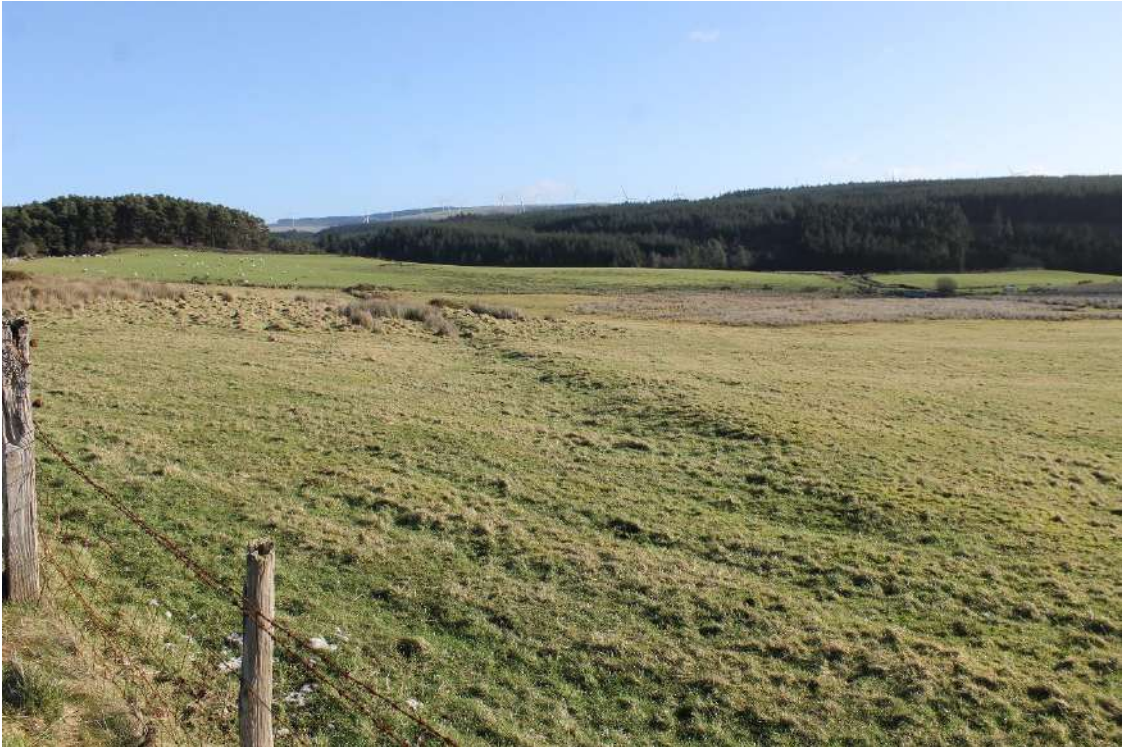
**Image EDP A1.9:** View of part of the rampart of the Roman camp illustrating how for most of its course is only very slight.

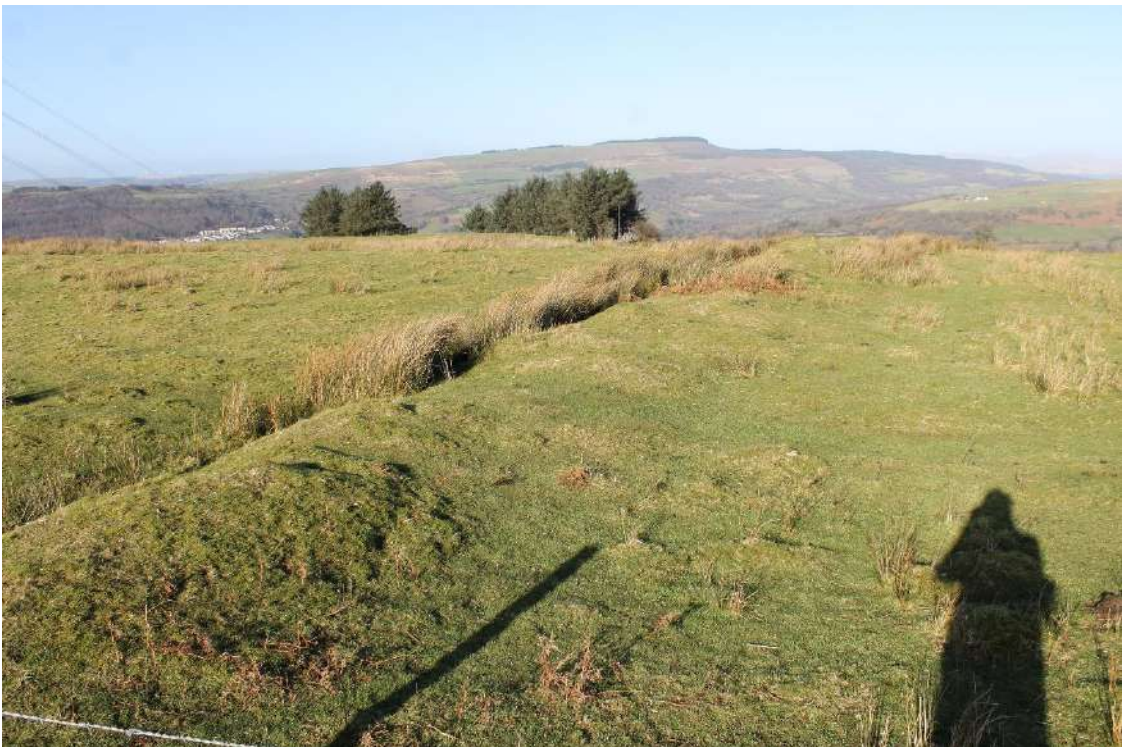
**Image EDP A1.10:** View of the western end of the Roman camp illustrating its best preserved external bank and ditch.

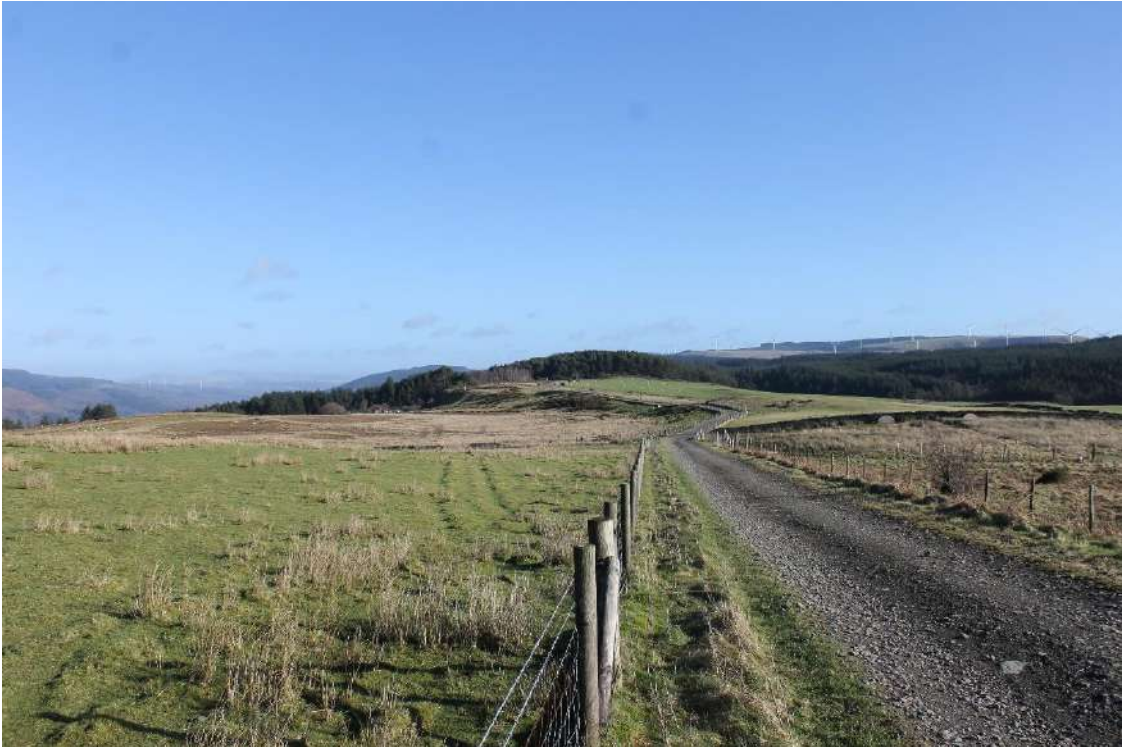
**Image EDP A1.11:** View across Blaen-Cwmbach Camp to the east towards the Site, from adjacent to the Blaen-Cwmbach Earthwork illustrating the character of the landscape and the screening effect of the coniferous trees on the Site's western edge.

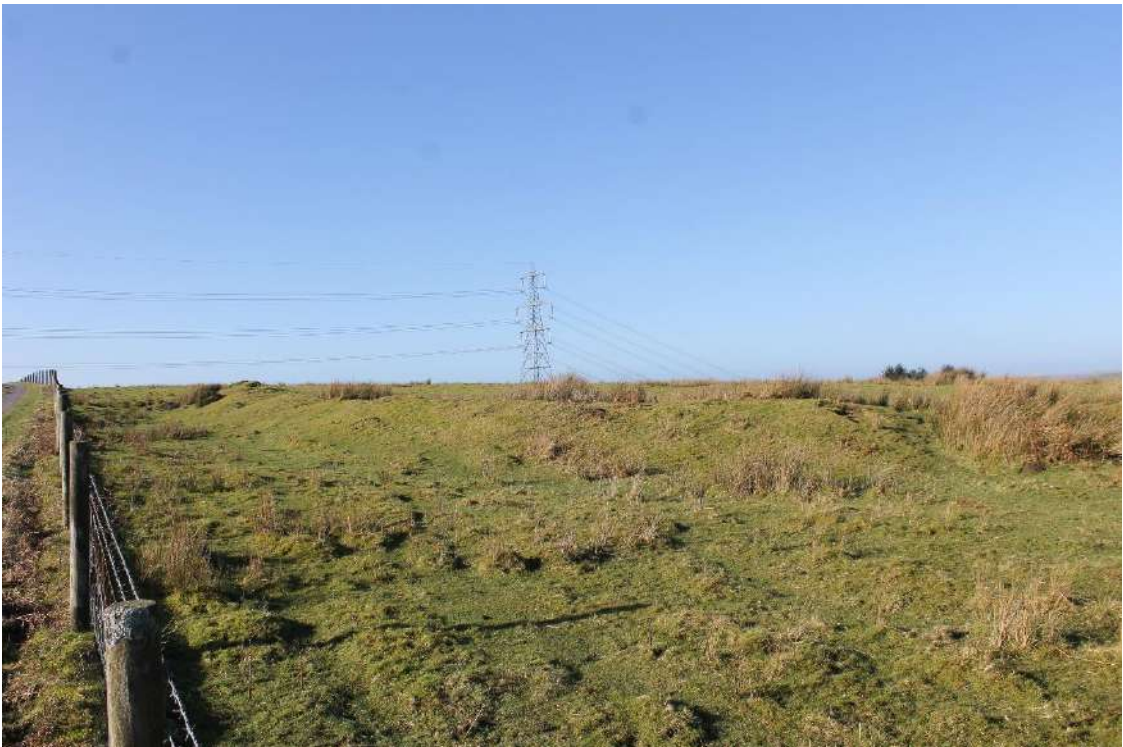
**Image EDP A1.12:** Part of the ramparts of the Blaen-Cwmbach Earthwork illustrating its appearance.

- 4.47 The monument (**Image EDP A1.12**): c.630m west of the Site) is recorded by Cadw as a small earthwork enclosure (**GM277**) situated within the Roman marching camp. The enclosure, situated at a high point of the ridge, is defined by an earth and stone bank c.9m wide and c.1.5m high, which utilises a steep natural scarp to the north as part of its circuit. The south-eastern side has an external ditch and causewayed entrance.

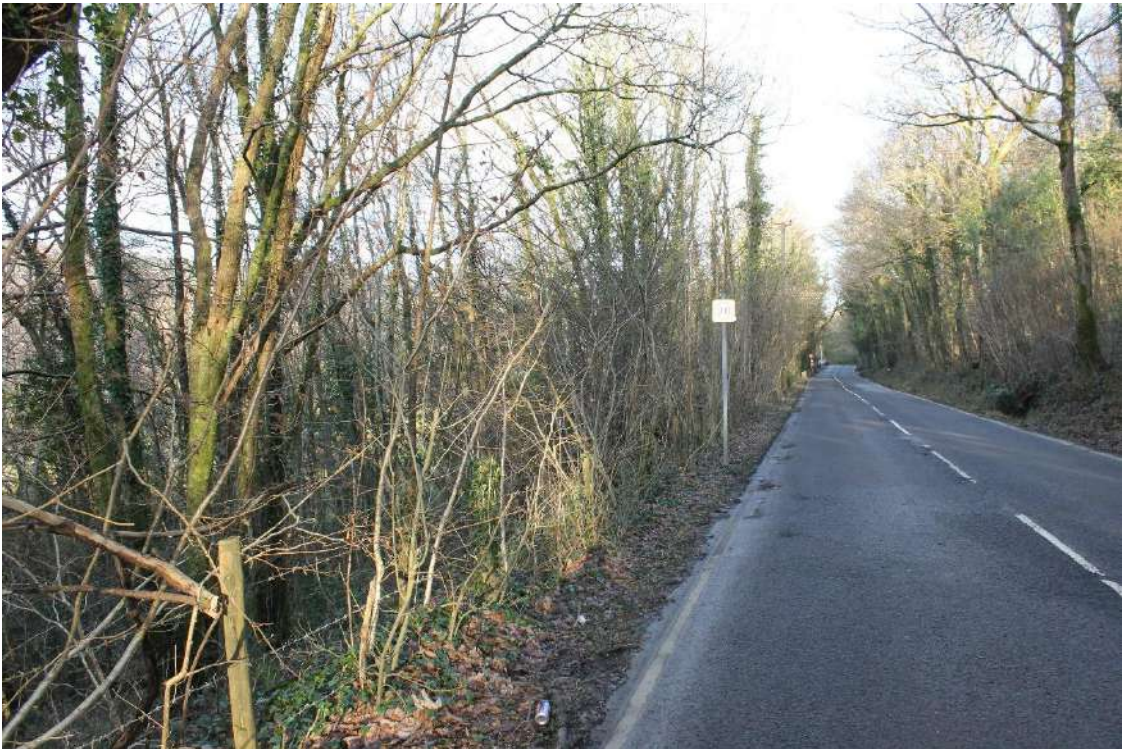
**Image EDP A1.13:** View along the B4434 illustrating the dense stands of trees on either side for the road that screen views down to the Neath Canal (to the left).

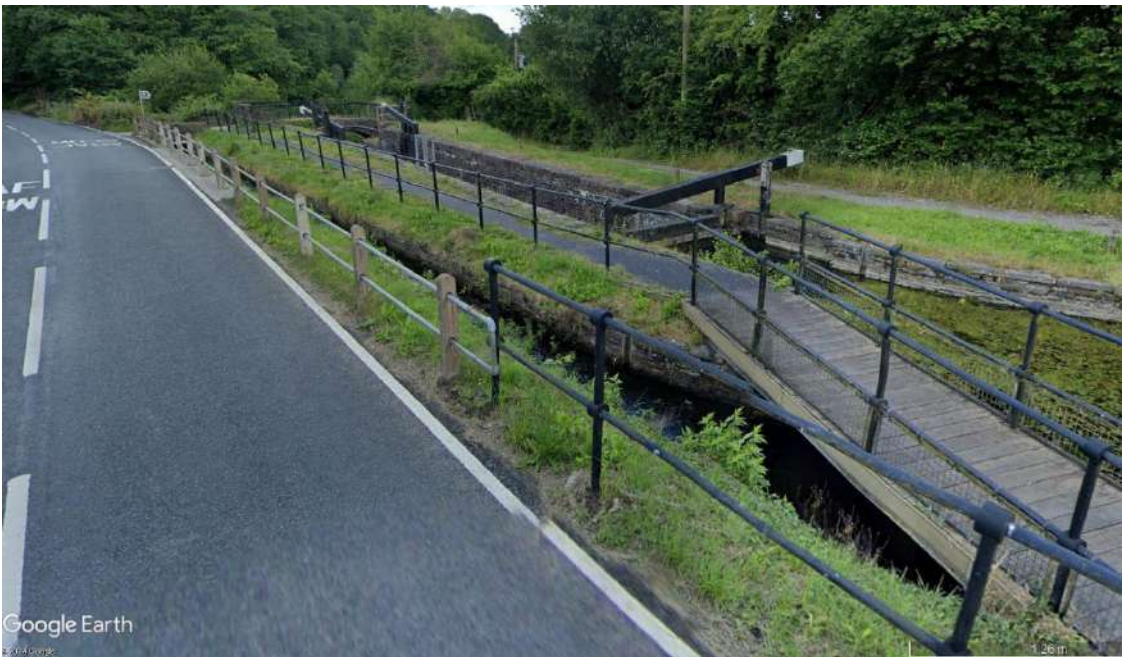
**Image EDP A1.14:** View of the listed culvert and sluice on the Neath Canal illustrating its roadside setting. (Google Earth Streetview ©2024).

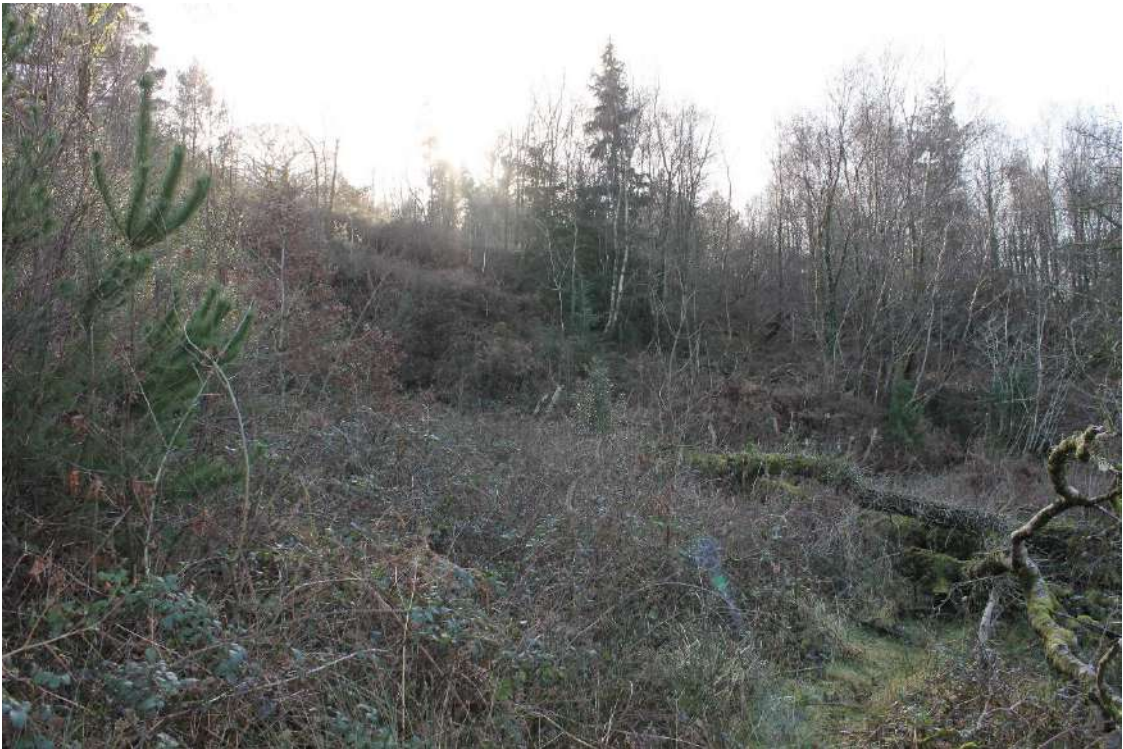
**Image EDP A1.15:** View across the location of the former Cefn Mawr Colliery illustrating the densely wooded nature of its location and setting.

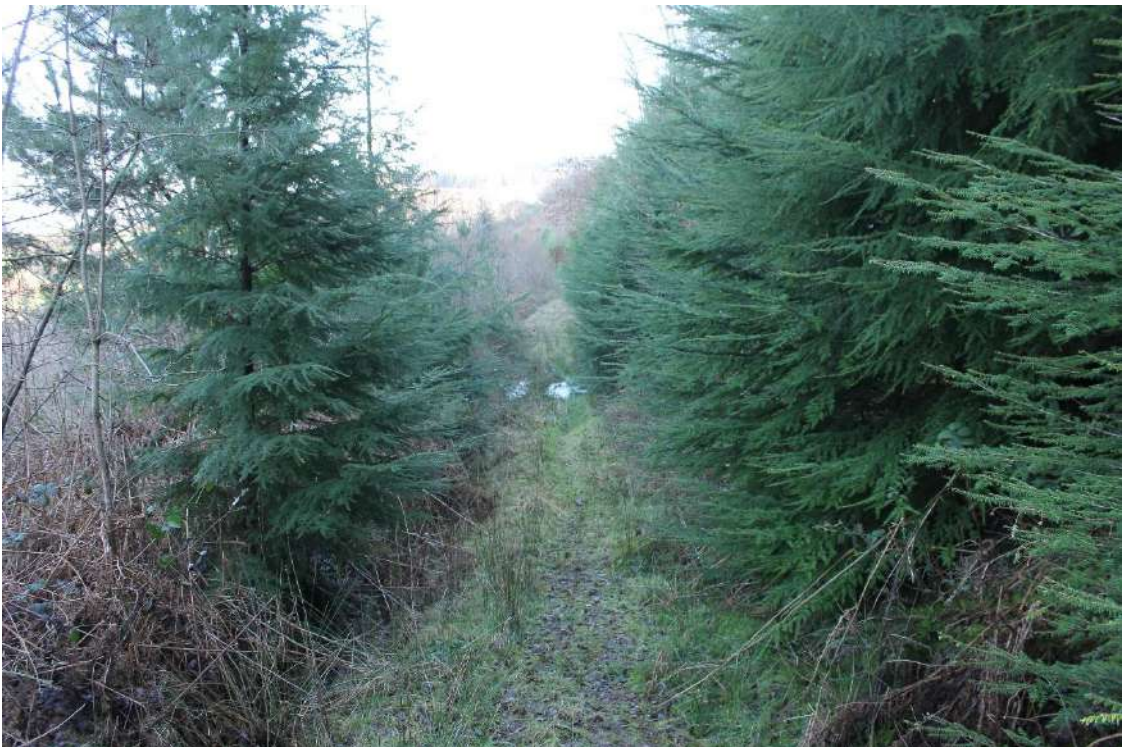
**Image EDP A1.16:** View along one of the former tramways which cross the Site.

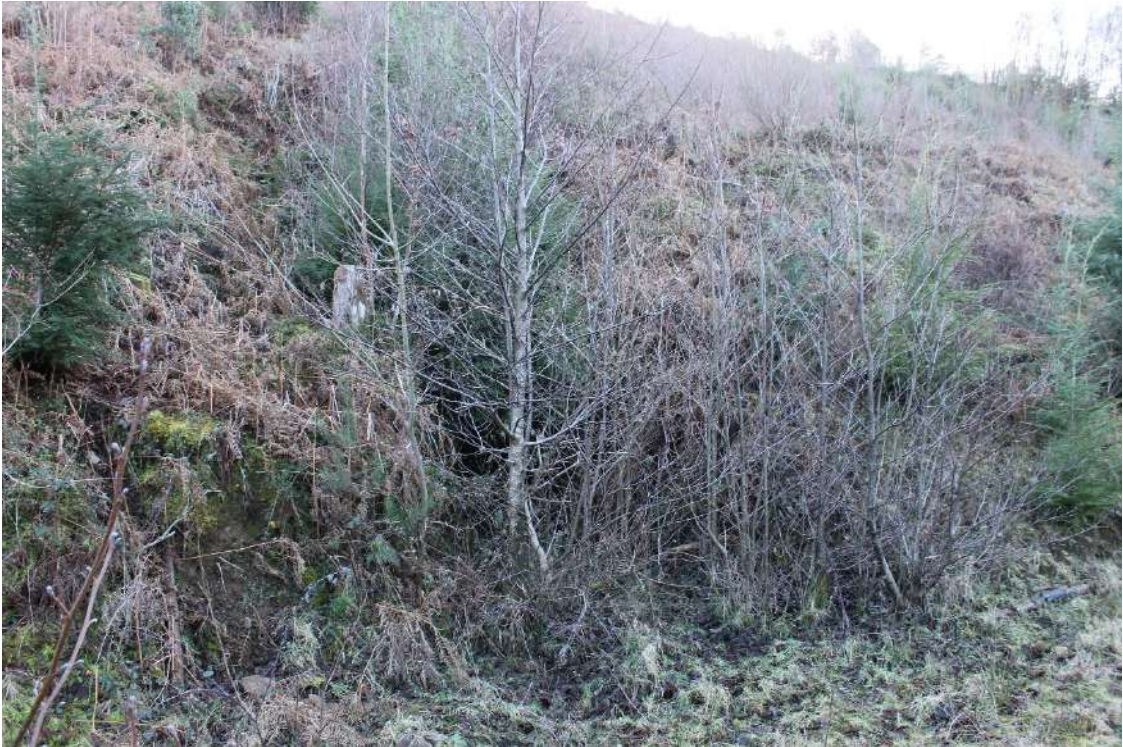
**Image EDP A1.17:** View of the extant mining level entrance located c. 185m to the east of the Site.

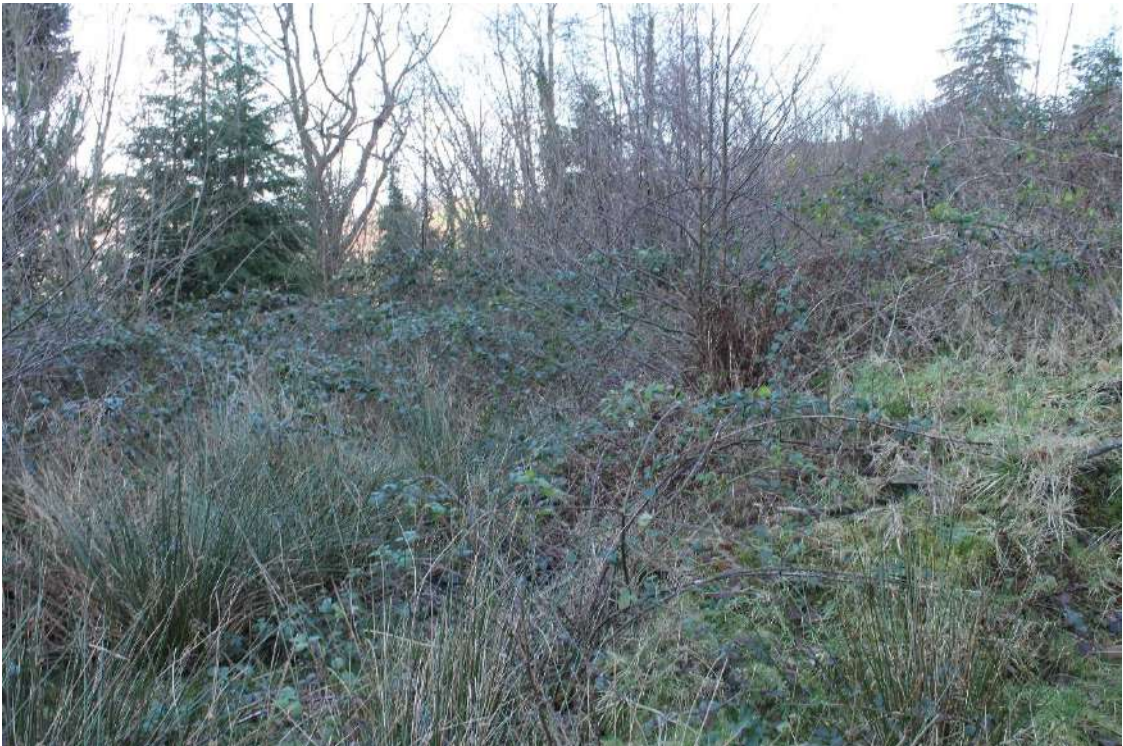
**Image EDP A1.18:** View of one of the depressions adjacent to the track that may be a former entrance to a mining level.

- 4.120 Further to the east, outside the Site boundary, as noted above, numerous small depressions (**C**) are depicted in a linear form adjacent to a series of former tramroads. These are probably associated with the two known level entrances in this area (**Image EDP A1.17**) and may represent some form of mining technique, possibly extraction along an exposed seam or through shallow workings that have collapsed or, possibly prospection, by digging test levels leading to the delving of the two more substantial entrances (one of which is extant). Whilst this area is shrouded in vegetation some of these depressions could be seen from the adjacent track (**Image EDP A1.18**).

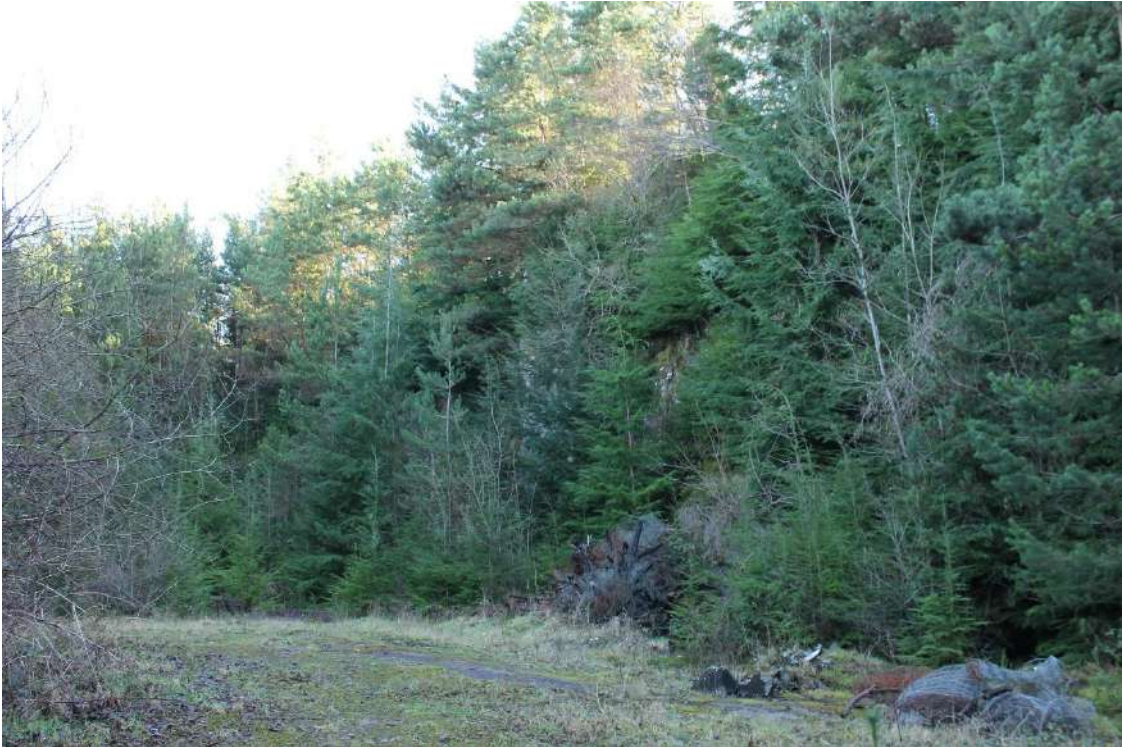
**Image EDP A1.19:** One of the former quarries in the Site with the rock face hidden just behind the trees.

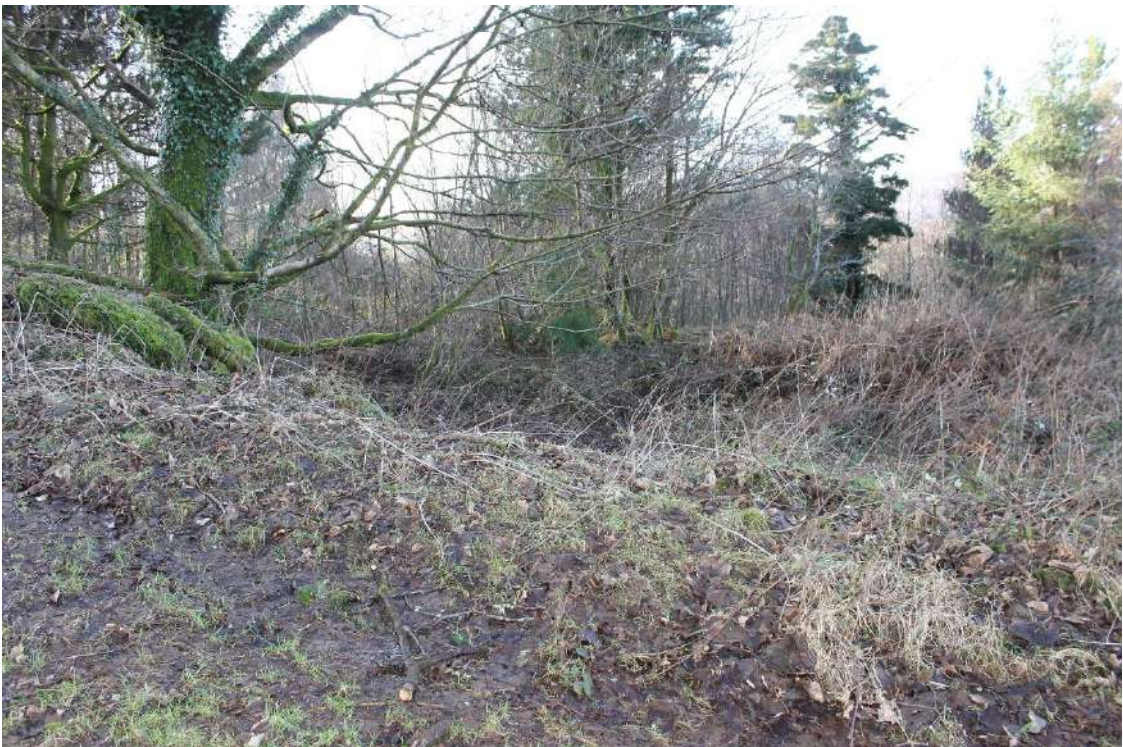
**Image EDP A1.20:** One of the pits located to the south of Cefn Mawr Colliery possibly reflecting the collapse of underground workings.

- Pits were noted in woodland to the south-west of the colliery (**Image EDP A1.20**). Whilst these pits may relate to surface mining, the greater likelihood is that they represent ‘crown holes’ or surface collapse due to below-ground mine workings. In this regard these are probably not historic assets in their own right but do relate to the Site’s industrial history.
