# EAF Project

Phase 2 Geo-environmental Investigation

315531-R03 (04)

**Title:** Phase 2 Geo-environmental Site Investigation: EAF Project

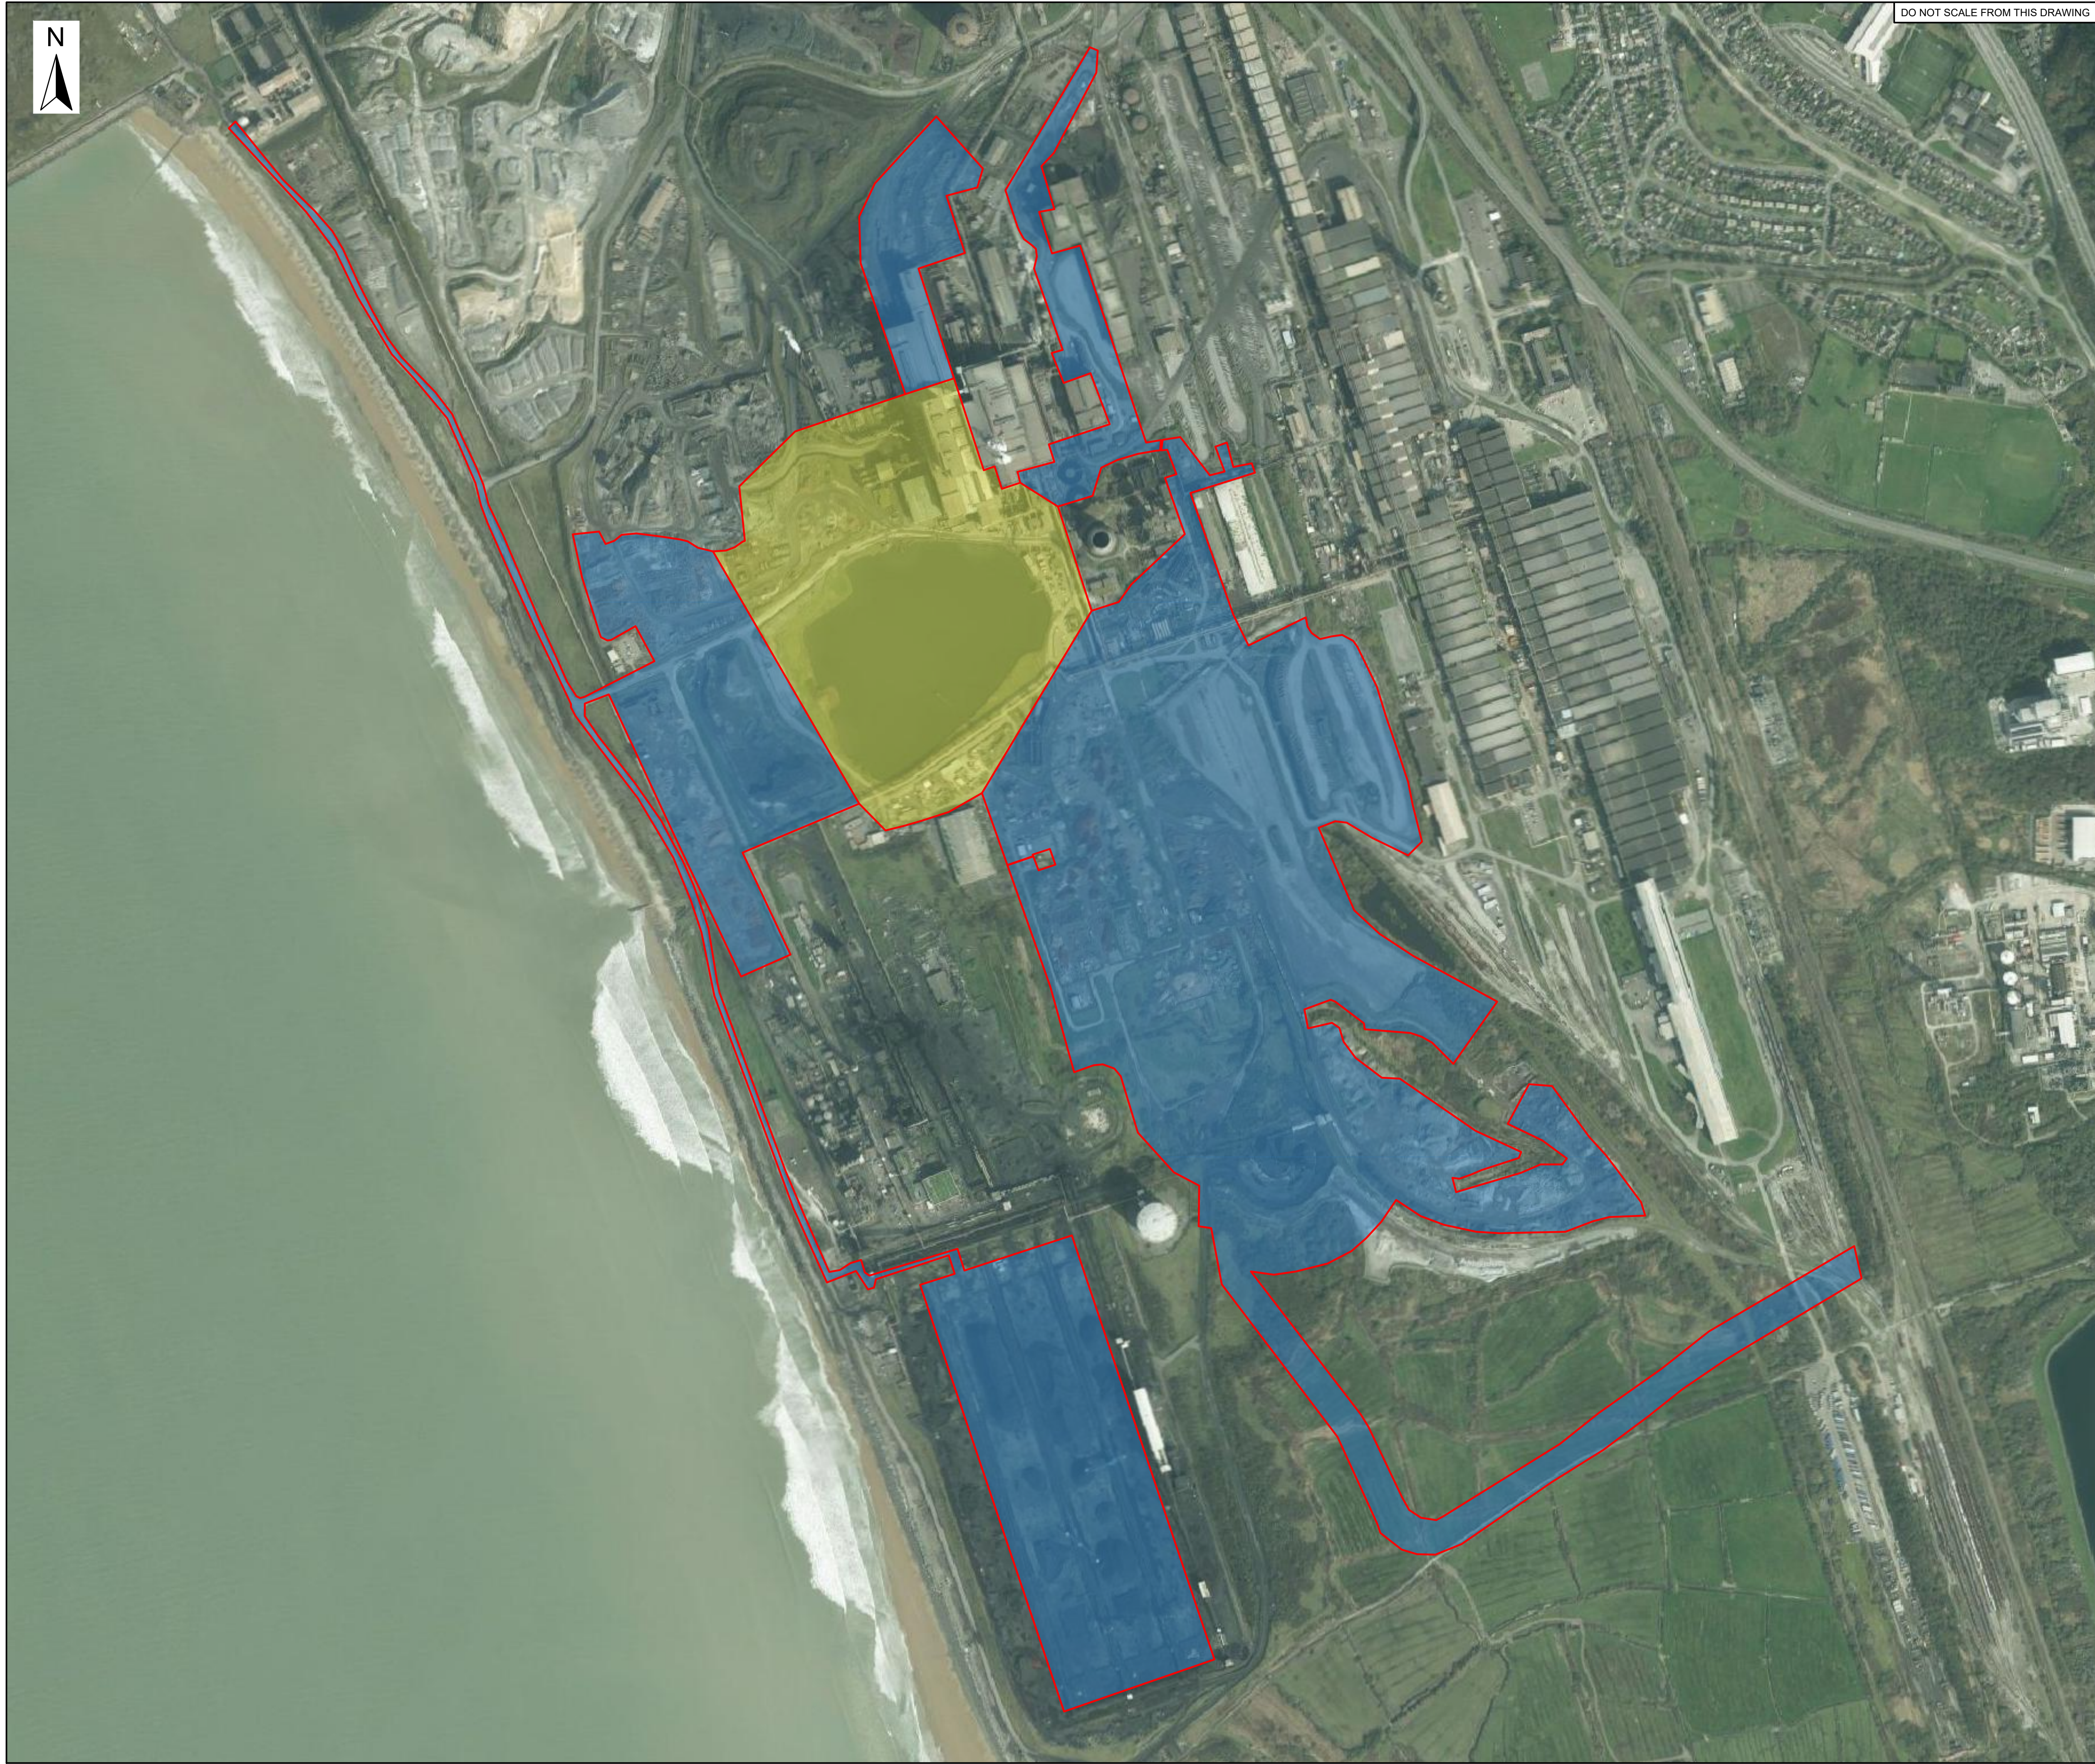
**Figure 3 EXPLORATORY HOLE LOCATION (BOREHOLES ONLY)  
PLAN WITH DEVELOPMENT AREAS**

For the purpose of discussion, the ground conditions encountered during the fieldworks have been sub-divided into 2 separate areas. Area 1 focuses on the development and construction of the EAF itself, where area 2 encompasses the associated infrastructure for the development including the widening of existing roadways, car park and lay down areas.
