| 25035/R1 | August 2025 |
| Project | <b>DAYS NEATH – PHASE 1 DESK STUDY</b> |

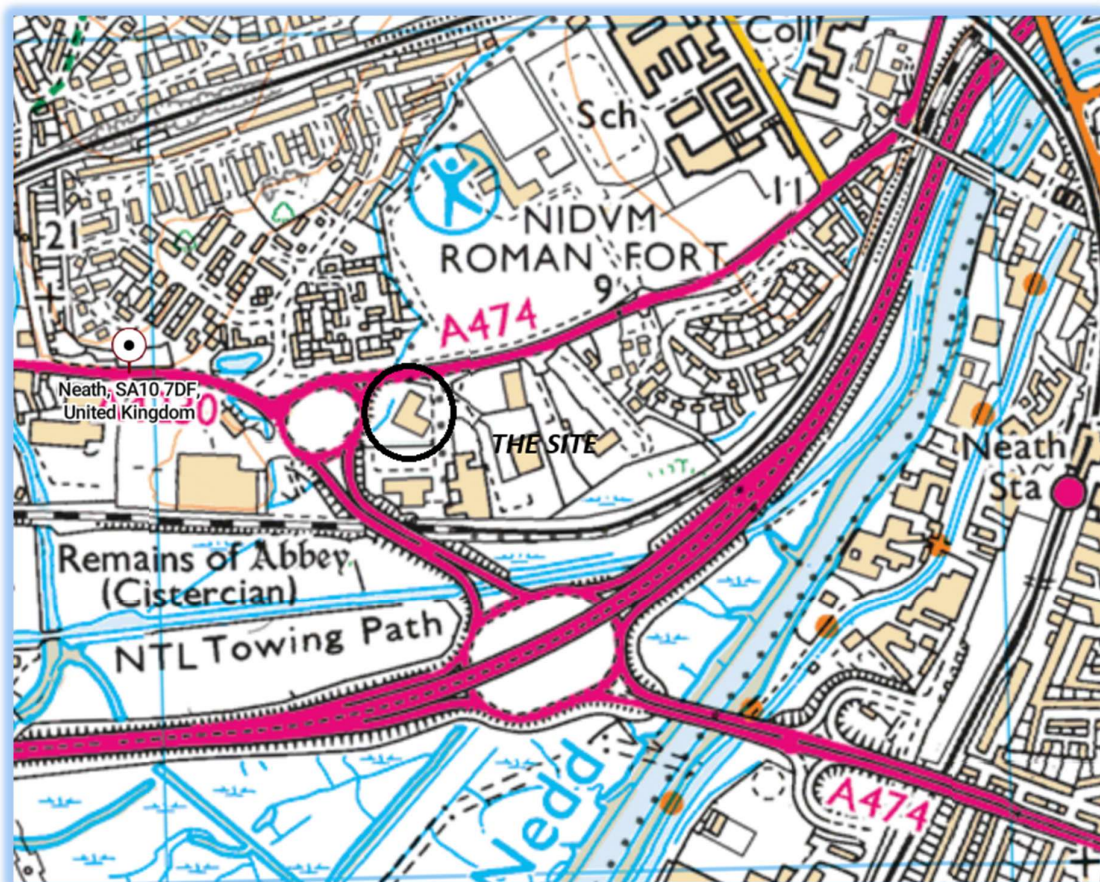
**Figure 01. Site Location Plan**

The site lies to the west of Neath, at Grid Reference 274304 197526, and is approximately 0.59ha.

The site is bounded by the A474 to the north, industrial buildings to the east and road and rail infrastructure to the south.

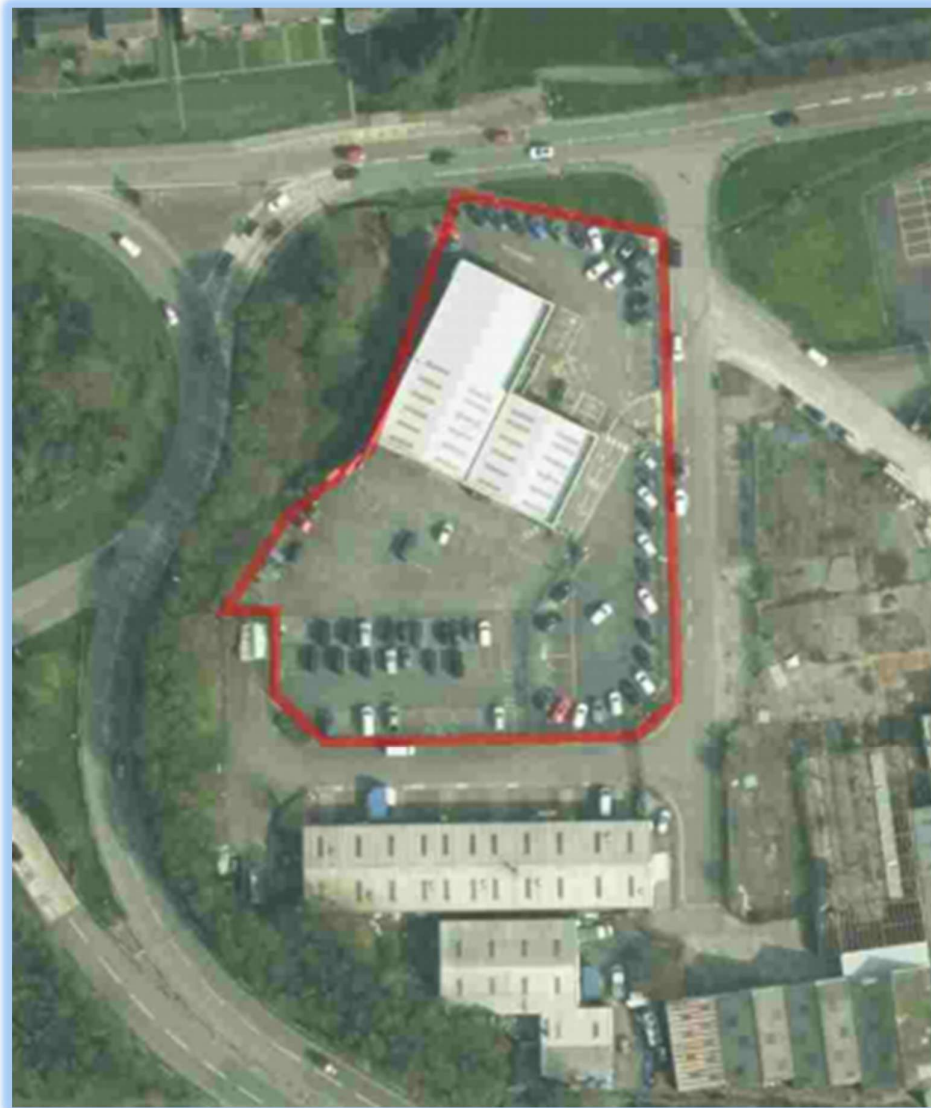
**Figure 2: Planning Red Line Boundary.**

The planning red line is shown in Figure 2.

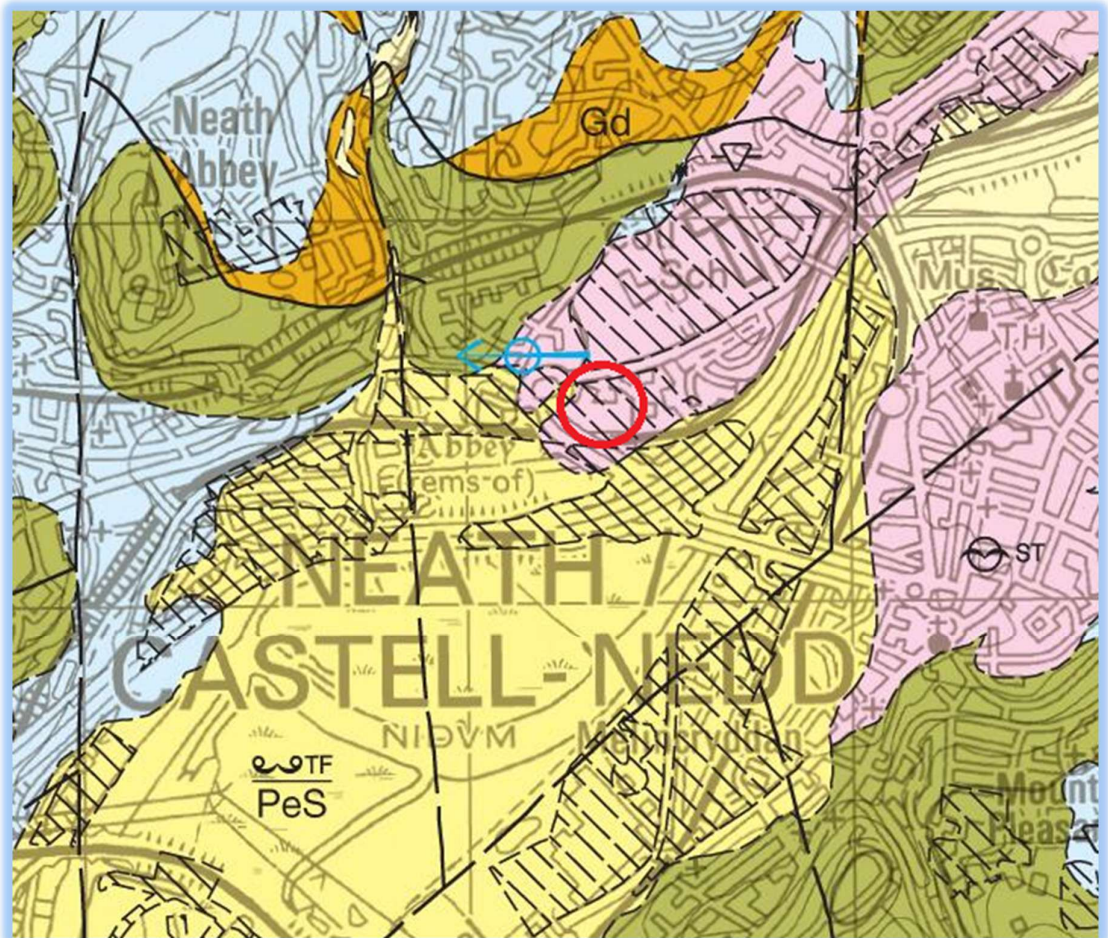
**Figure 03a: Superficial Geological Setting**

Glaciofluvial Sheet Deposits, Devensian - Sand and gravel. Sedimentary superficial deposit formed between 116 and 11.8 thousand years ago during the Quaternary period.

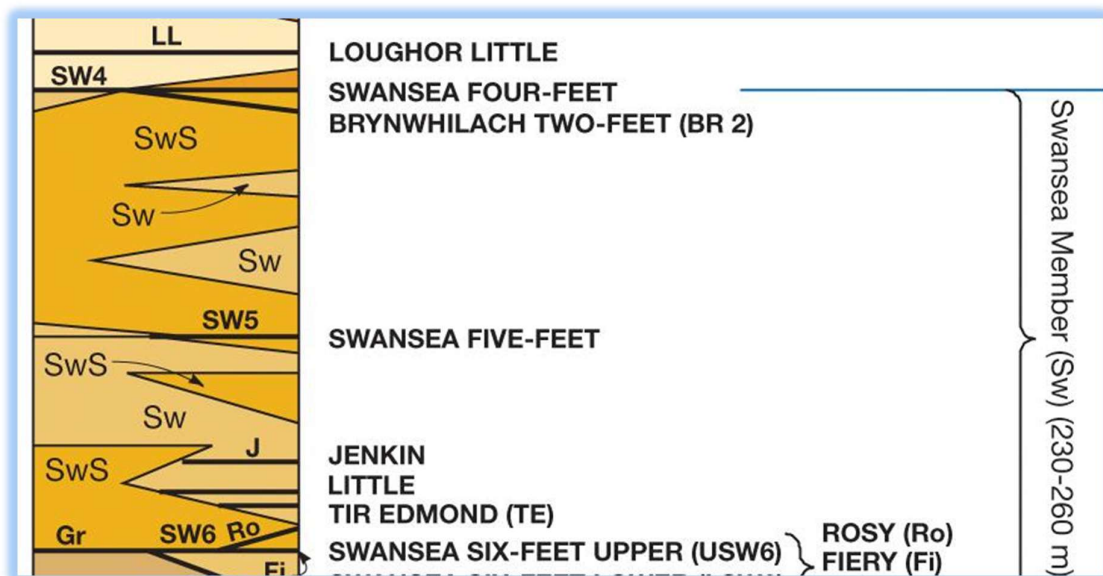
**Figure 4b: Solid Geological Column**

Swansea Member - Sandstone. Sedimentary bedrock formed between 309.5 and 308 million years ago during the Carboniferous period.

The solid geology is that of Coal Measures Cyclothem, dipping approximately 10 degrees north. The Swansea 4ft seam outcrops to the north off the site, with what is likely to be the Loughor Little outcropping to the south, beneath the site area.

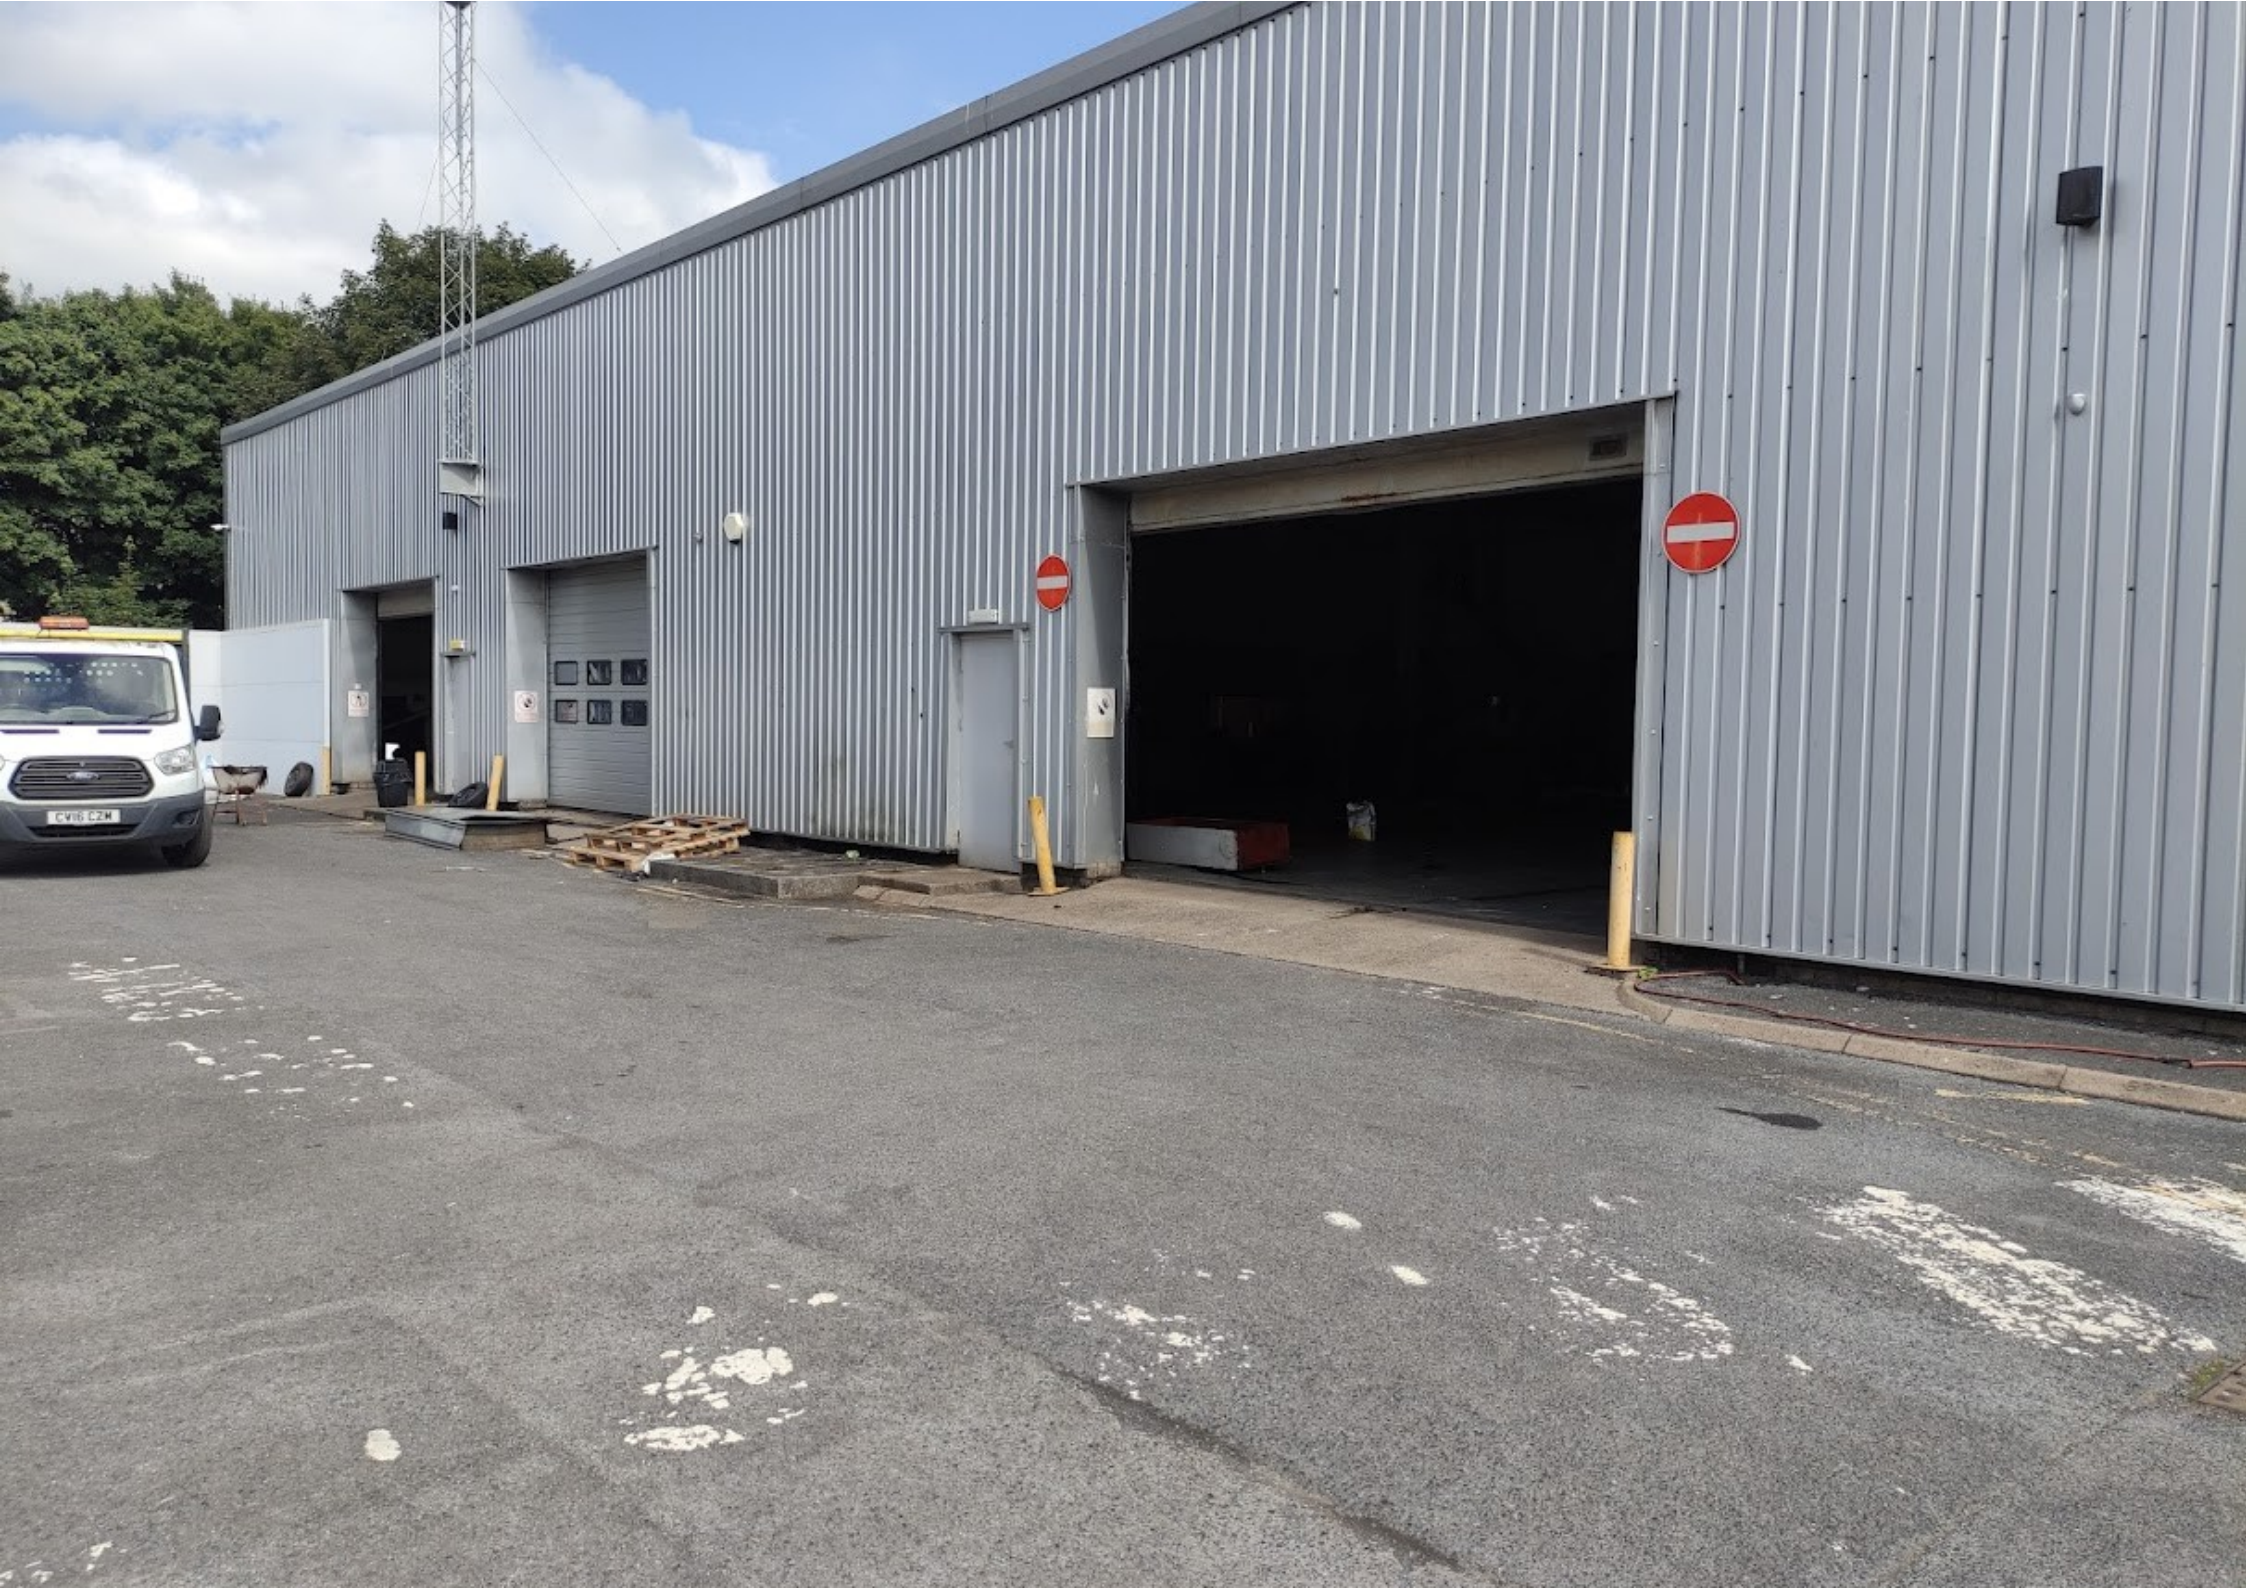
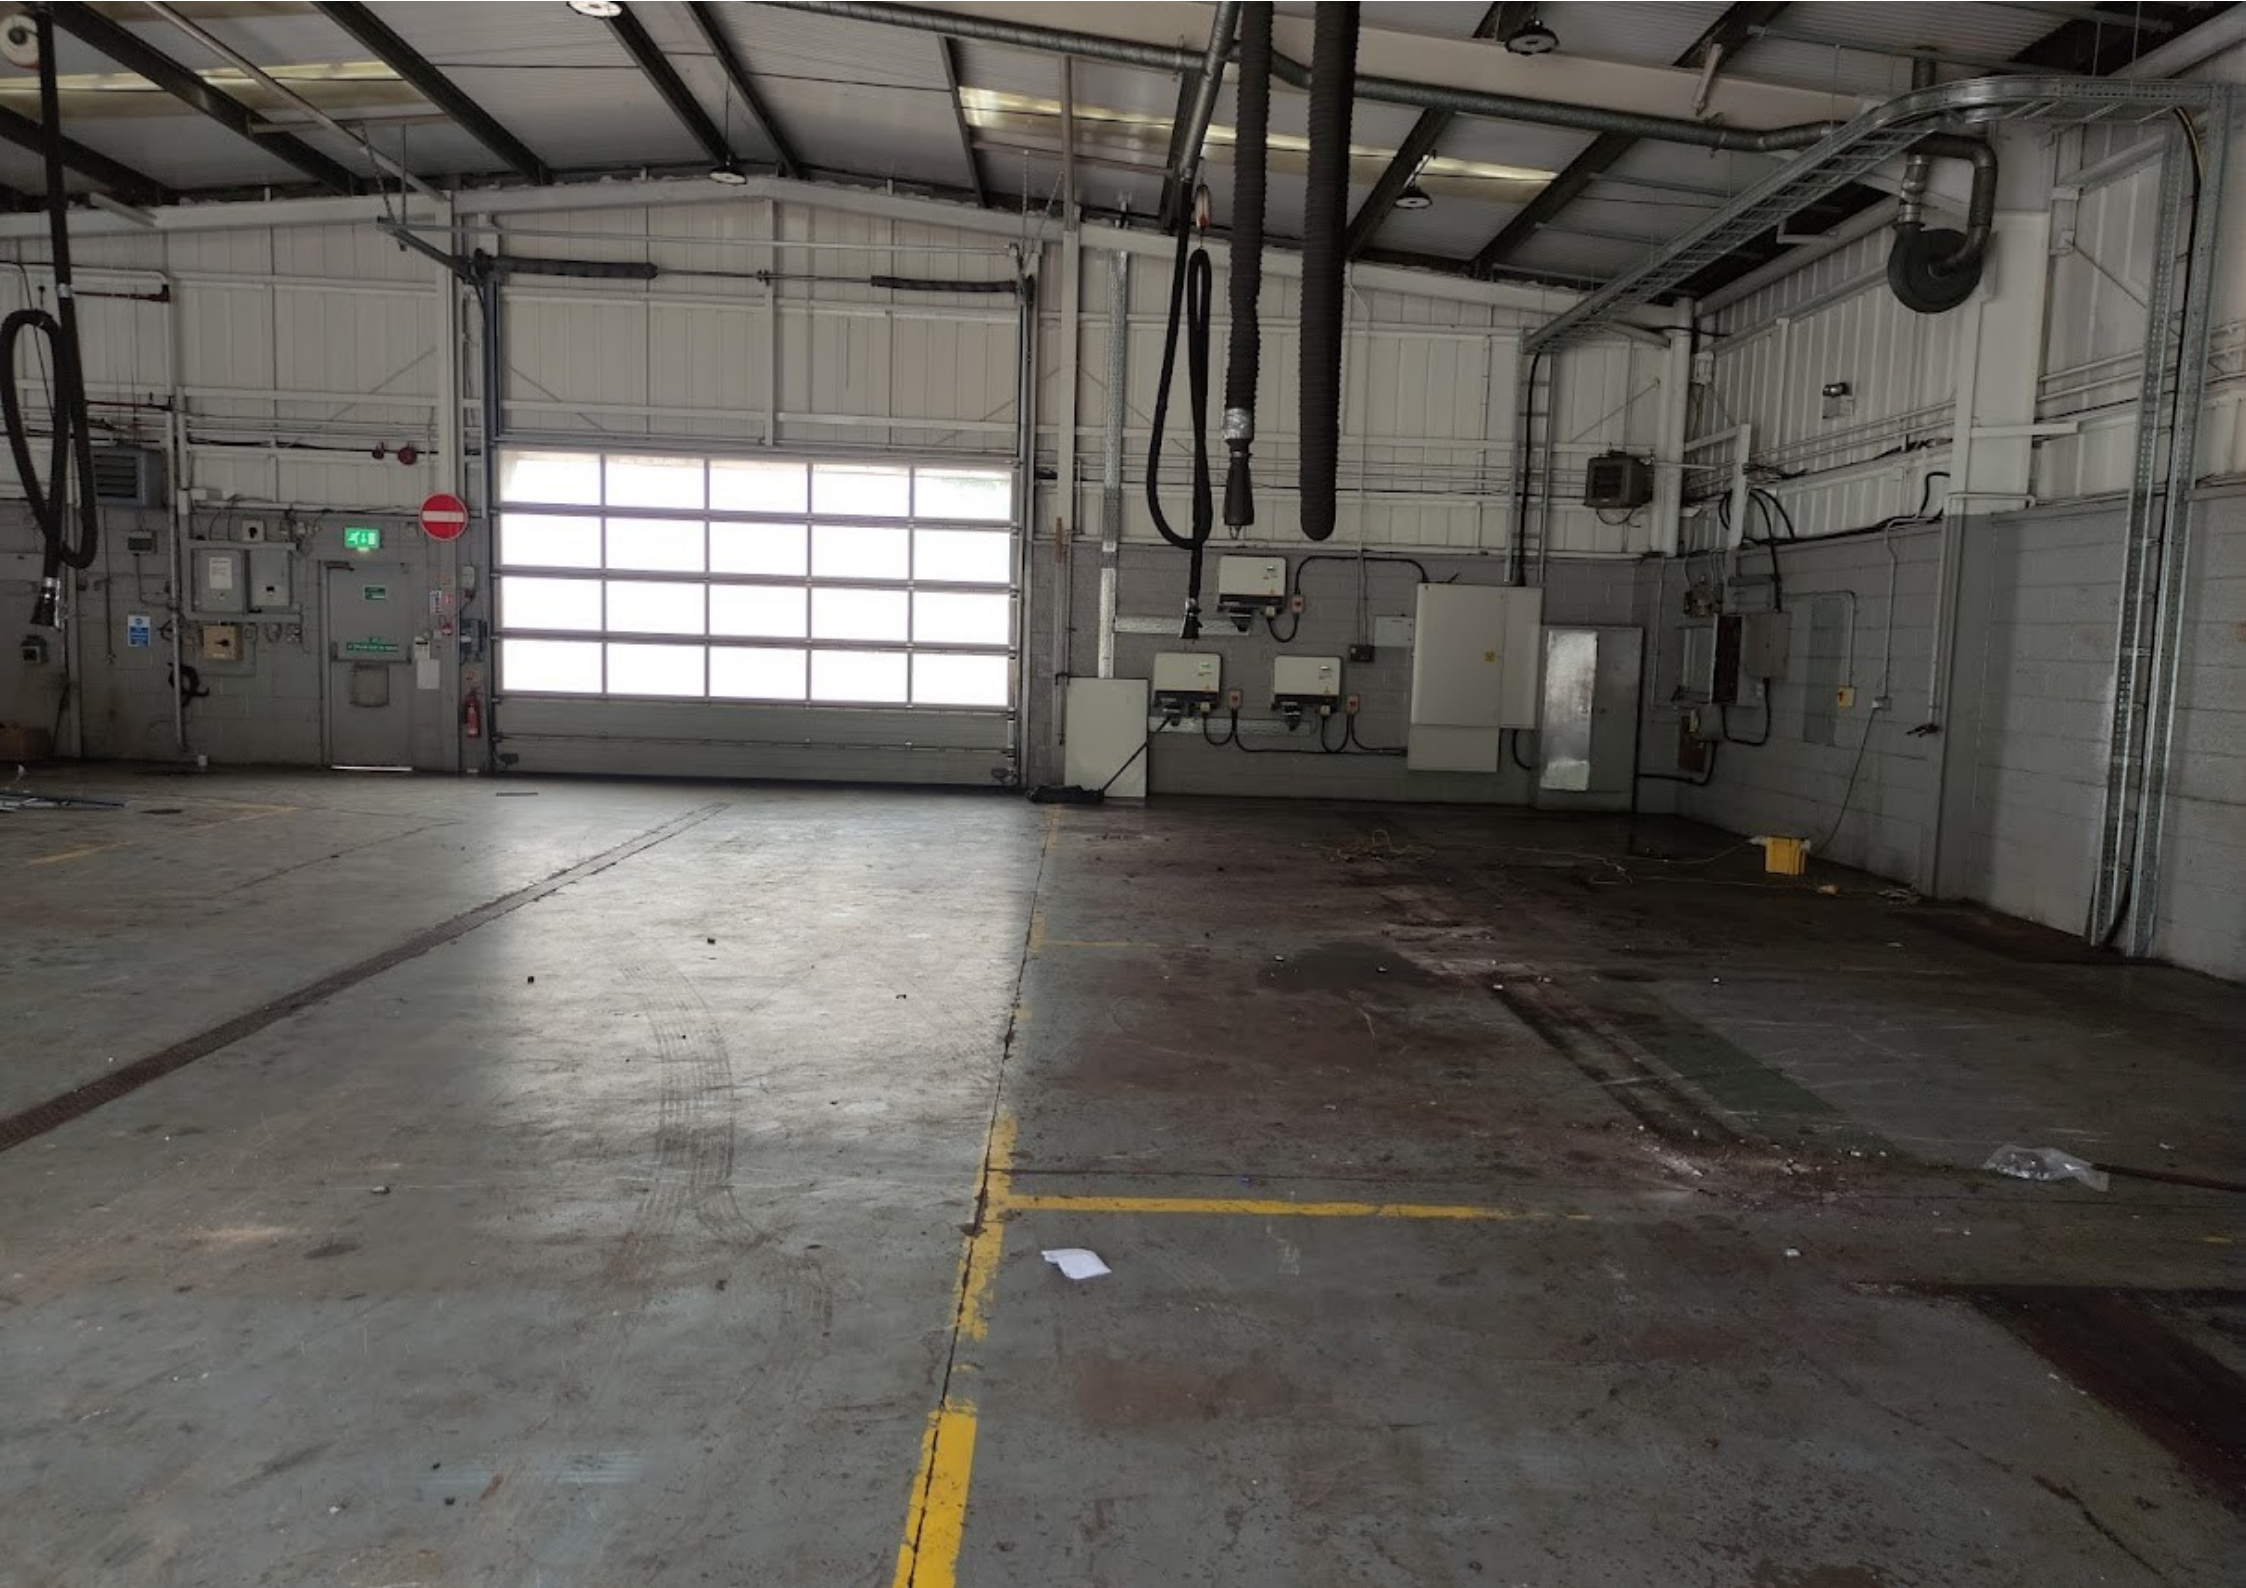
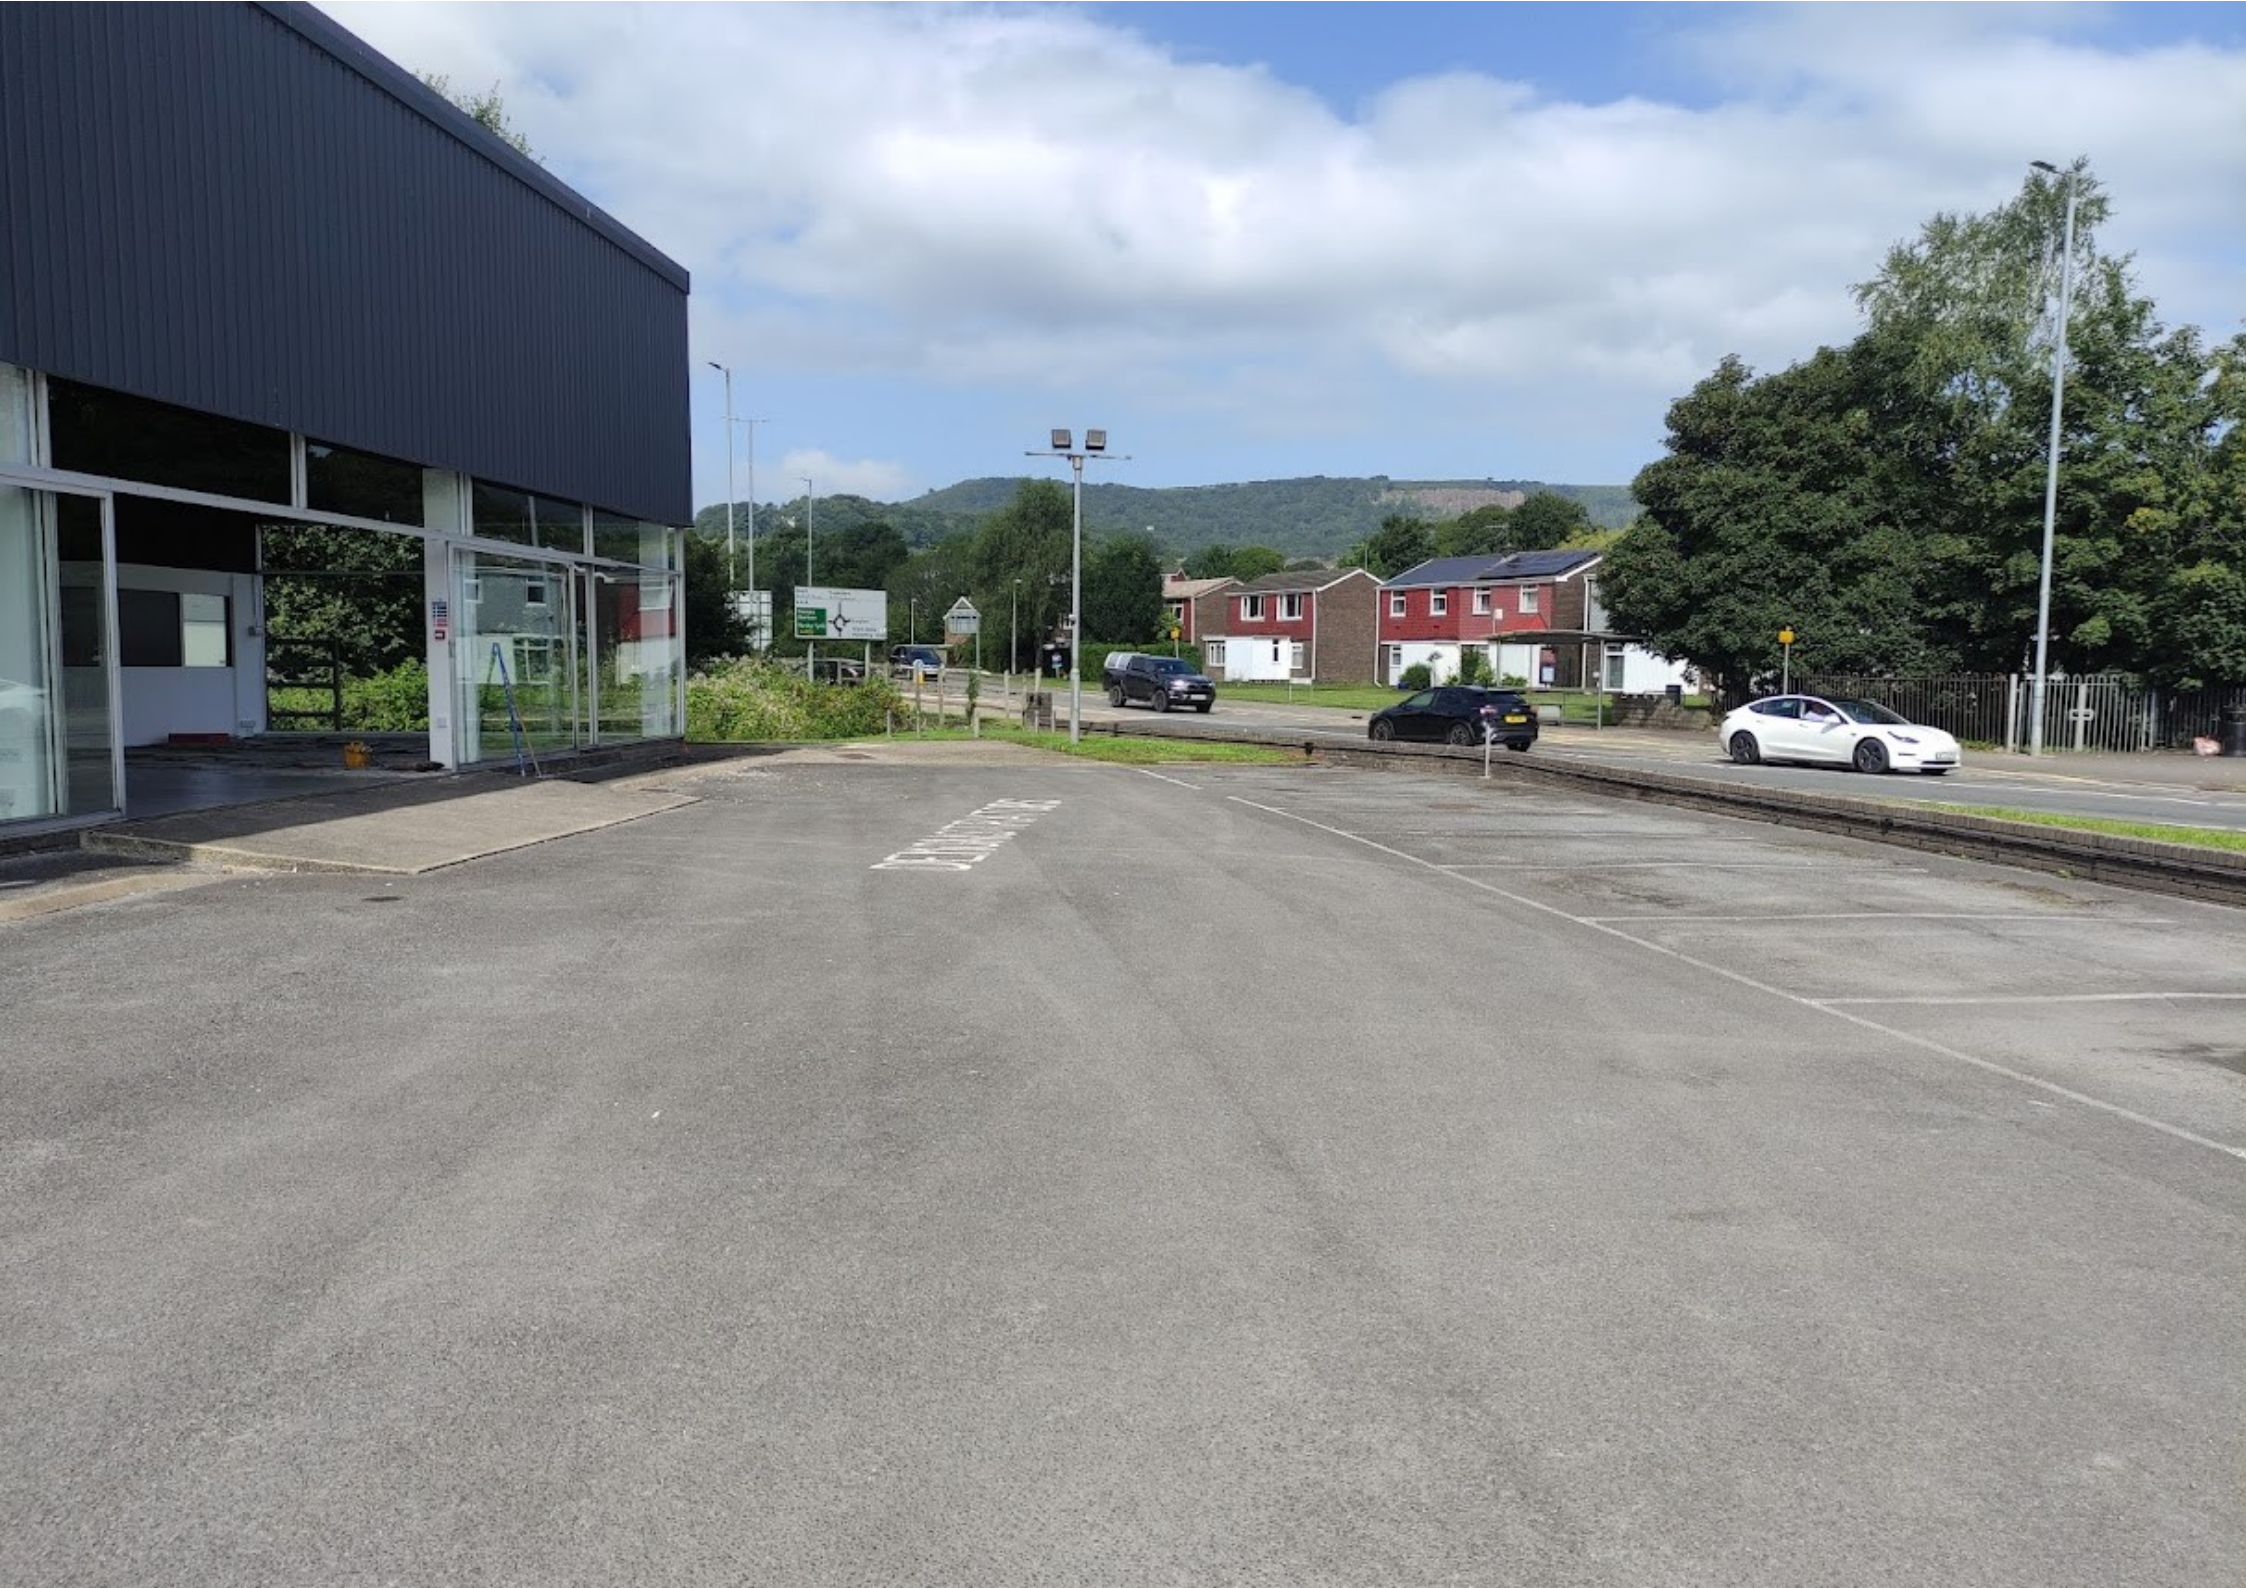
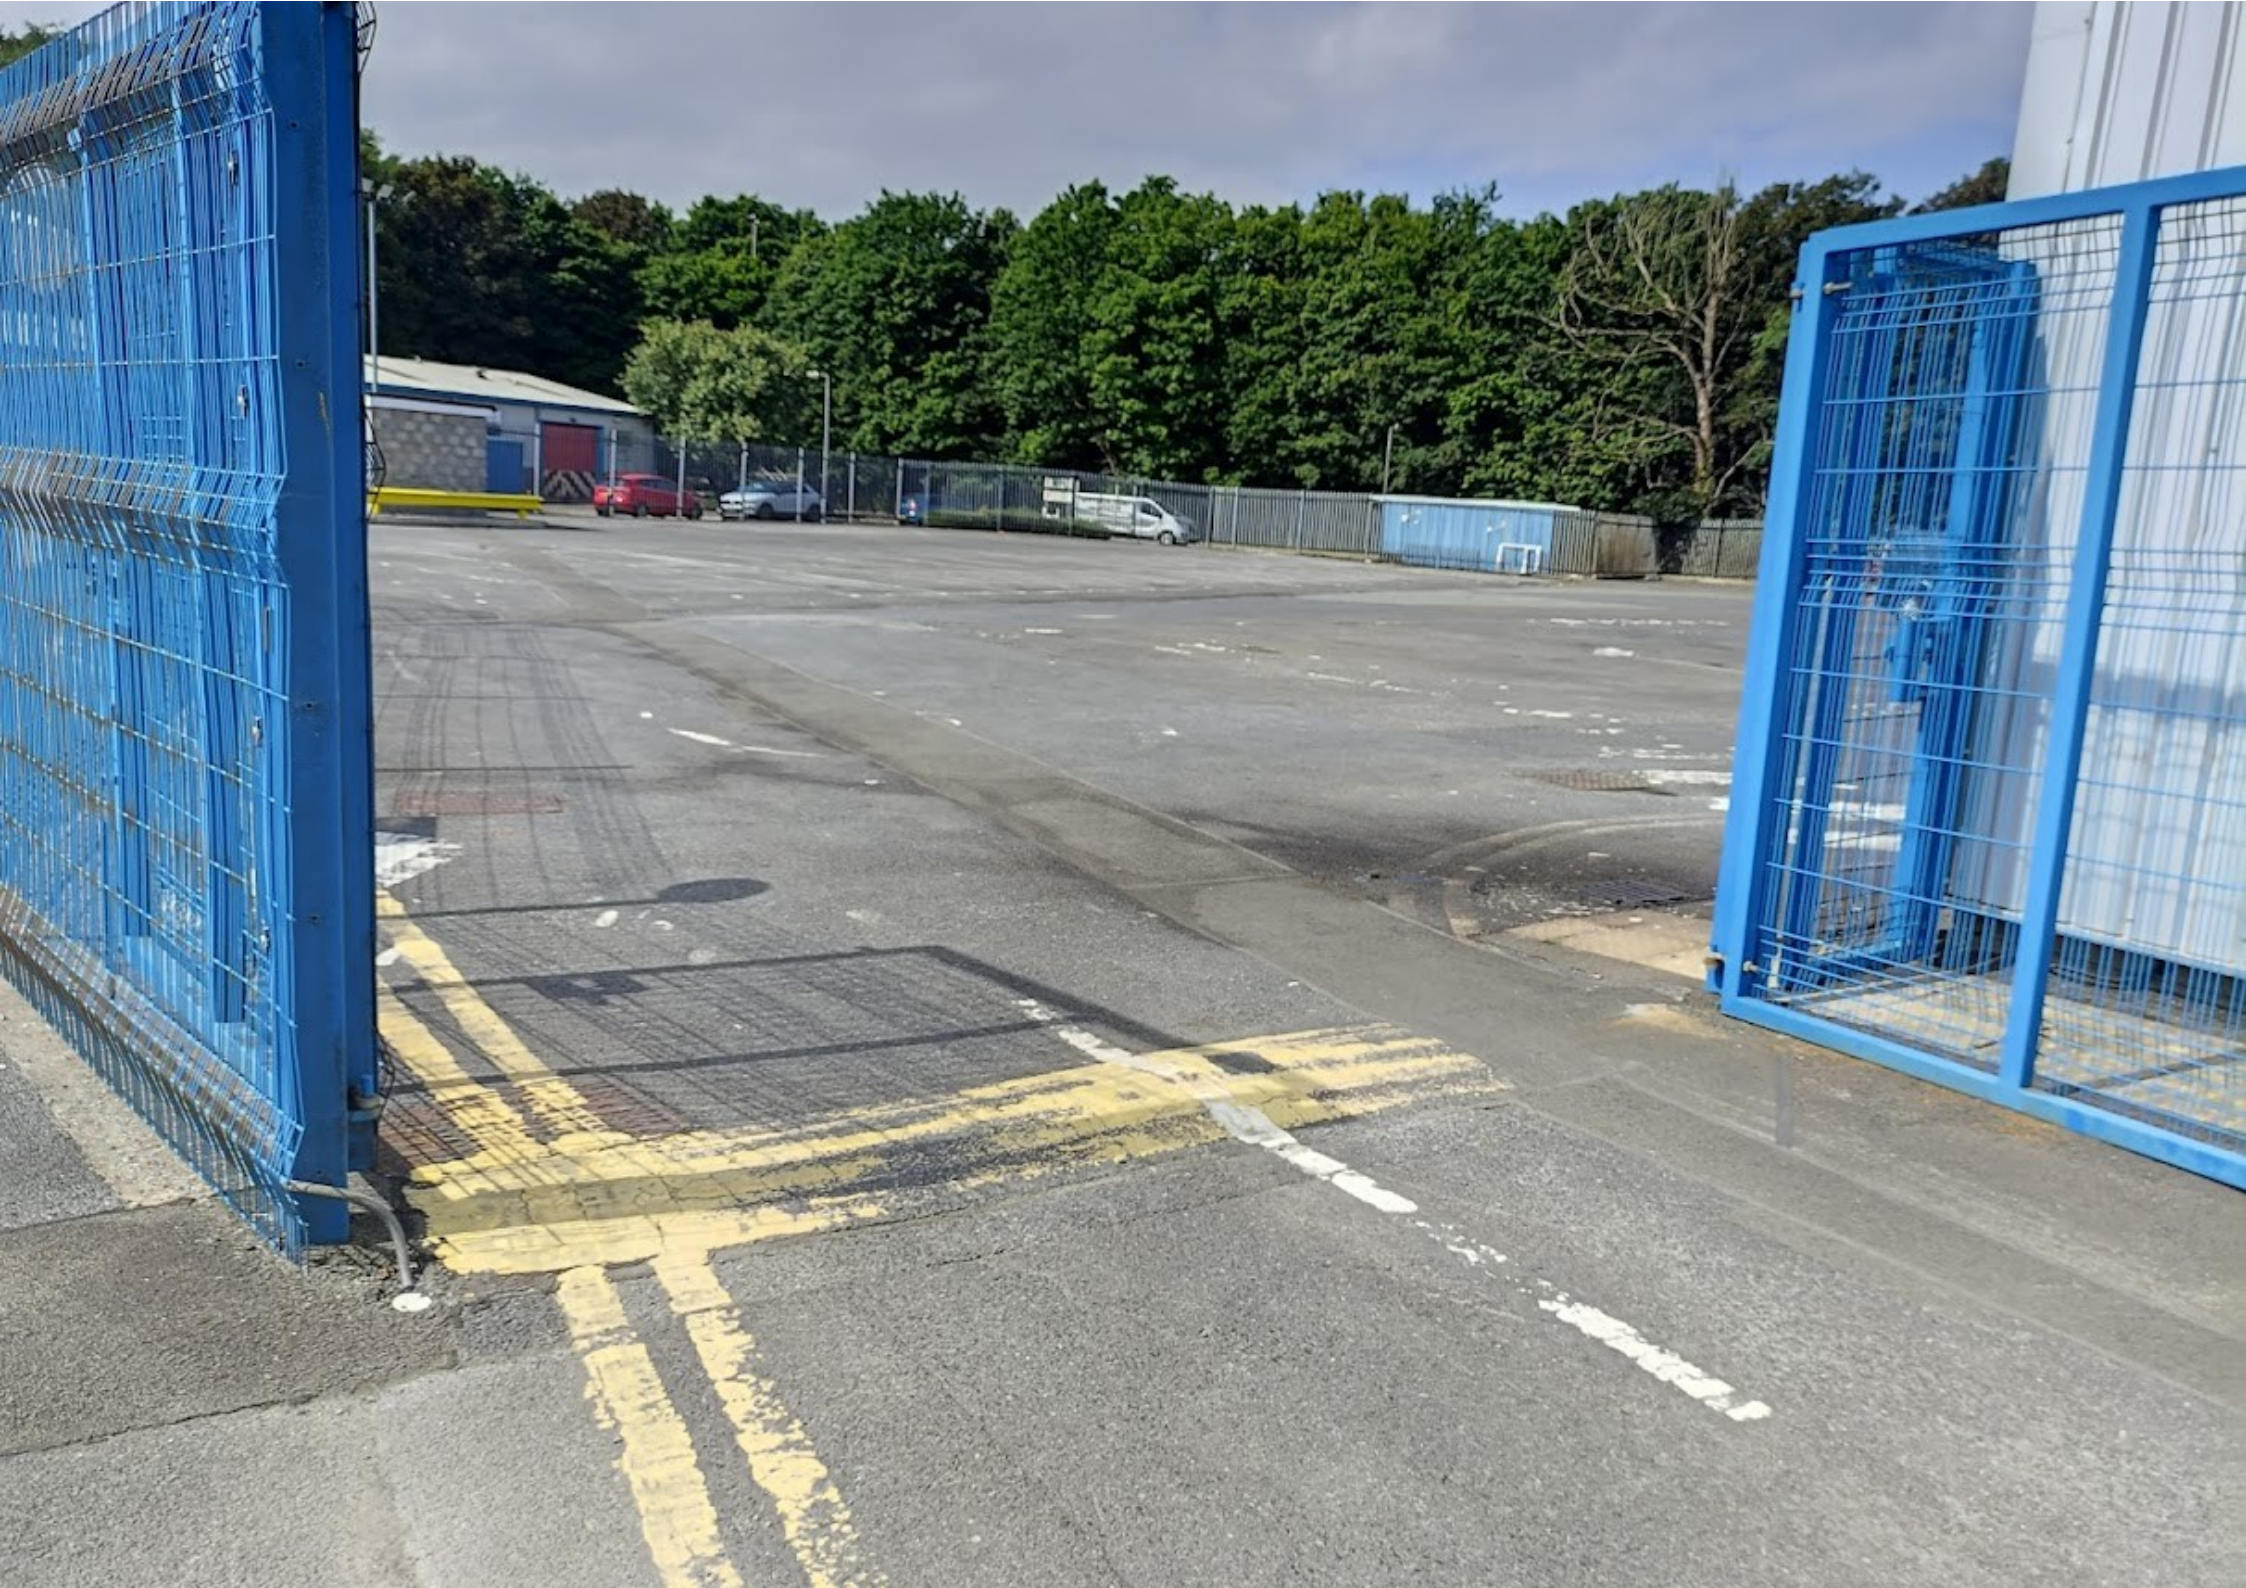
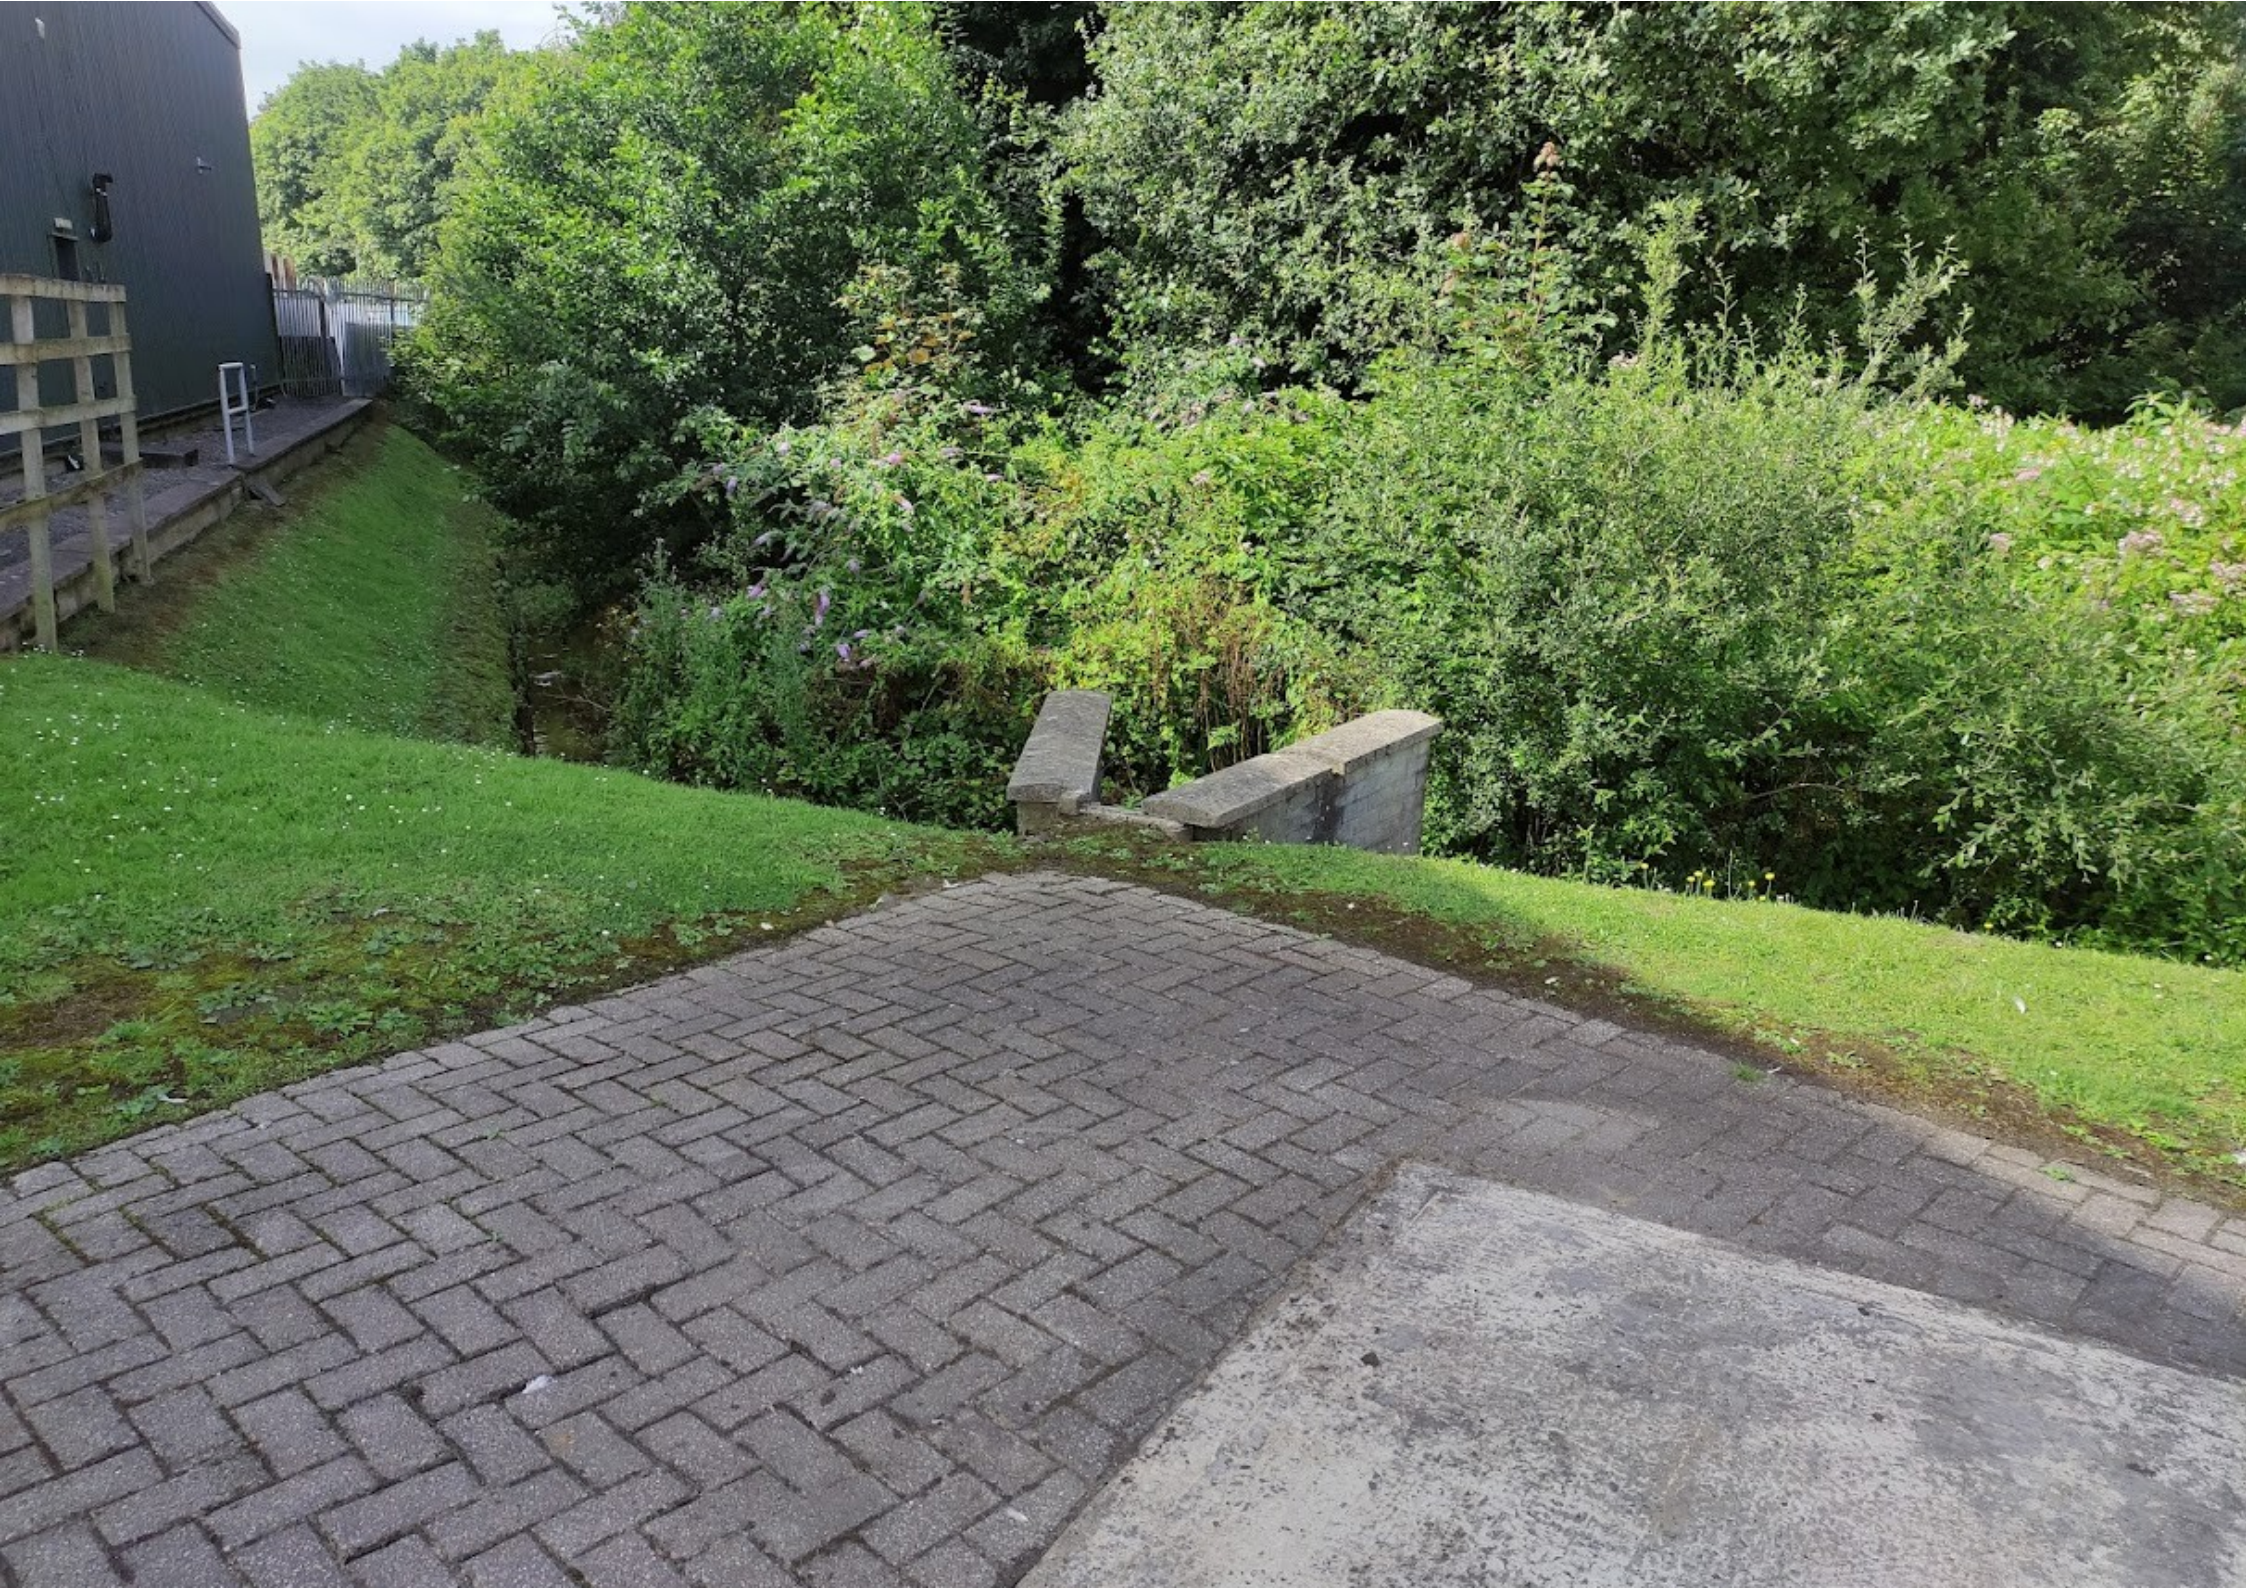
The site is completely Macadamed and level with a large industrial building at its centre, formerly used for selling and repairing cars.

Many surface water drains are found across the site with some slit type drainage located within the building itself (see picture).

At the west side of the building there is a small stream running parallel to it which has a large amount of orange iron oxide within it, possibly drainage from a mine or adit.
