## **DESIGN ACCESS STATEMENT – PART 2 (WALL)**

PLANNING DOCUMENT REF: 24/457-304

SITE ADDRESS: 74 Pine Valley, Cwmavon, Port Talbot, SA12 9NG

PROPOSED DEVELOPMENT: Side Extension & Re-Development of the Garden Area

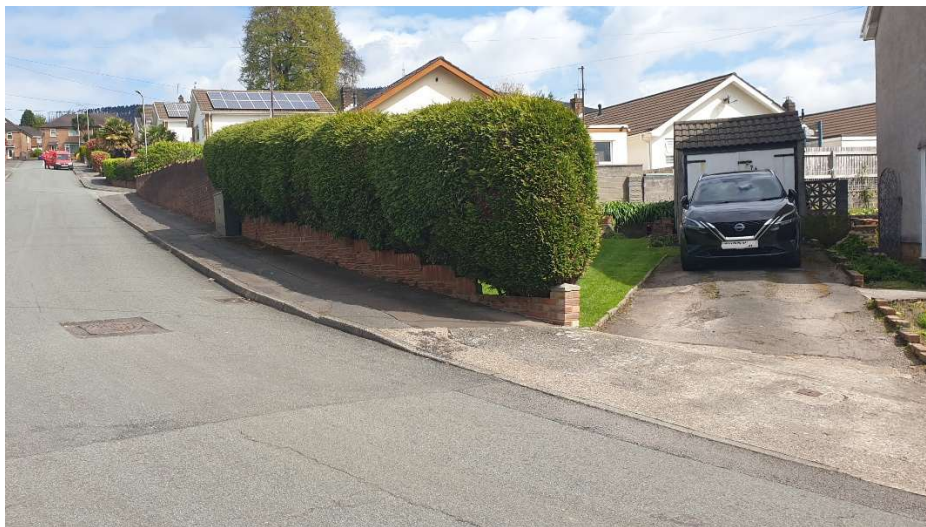
The existing Hedge mostly consisted of Leylandii (Leyland Cypress) plants and was approximately 2.5m high above the low wall on the pavement side. The brick wall was only a single skin structure, with a capping of bricks in a soldier formation (upright), to a height of 590mm (variable – staggered).

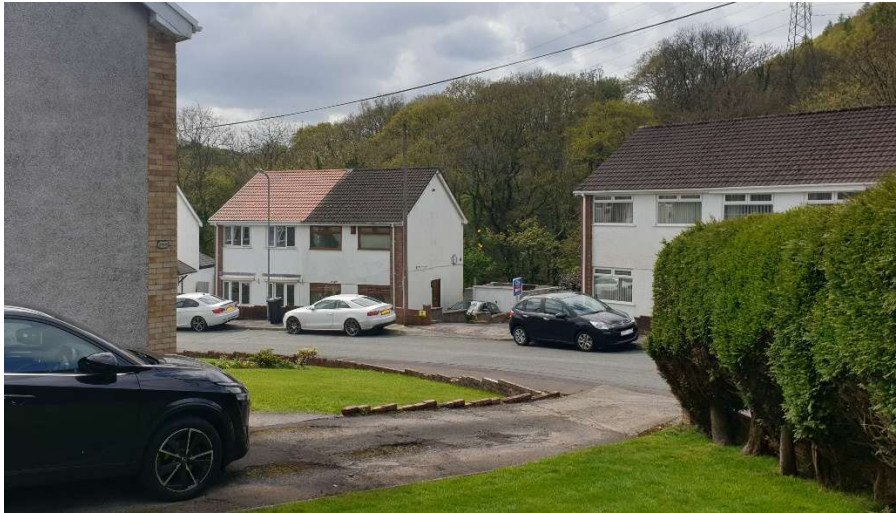
Around two – three years ago, the owner noticed that the wall was beginning to show signs of deterioration, cracks had appeared and started to spread, the end post (by the drive) had to be repaired as a temporary measure. This was probably caused by the roots of the hedge which have undermined the wall over time. In addition, when trimming the hedge, the owner had noticed that some areas had begun to die back and so tried to spread out the good branches to cover the dying parts – this can be seen on the inner side of the hedge. As is common with this type of plant, the lower levels start to thin out and go brown, the owner was unable to prevent this happening and was concerned that eventually the hedge would die off below, just leaving a green top.

The owner contacted several contractors for a solution to the brick wall – all opinions were that a new wall would still fail due to the hedge, and if another single skin wall could be constructed then this would not last and be a waste of money. Also, the owner decided to remove the hedge as the process of trimming it (with ladders and platforms) and constant maintenance was a concern to him in future years, and he wanted something which would be more easily maintained.

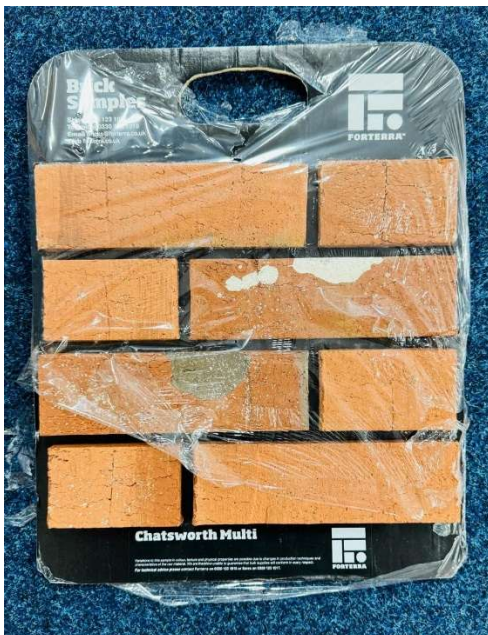
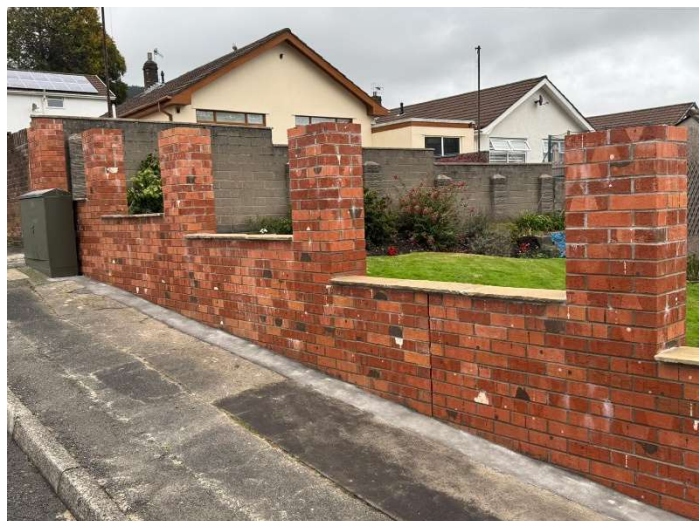
The owner decided on a design consisting of solid brick wall with piers and composite panels between, to a height of approximately 1.8m, which was lower than the hedge but more in keeping with the walls in the surrounding area. The brick selected is Forterra Chatsworth Multi, is very hardwearing and was felt to contrast well with the bricks on the house, as these are no longer available. Although the photo looks more red, the brick colour varies and is settling well into it's environment. The Charles & Ivy composite infill panels are in dark brown, and fit well with the brick and the sandstone capping.

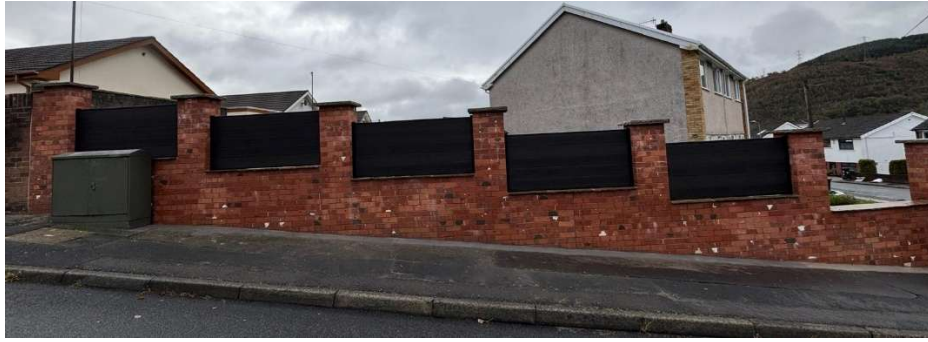
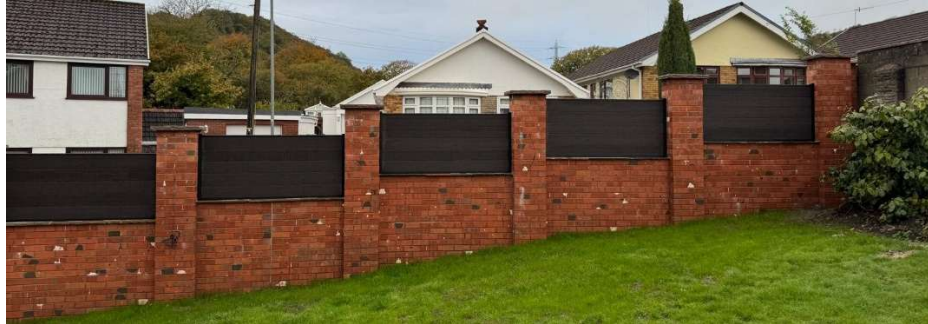
The new wall is well-constructed, has a double-skin structure and looks an appropriate replacement for the original low wall and hedge. The owner had to wait to find skilled contractors to carry out the whole project – hedge and wall removal, wall design and construction in a difficult sloping site which also supports the existing pavement. There was considerable cost involved for this project; however the owner feels that the wall will be easier to look after for his advancing years, and is intending to plant more bee/insect friendly shrubs/small trees once all the work has been completed and the garden has been landscaped.
