**Plaza, Port Talbot**

**HISTORIC BUILDING RECORDING**

(385)1902-GWP-A-2A-HBR-P00

Date: 06.01.20

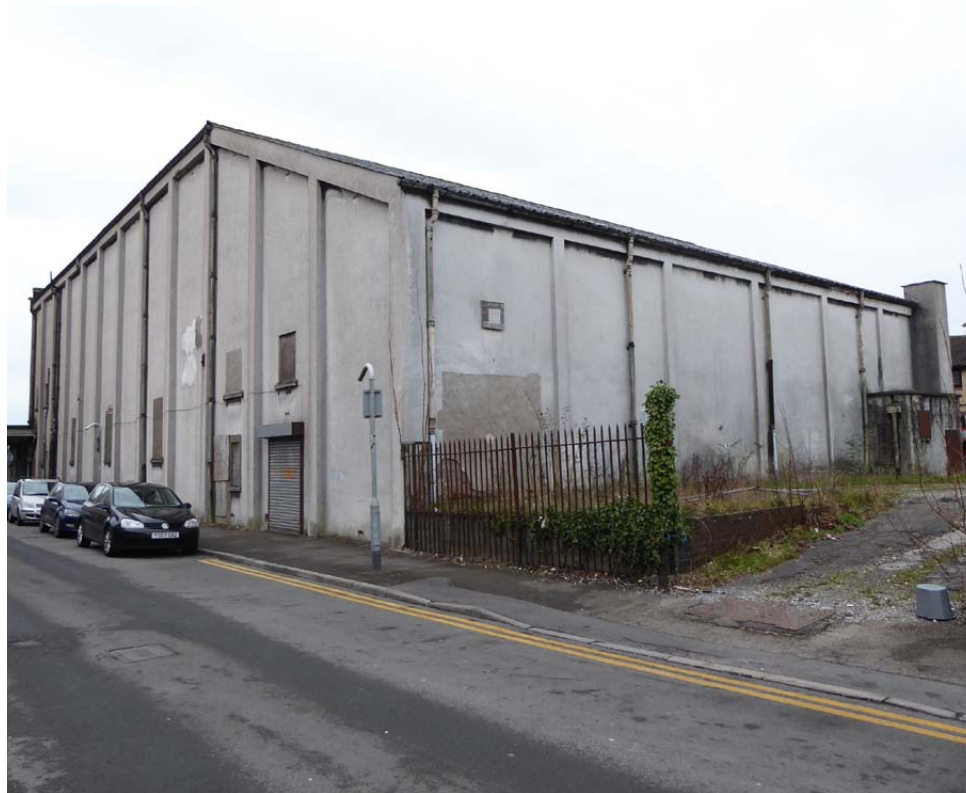
See photograph below taken looking at the junction between the faience tiled frontage and the rendered rear, with the two different types of downpipe.

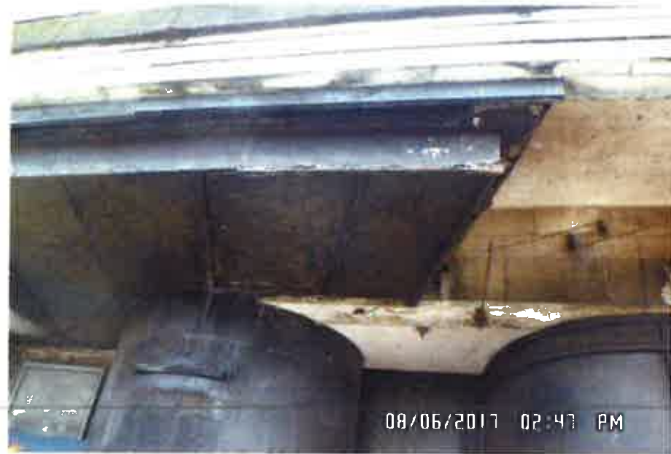
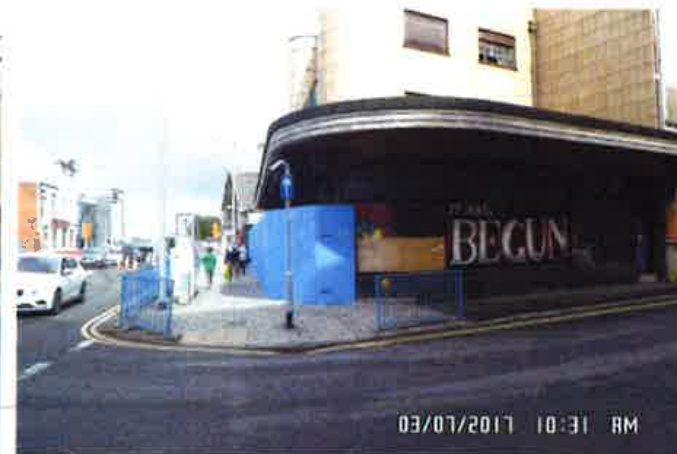
**Concrete Canopy (front elevation):** There were badly corroded steel soffit panels, support trims and metal work hanging loose which posed a risk to the public walking below. The area has now been fenced off with 8ft solid timber hoarding to prevent access under the canopy. See photographs below:

Loose/corroded metal soffit panels (June 2017) Pavement hoarded off below (July 2017)

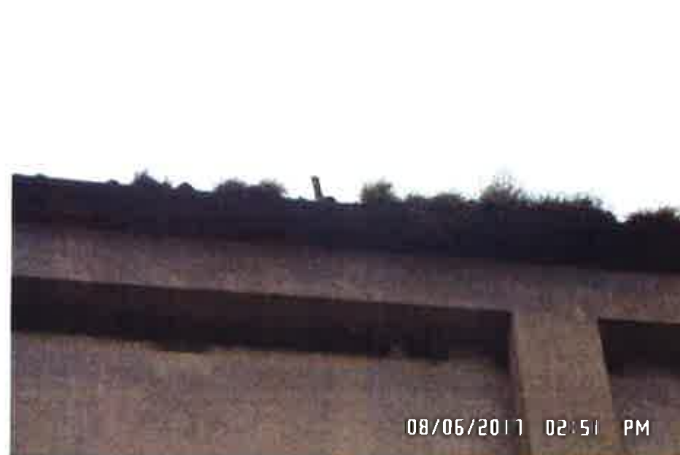
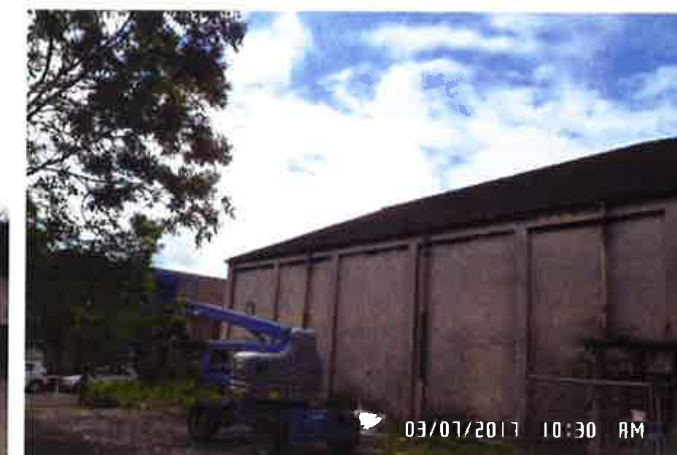
**High level asbestos cement guttering:** The guttering along Eagle Street was clearly overgrown with moss and vegetation. In one area it looked as though the guttering was sagging under the weight and if this were to fall onto a member of the public below it could cause serious injury. As a result the gutter has now been cleaned out and checked for damage including its support brackets via MEWP. The contractor has given assurances the gutter is secure. The rear and opposite side gutters were also cleaned and checked for damage. Whilst not immediately adjacent to a public highway they still pose a risk and a small length of guttering to the rear and side elevation had to be removed. See photographs below:

Overgrowth in high level gutters (June 2017) Overgrowth removed via MEWP (July 2017)

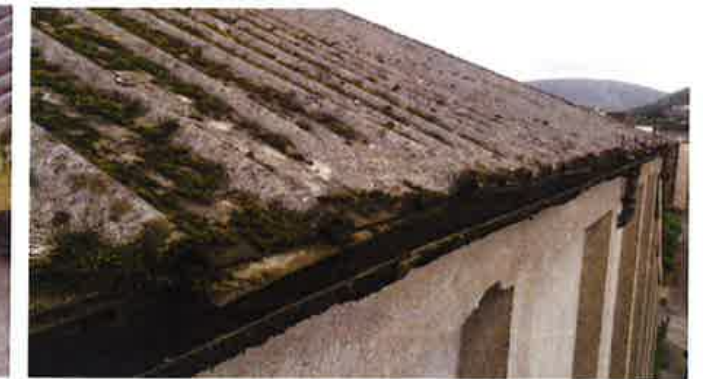
After clearing out (July 2017)

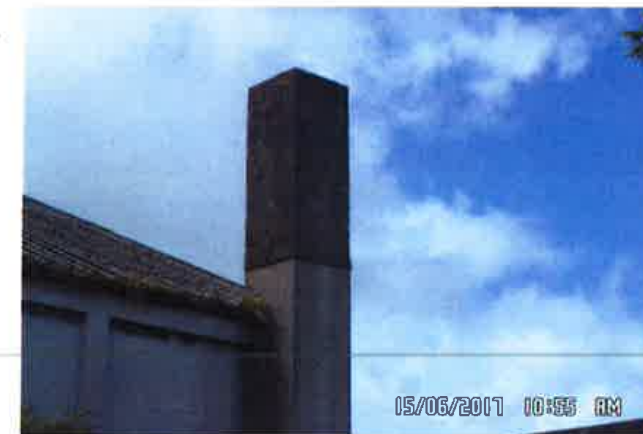
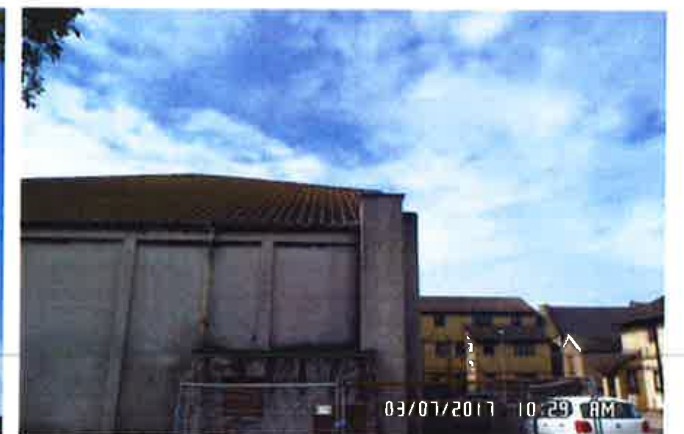
**Rear Chimney:** The chimney was clearly in a state of disrepair in 2012 and it was recommended to be reduced in height to a safe level in the J&N report. The chimney had deteriorated and looked extremely unstable and could potentially fall into the parking area outside the side boundary. There was a clear danger so the decision was made to remove the chimney down to a safe level. This work has been carried out and approximately 1.5m of the top section of chimney has been taken down. Refer to photographs below:

Rear Chimney cracked and leaning (June 2017) Top portion of chimney removed (July 2017)

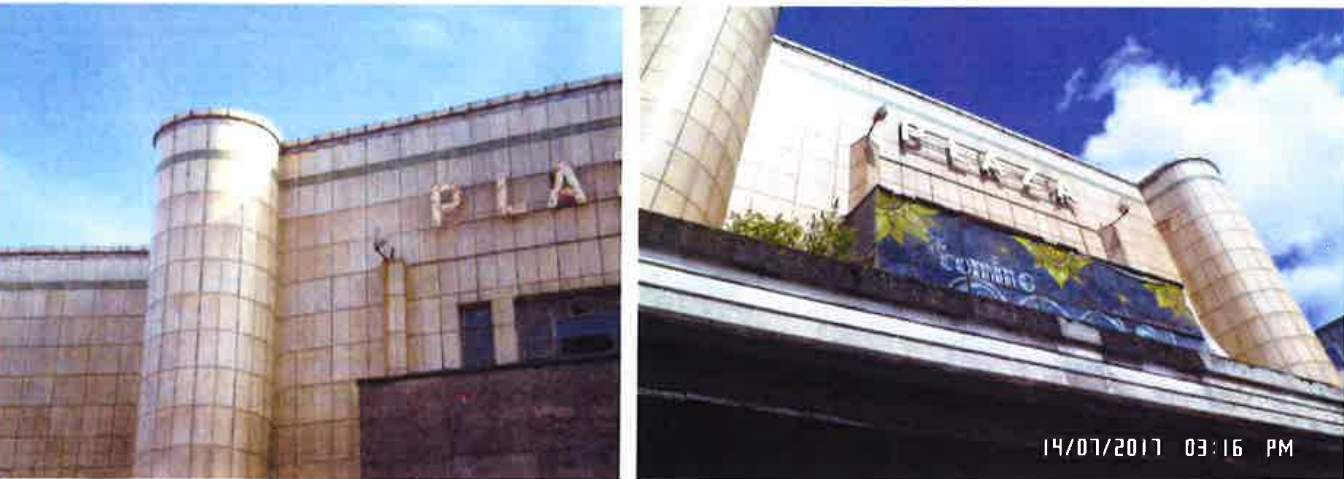
The 2012 report made no mention of any defects to the tiles, however, it did suggest a detailed inspection would be required to assess if they still had adequate bond to the wall. During our inspection it was noted that a section of tile has fallen from the RHS curved portion of the elevation. This has shown that the bond has failed locally and water ingress behind could affect the tiles immediately local to this in future. Refer to photographs below:

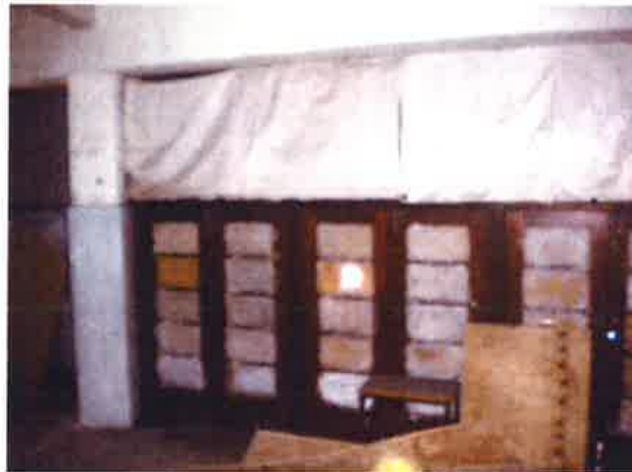
Photograph of entrance steps 2012

The paint is peeling off the reinforced concrete columns and beams. There are metal soffit panels to the front down stand beam that are badly corroded and on one side dangerously hanging loose. The Concrete frame and roof slab, however, do not show any evidence of rust staining or spalling. There is visual evidence of further deterioration in comparison to the 2012 report photographs, see below:

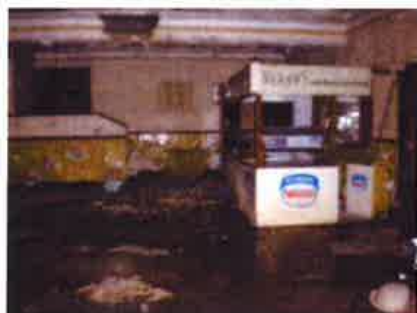
Foyer area (2012)

The paintwork to the soffit of the concrete slab, down stand beams and columns are peeling away badly in all locations. There is clearly standing water on the slab above as there are hairline cracks in the soffit with rust staining and damp areas. This area is clearly in a poor state of repair and has deteriorated further since 2012 with the majority of the feature cornicing breaking away from the ceiling. Refer to photographs below:

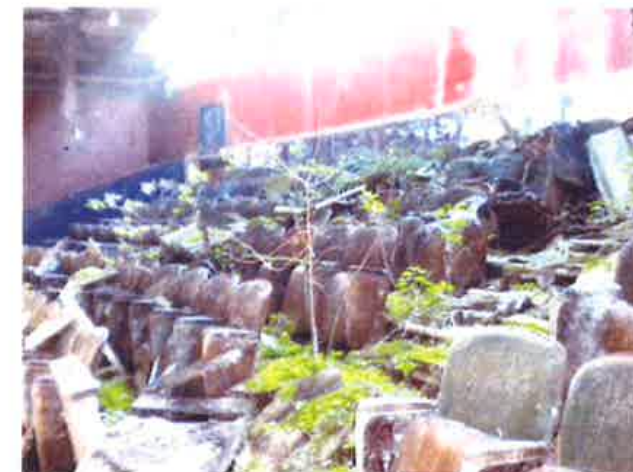
The projection room and balcony were not inspected as it was deemed to be dangerous to enter these areas due to the extent of dilapidation and excessive build-up of pigeon droppings over the years. We managed to gain access through to the main auditorium at ground level and the vegetation that was noted as growing from the balcony seats in 2012 are now fully grown trees that extend up towards the broken roof sheeting and beyond. The trees also appear to be directly adjacent to the front wall to the auditorium structure. Whilst this wall has not been inspected the tree/vegetation roots may have caused damage to the wall. See photographs below:

2012 vegetation over seating

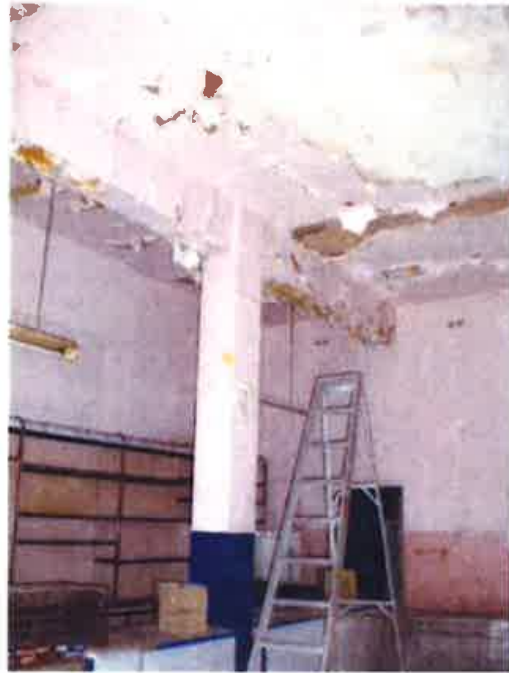
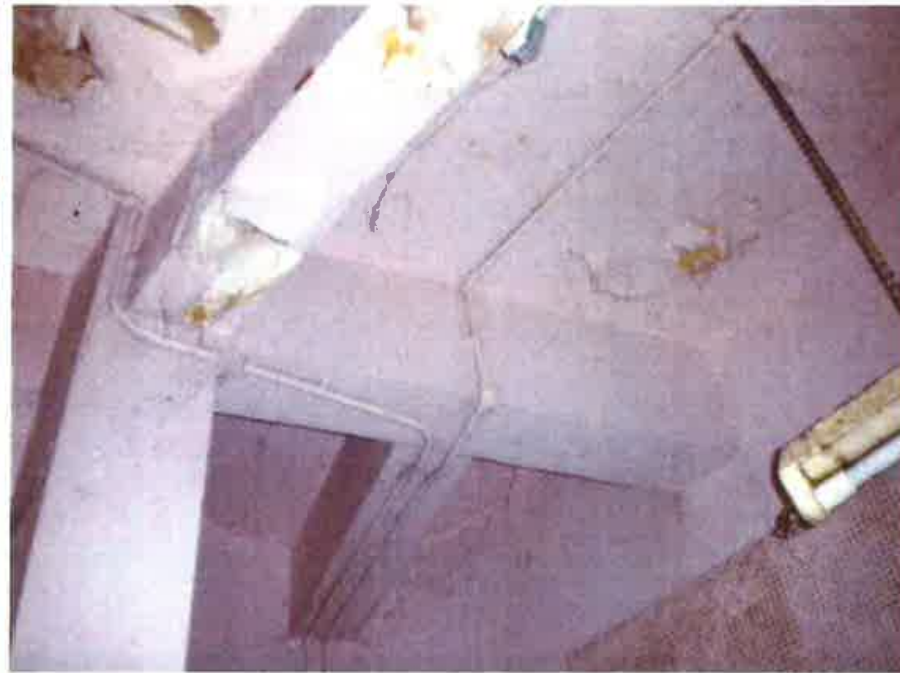
The 2012 report identified water ingress through the concrete roof slab revealing some corroded reinforcing bars. During the inspection it was clear that the paintwork to the concrete in general had deteriorated with almost all concrete surfaces peeling. Refer to photographs below:

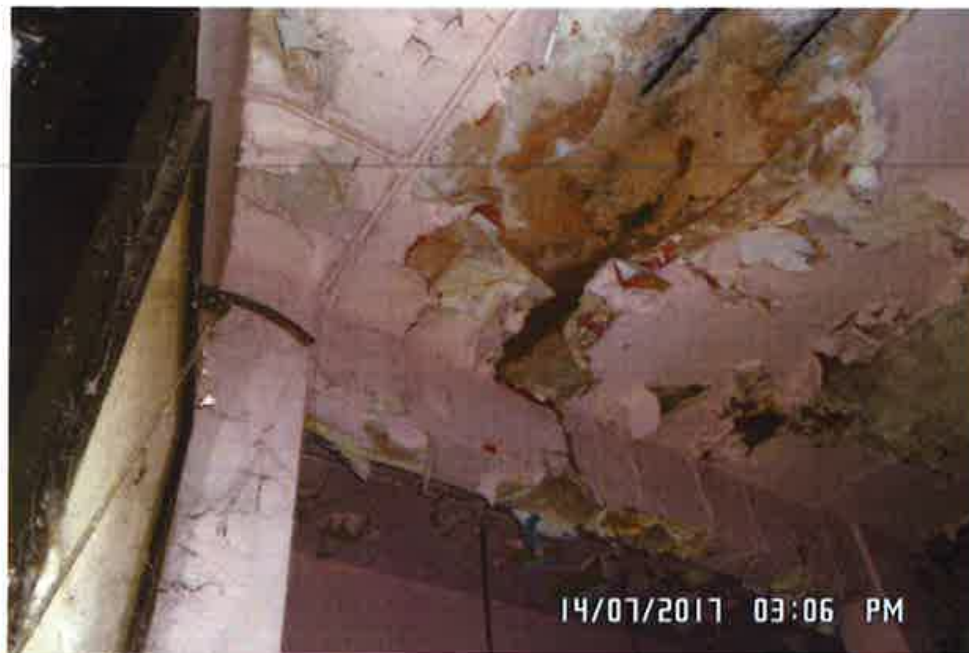
Likewise with unit 1 there are hairline cracks with water penetration to the soffit of the slab in two areas with algae staining and exposed corroded reinforcement. The paintwork is also looking in a much poorer state than the photographs on the 2012 report. Refer to photographs below:

July 2017 indicates clear evidence of water penetration through hairline cracks

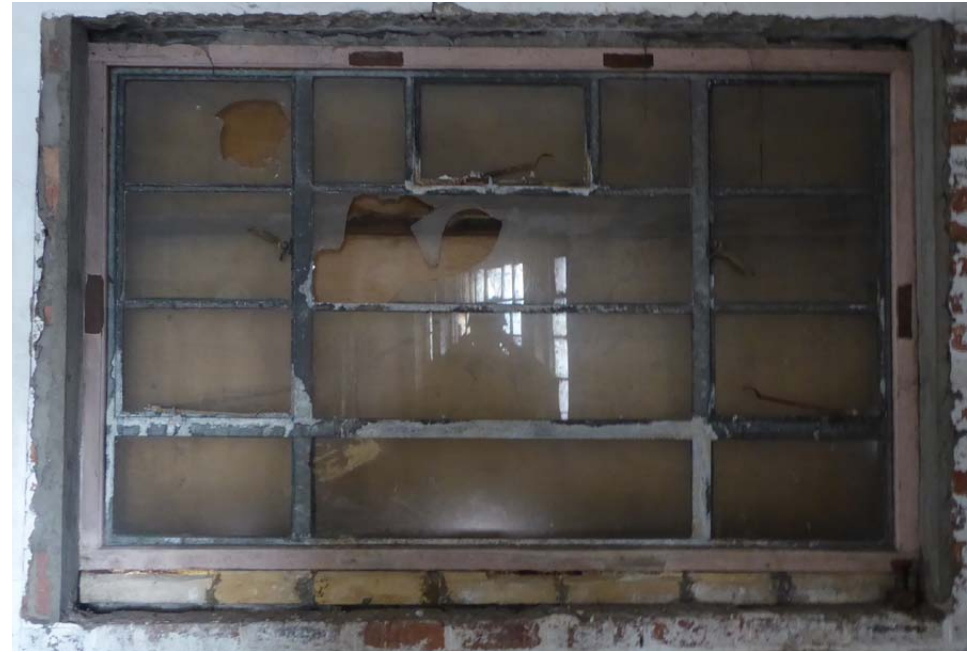
**C Crittall Window to be Retained & Restored - Window S2**

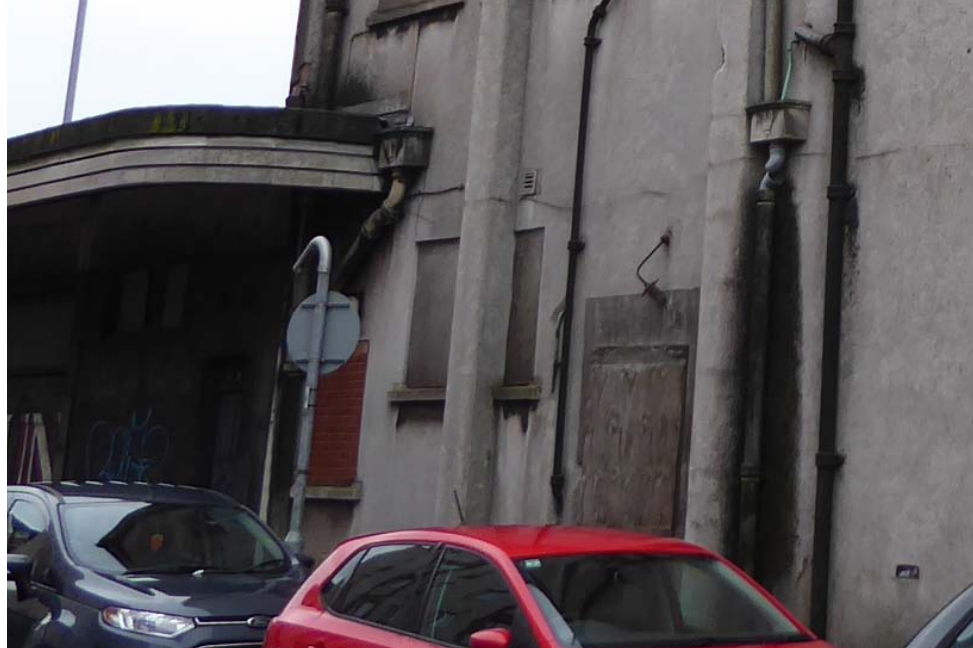
**Q** Existing Masonry Columns, Beams & Infills to be Repaired

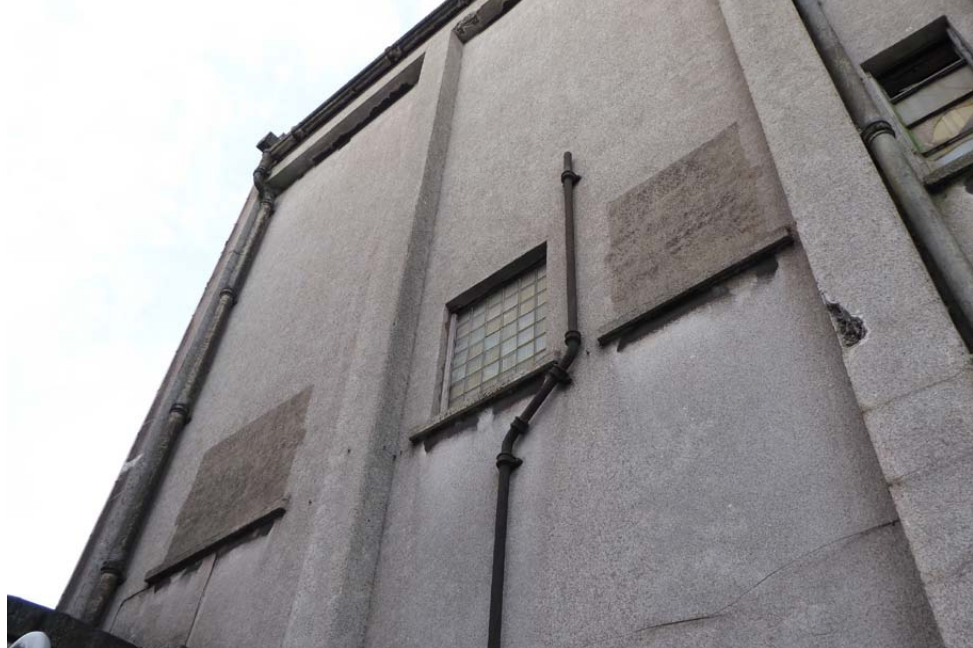
**R** Existing Masonry Infills to be Replaced

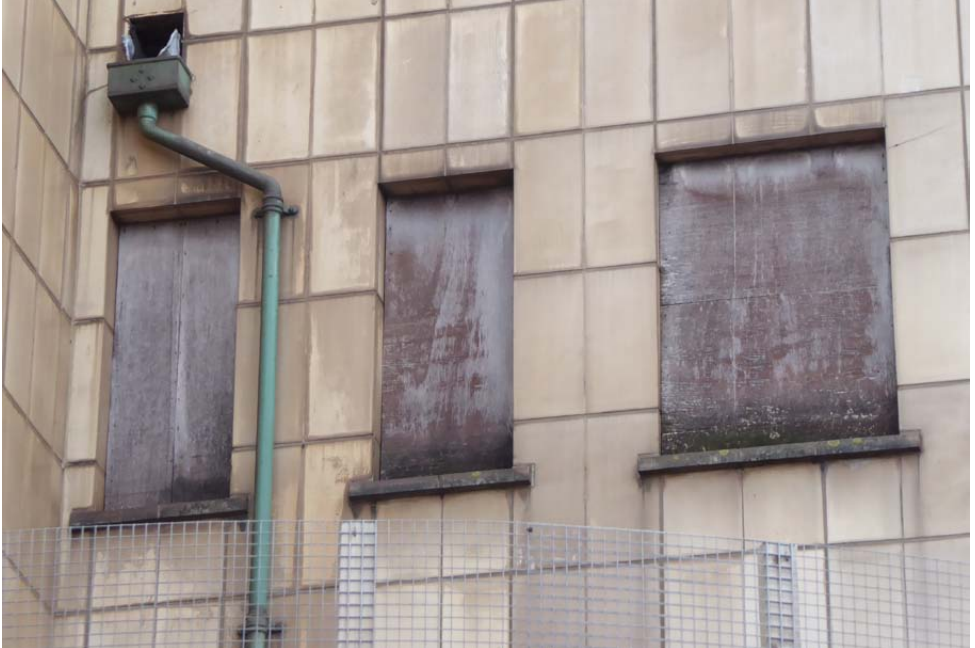
- X Existing Rainwater Pipes & Hoppers to be rubbed down, any corrosion abraded off, primed & re-painted. Any damaged areas to be repaired or replaced. Lead dressing into hopper to be re-formed once roof behind is laid.

**X** Existing Rainwater Goods to be Retained & Restored

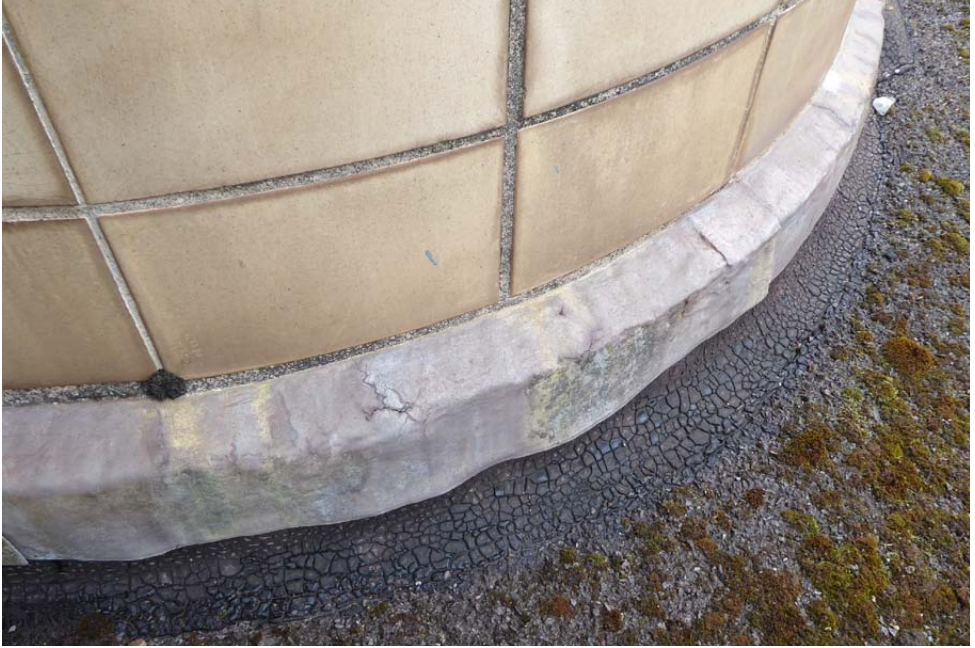
- Y Lead flashing at base of faience tiling, dressed over flat bitumen roof, damaged in areas. Removal of lead could damage faience tiling, so proposal is to dress new roof finish under lead, chased into bottom joint, & patch repair all damaged areas to lead flashing in situ. [YX = damaged to lead flsahing]

**Y** Lead Flashing at base of faience tiling

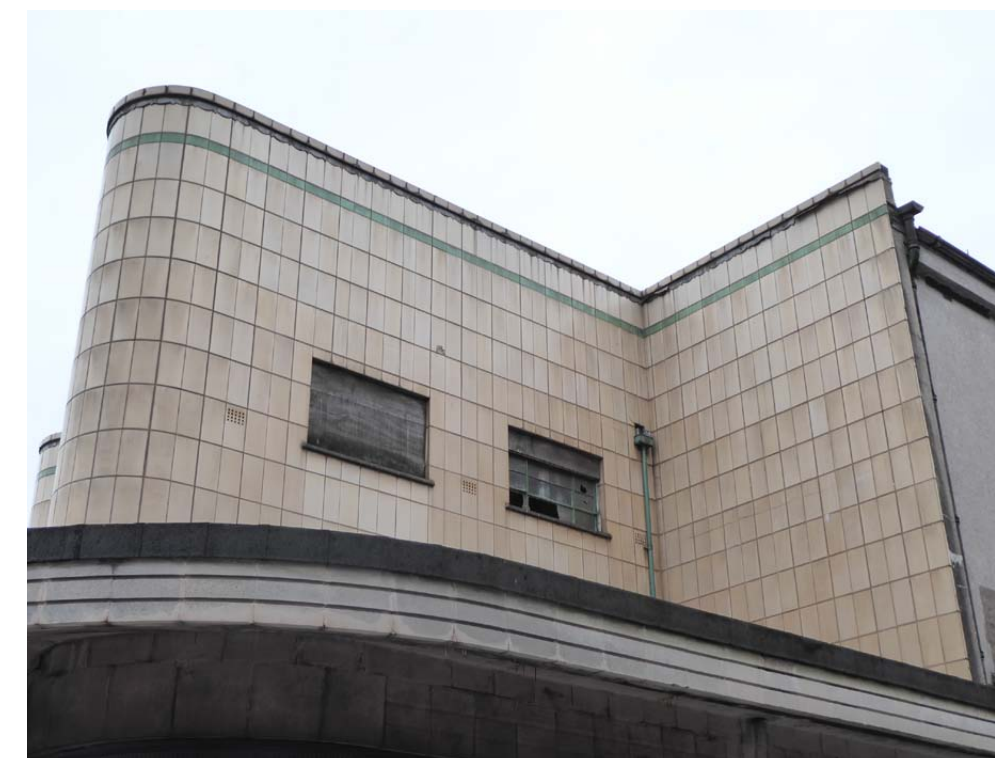
*A recent photo of the Plaza frontage shows that, despite its dereliction, it retains the iconic Art Deco forms, lines & features*

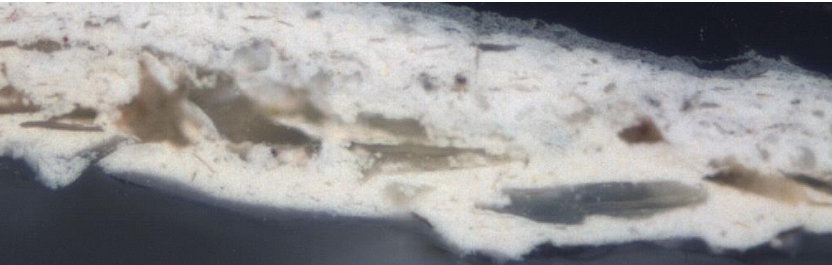
Sample 19 taken from the ground floor front elevation column, showing its initial decoration executed in imitation of stone. Photographed in cross-section under reflected light using a 20X magnification lens. Printed magnification not calculated.

Textured paint layer containing large chunks of silica resting over a light stone coloured base coat

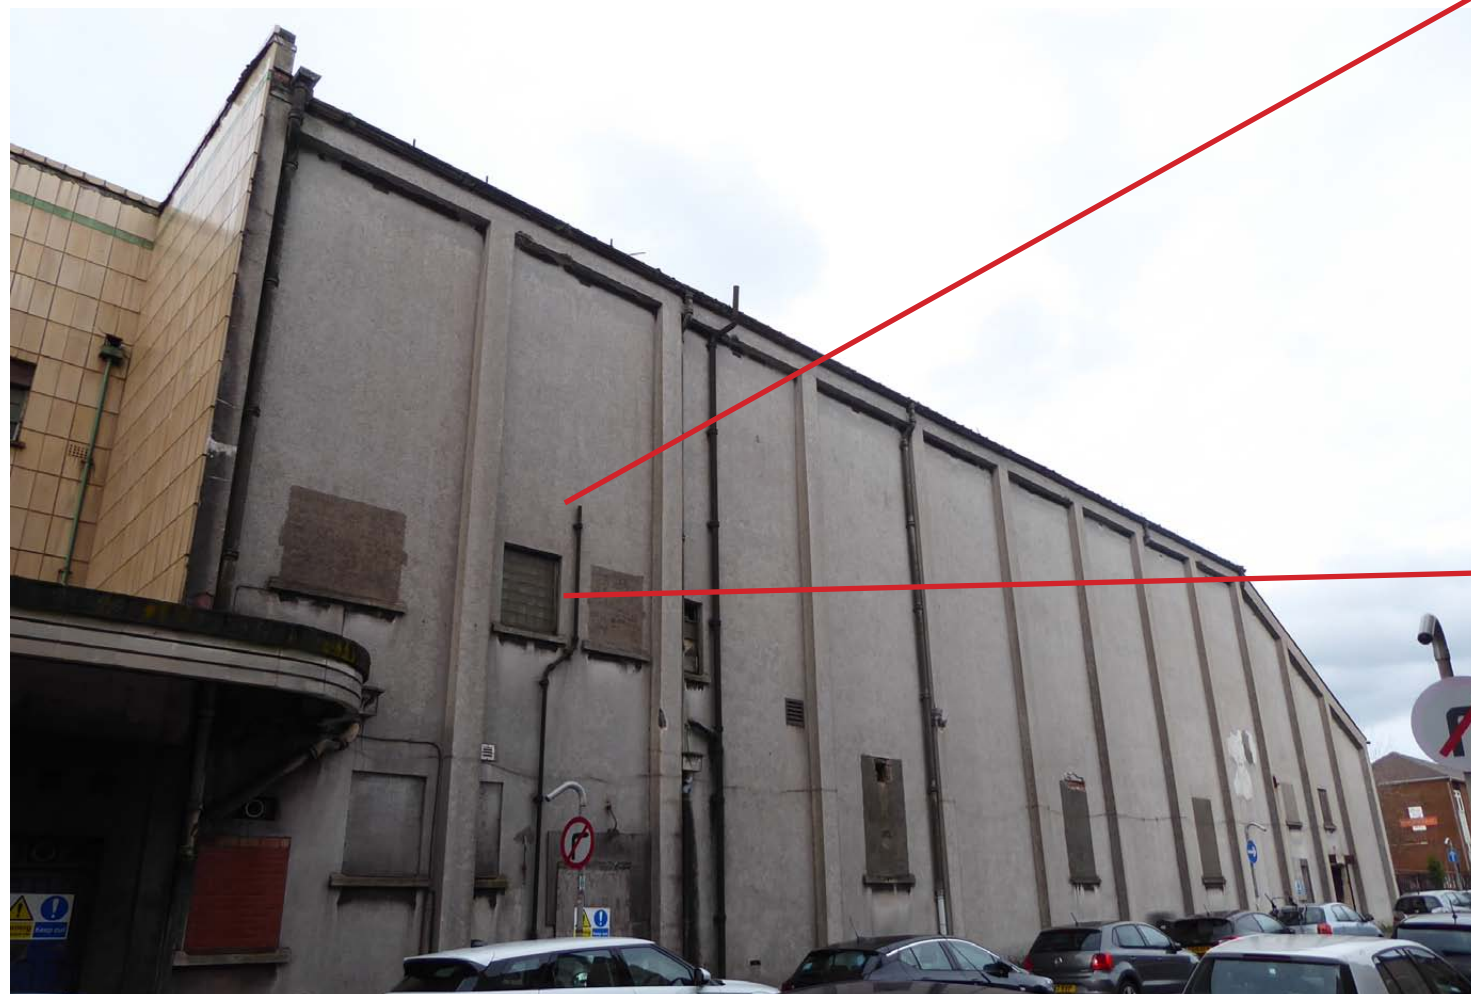
*View of rear (rendered) section of Eagle Street (east-facing) Elevation*

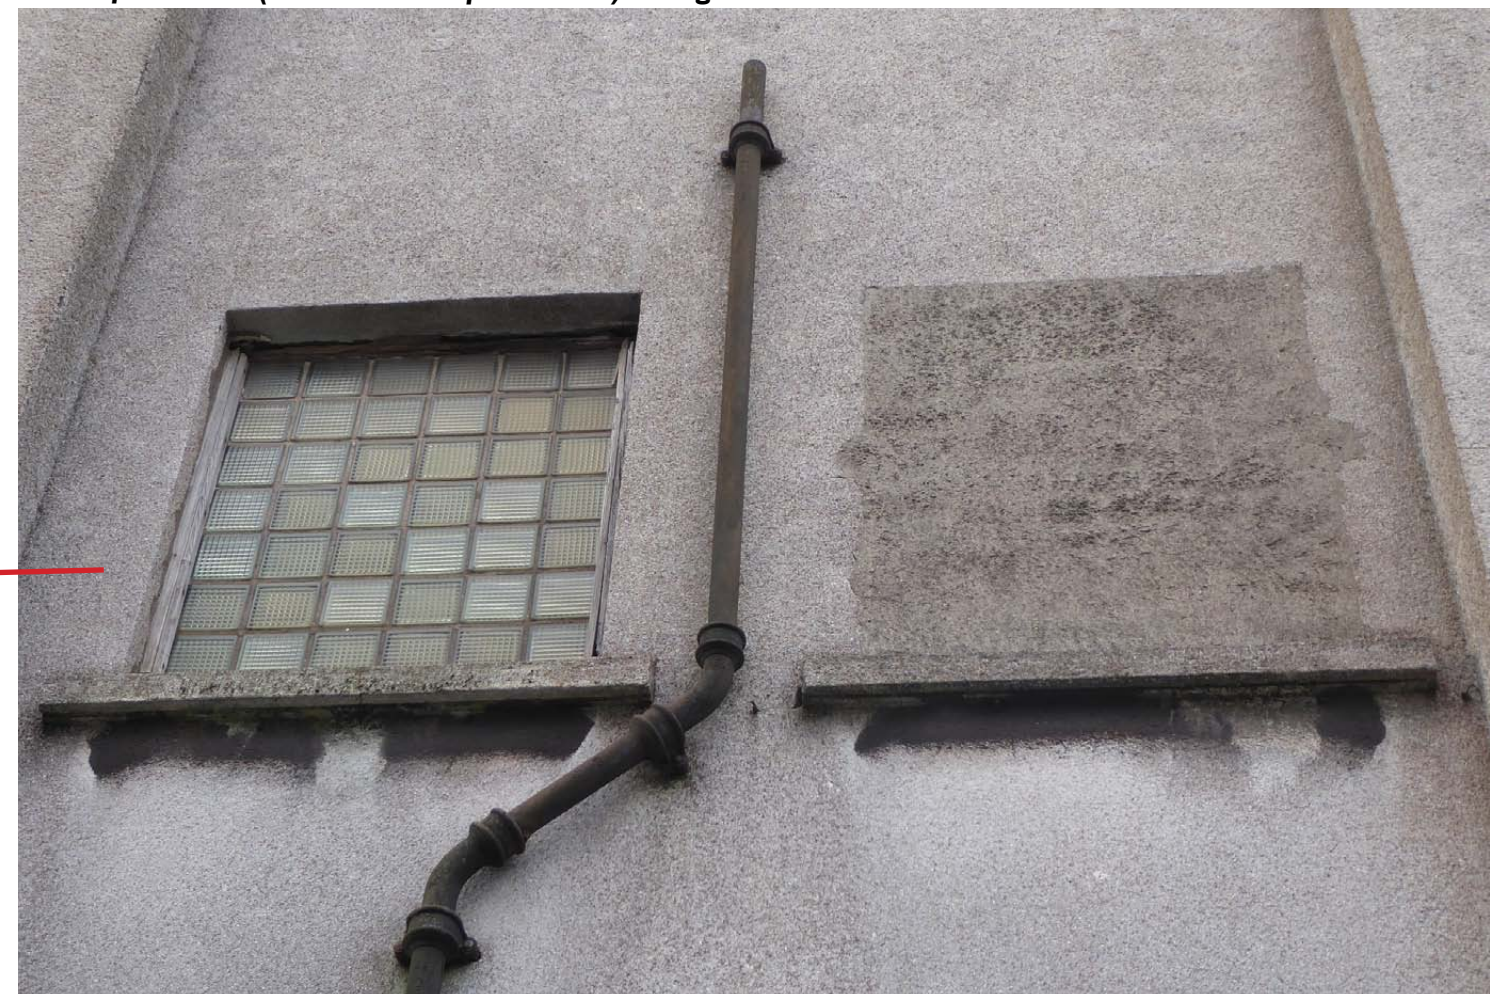
*Detailed view of glass block window and one blocked up windows at high level*

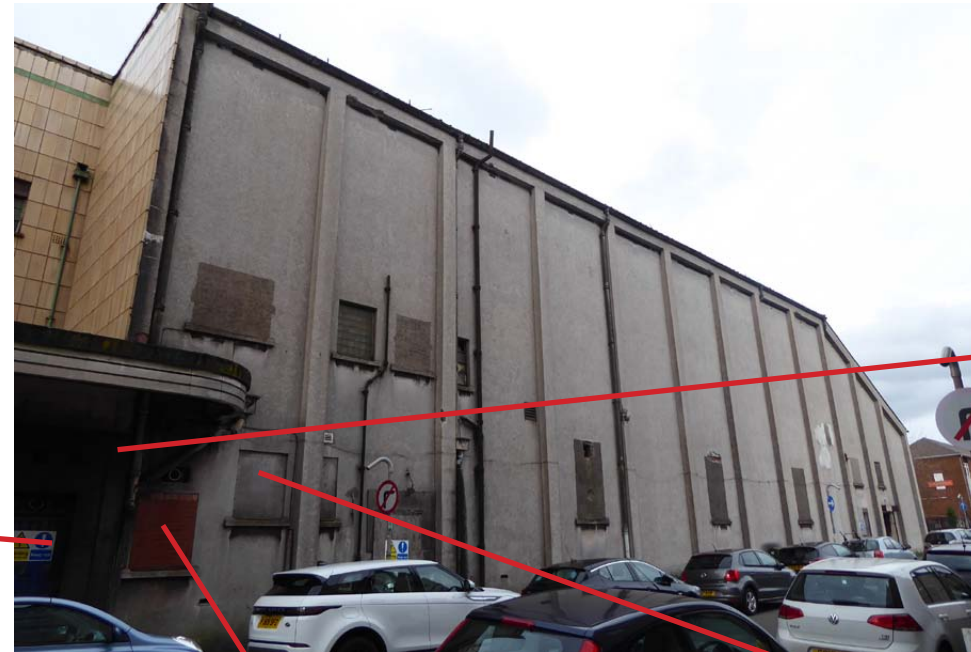
View of bricked up window to ground floor to Retail unit Toilet

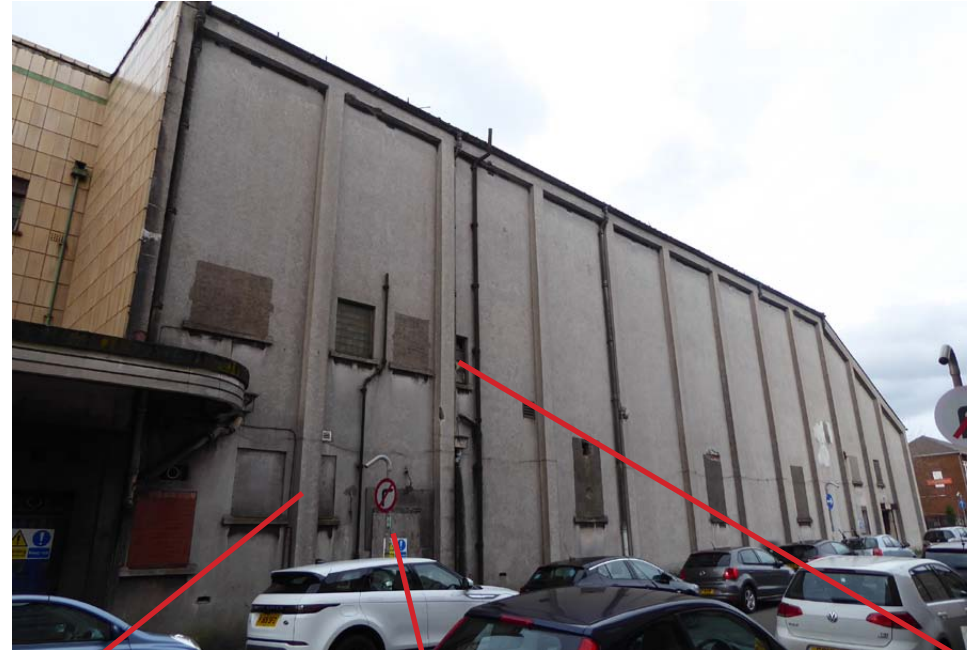
*View of boarded up windows to ground floor to Male Toilets*

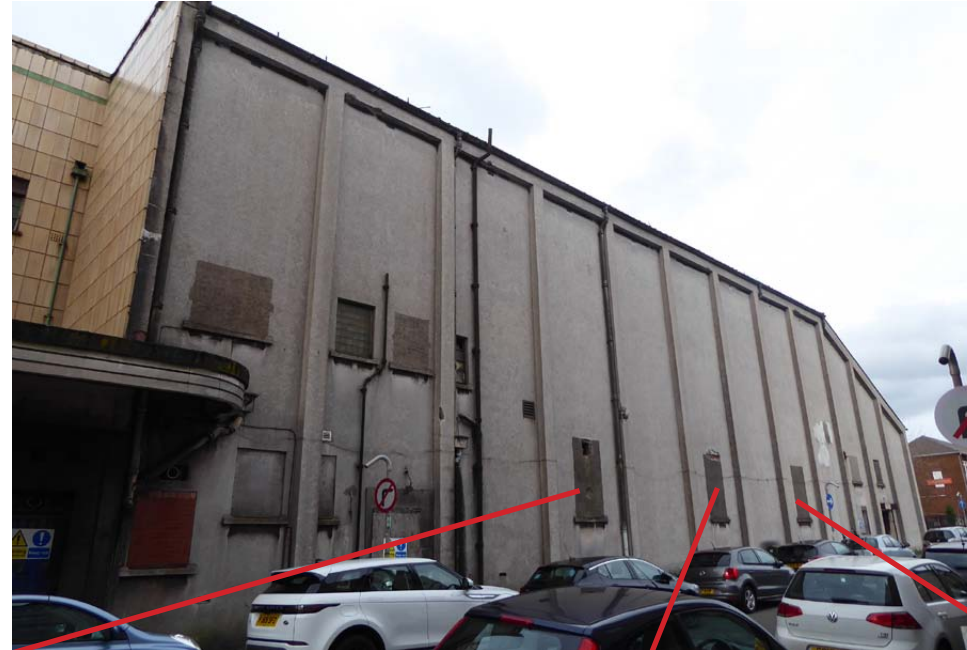
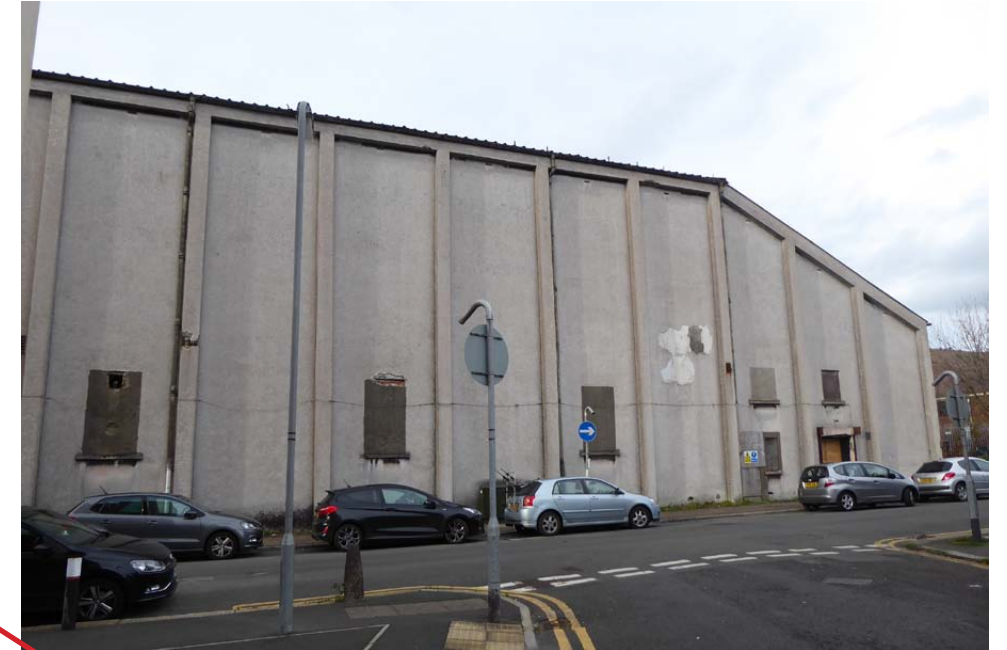
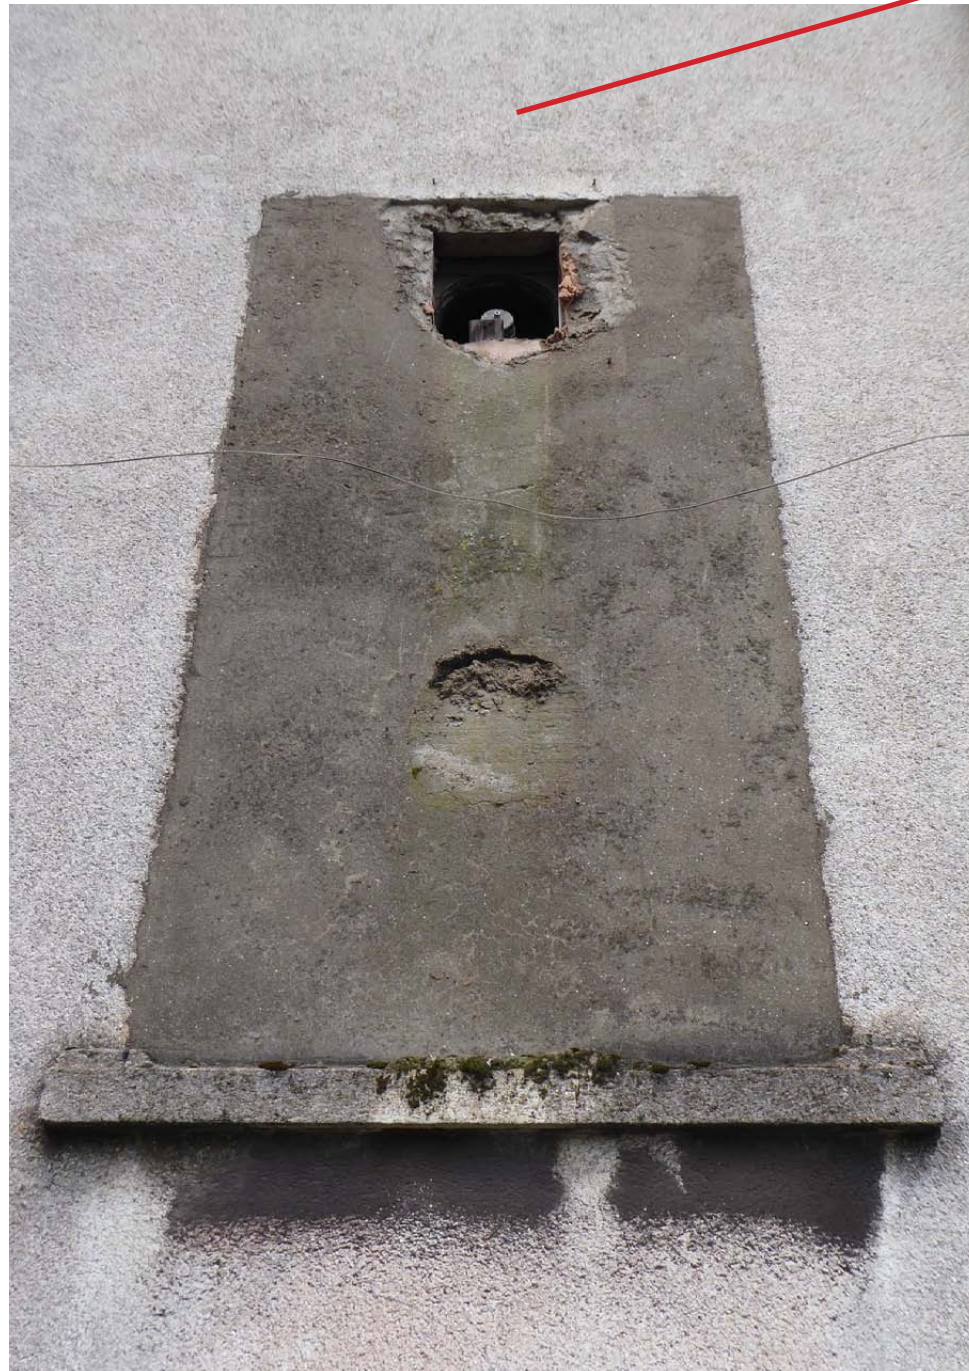
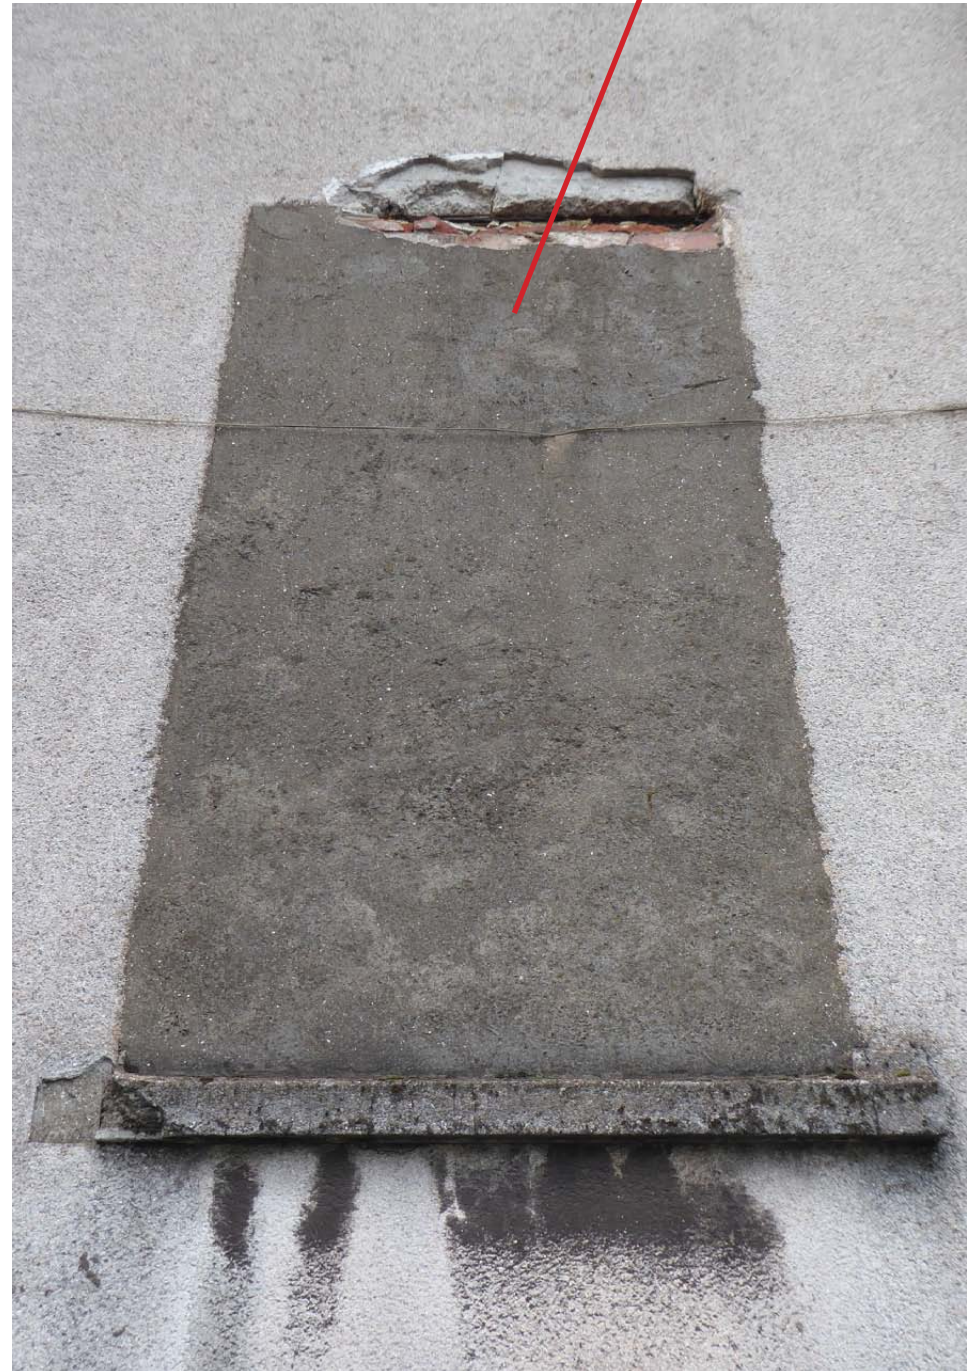
On this page are photographs of the 3no. bricked up and rendered windows openings to the auditorium, with the left hand one to the east cinema.

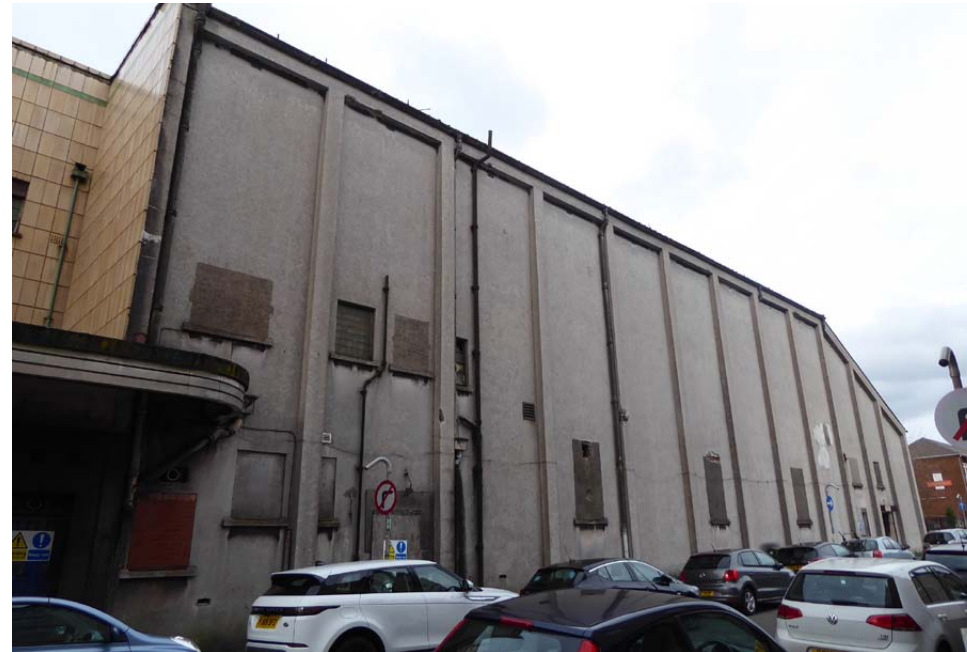
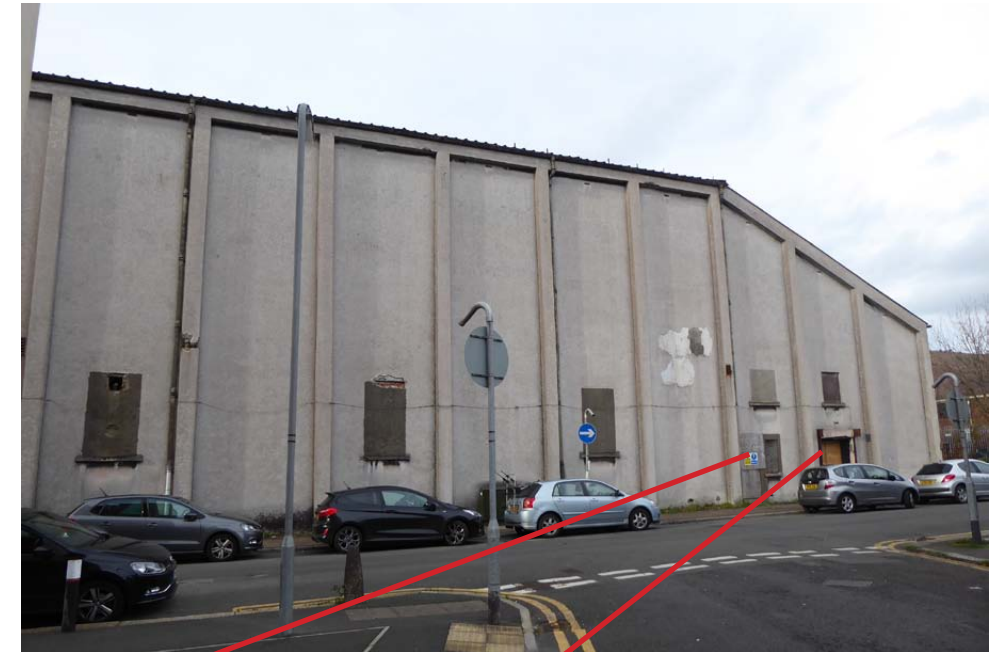
View of blocked / boarded up windows and door to auditorium
