**Plaza, Port Talbot**

**HISTORIC BUILDING RECORDING**

(385)1902-GWP-A-2A-HBR-P00

Date: 06.01.20

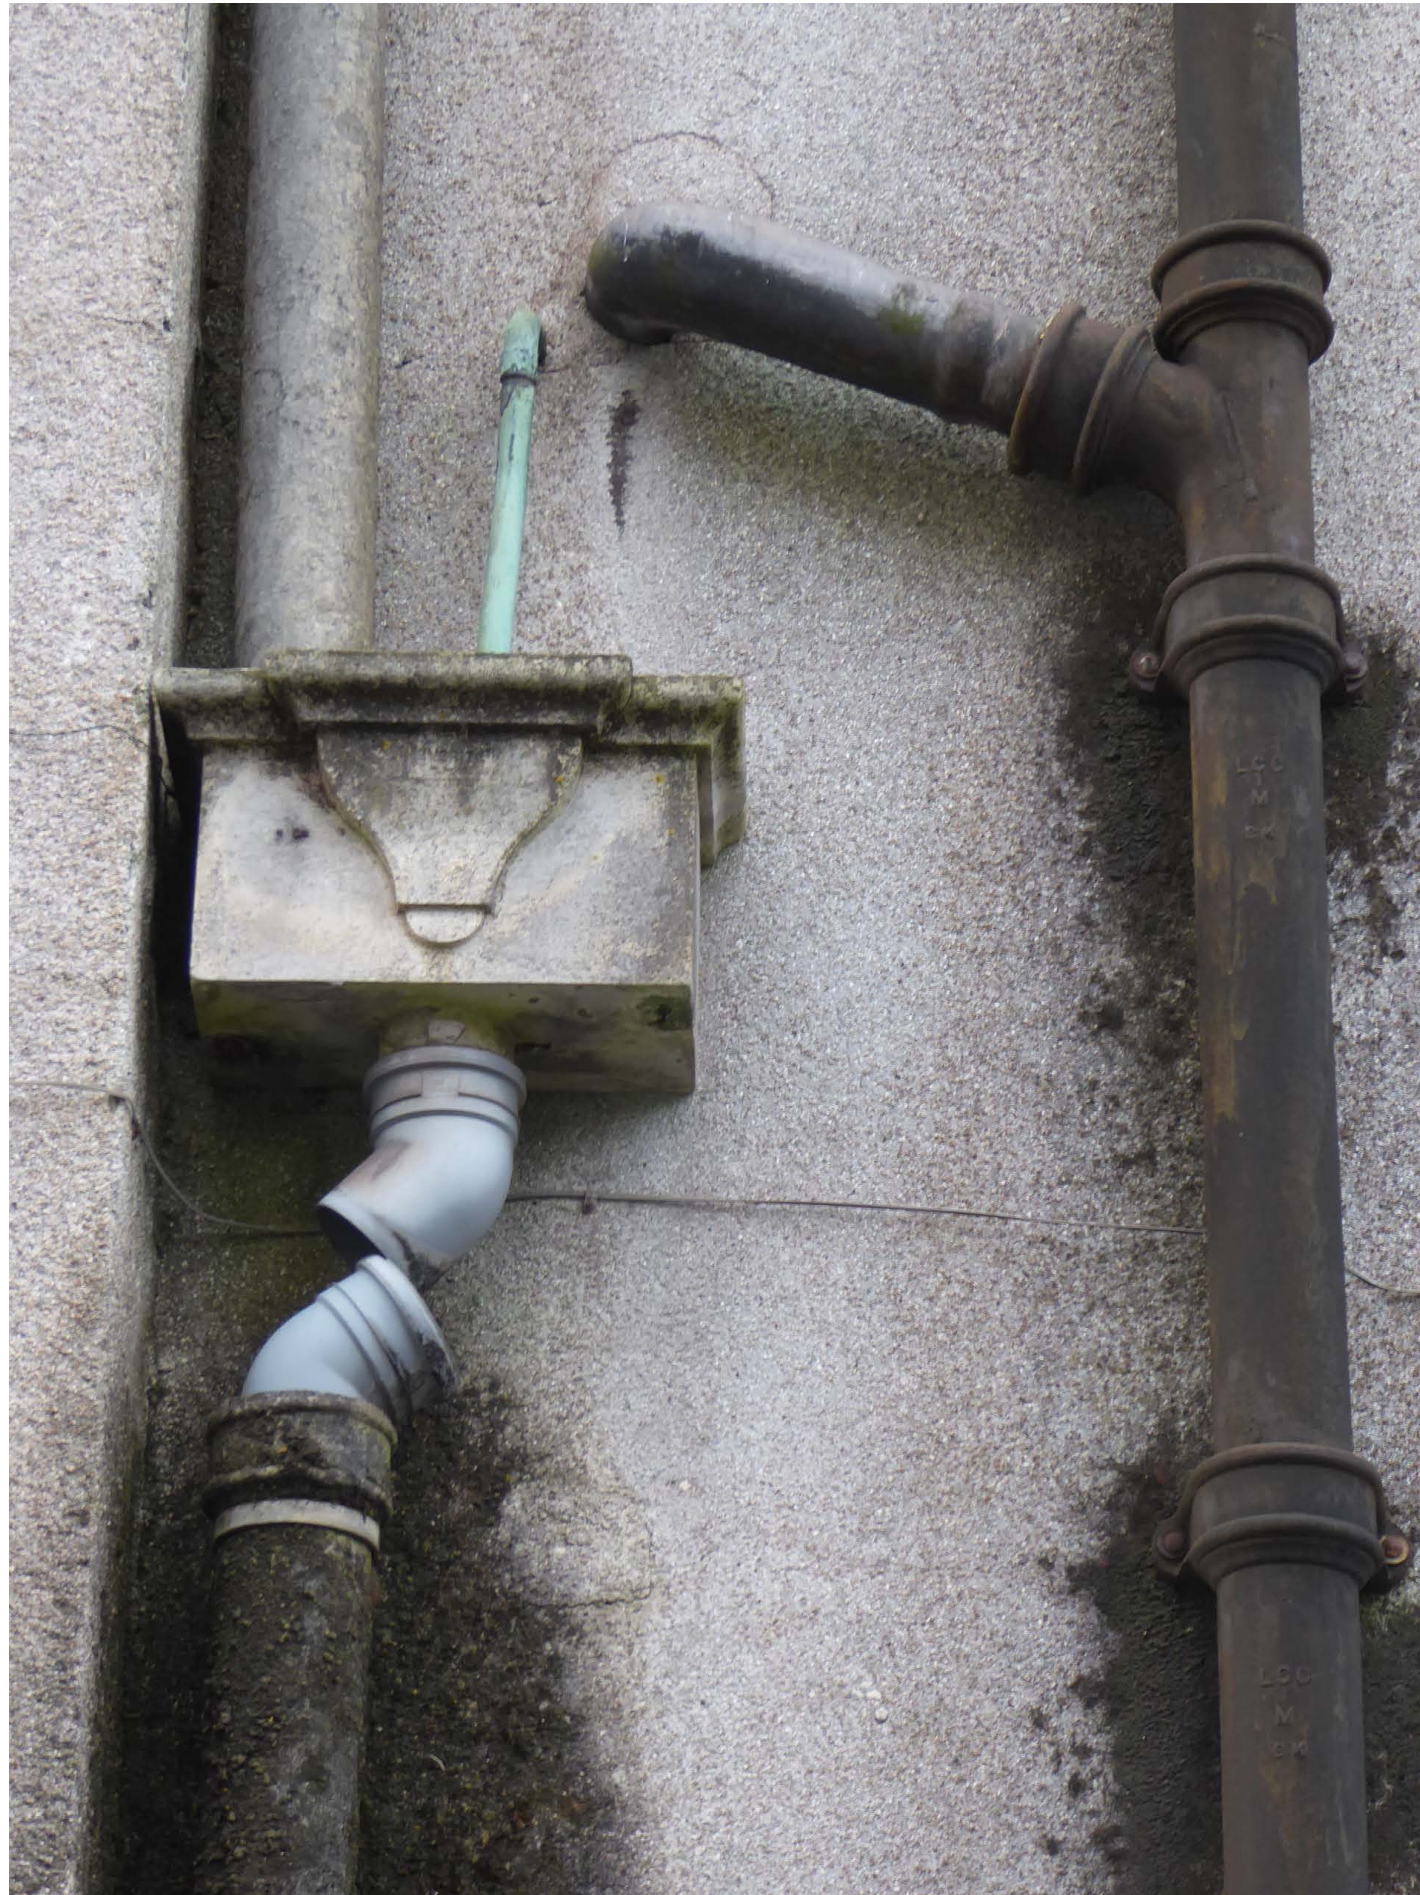
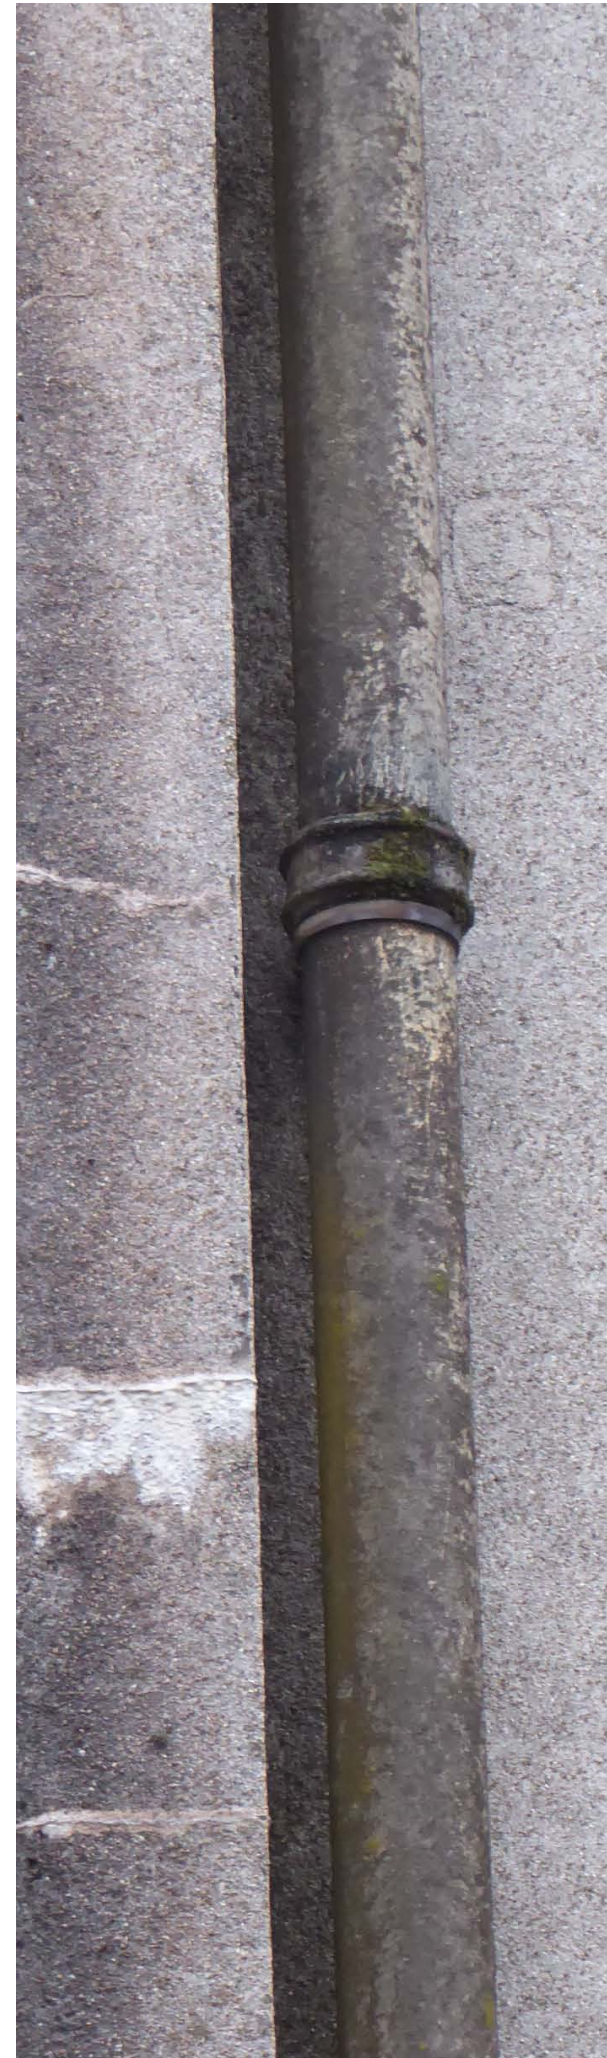
The rainwater goods are of cast iron with the downpipes round. To the rear section, the gutters are moulded half-round and both gutters and downpipes are painted black. The hoppers are white plastic.

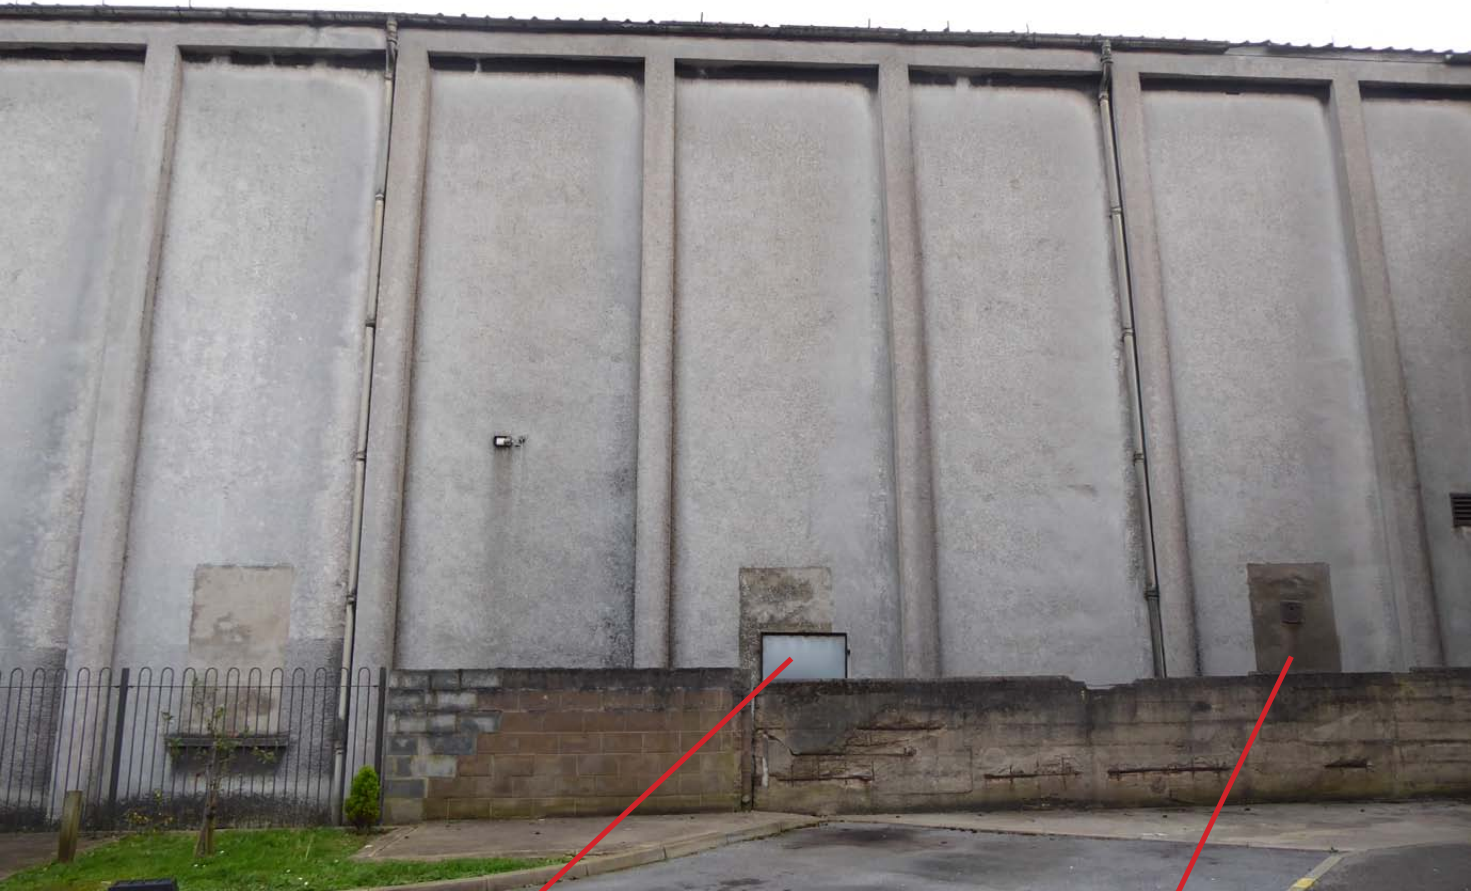
View of the blocked & boarded up windows and exit door to the central section of the west side elevation

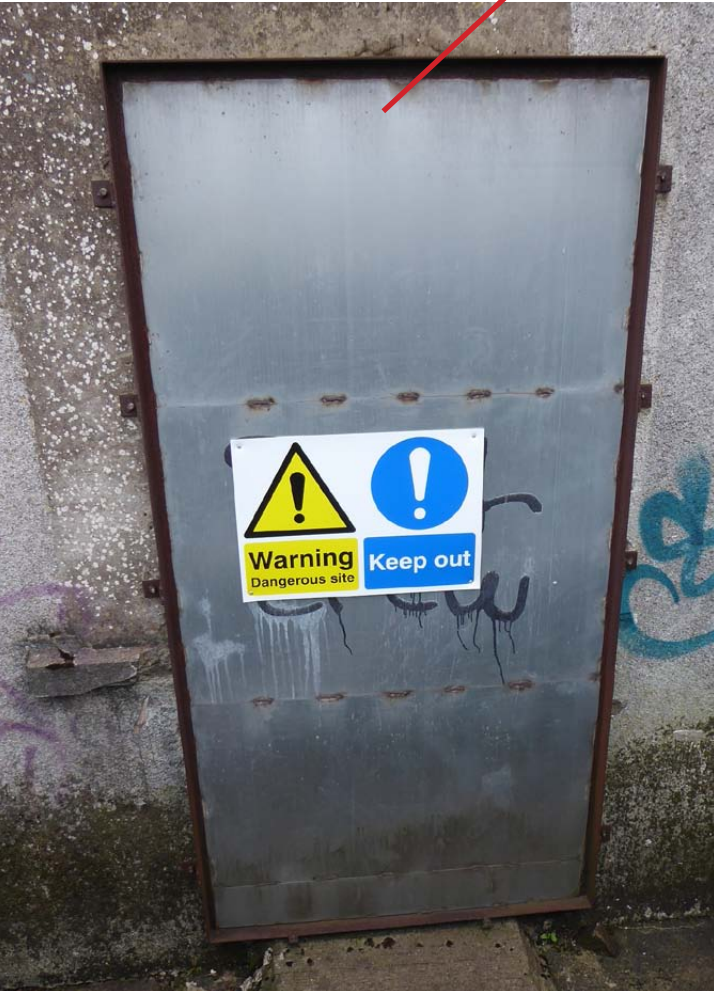
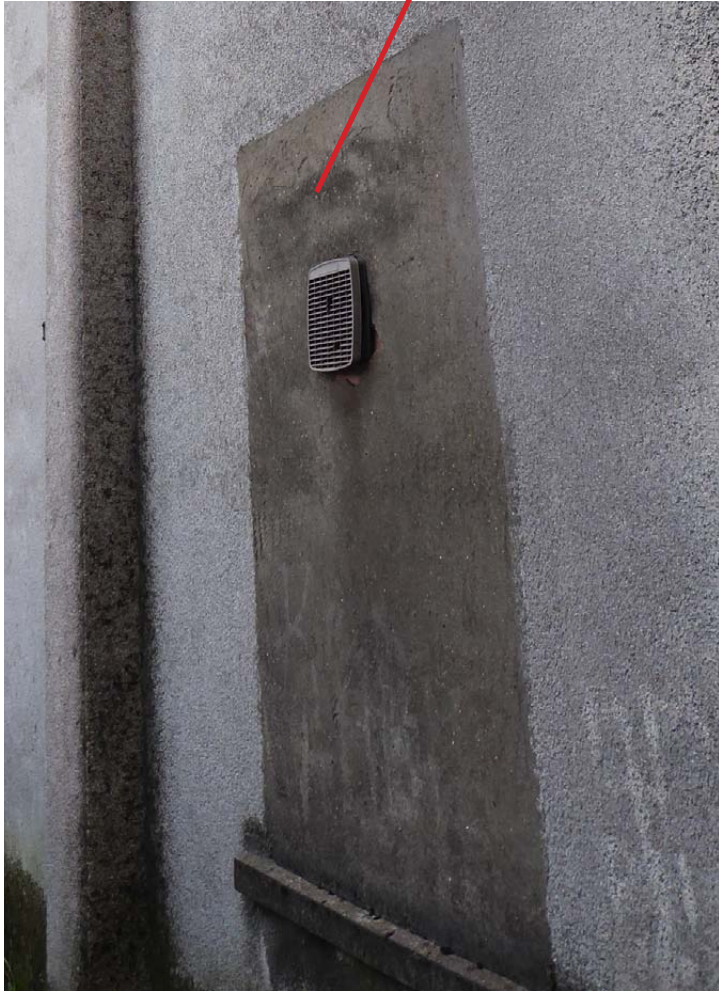
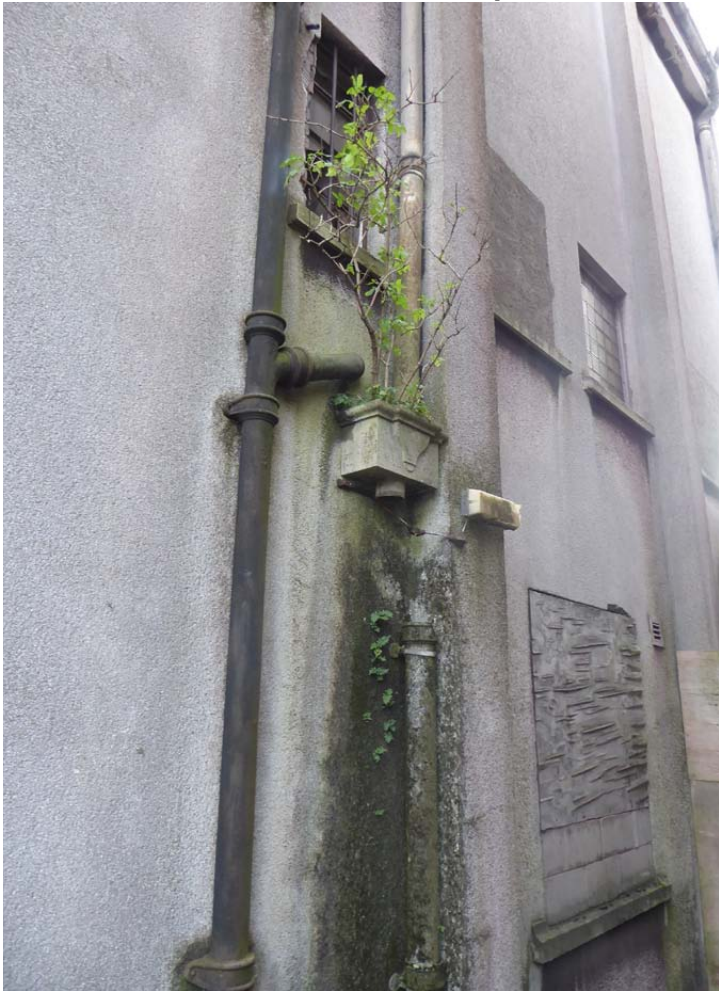
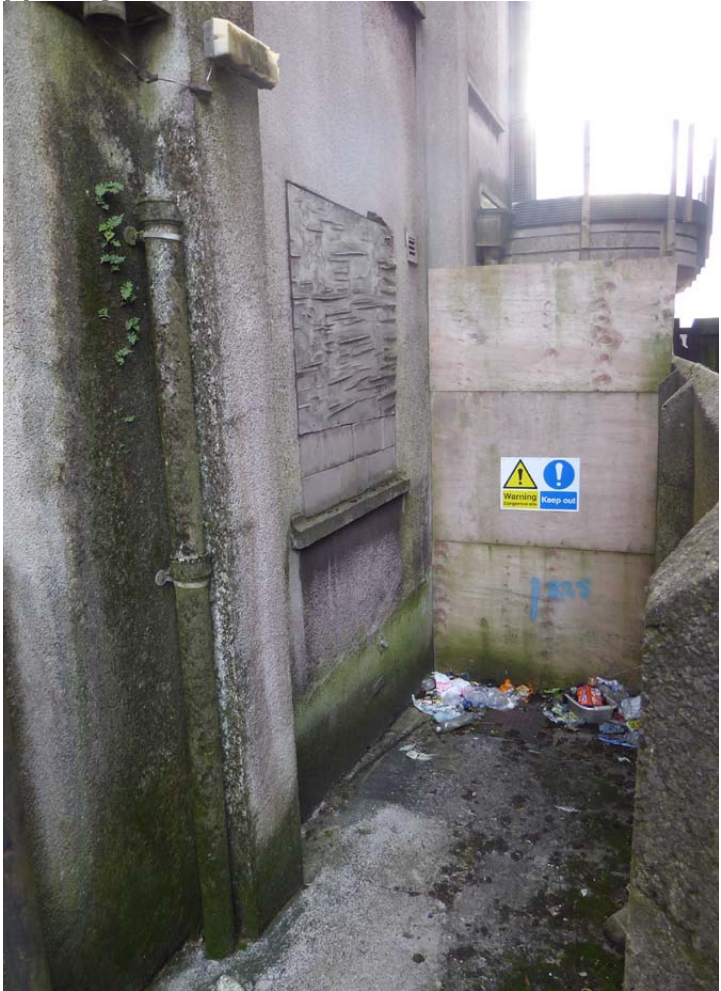
View of the windows and blocked up windows to the lower right hand side of the west side elevation

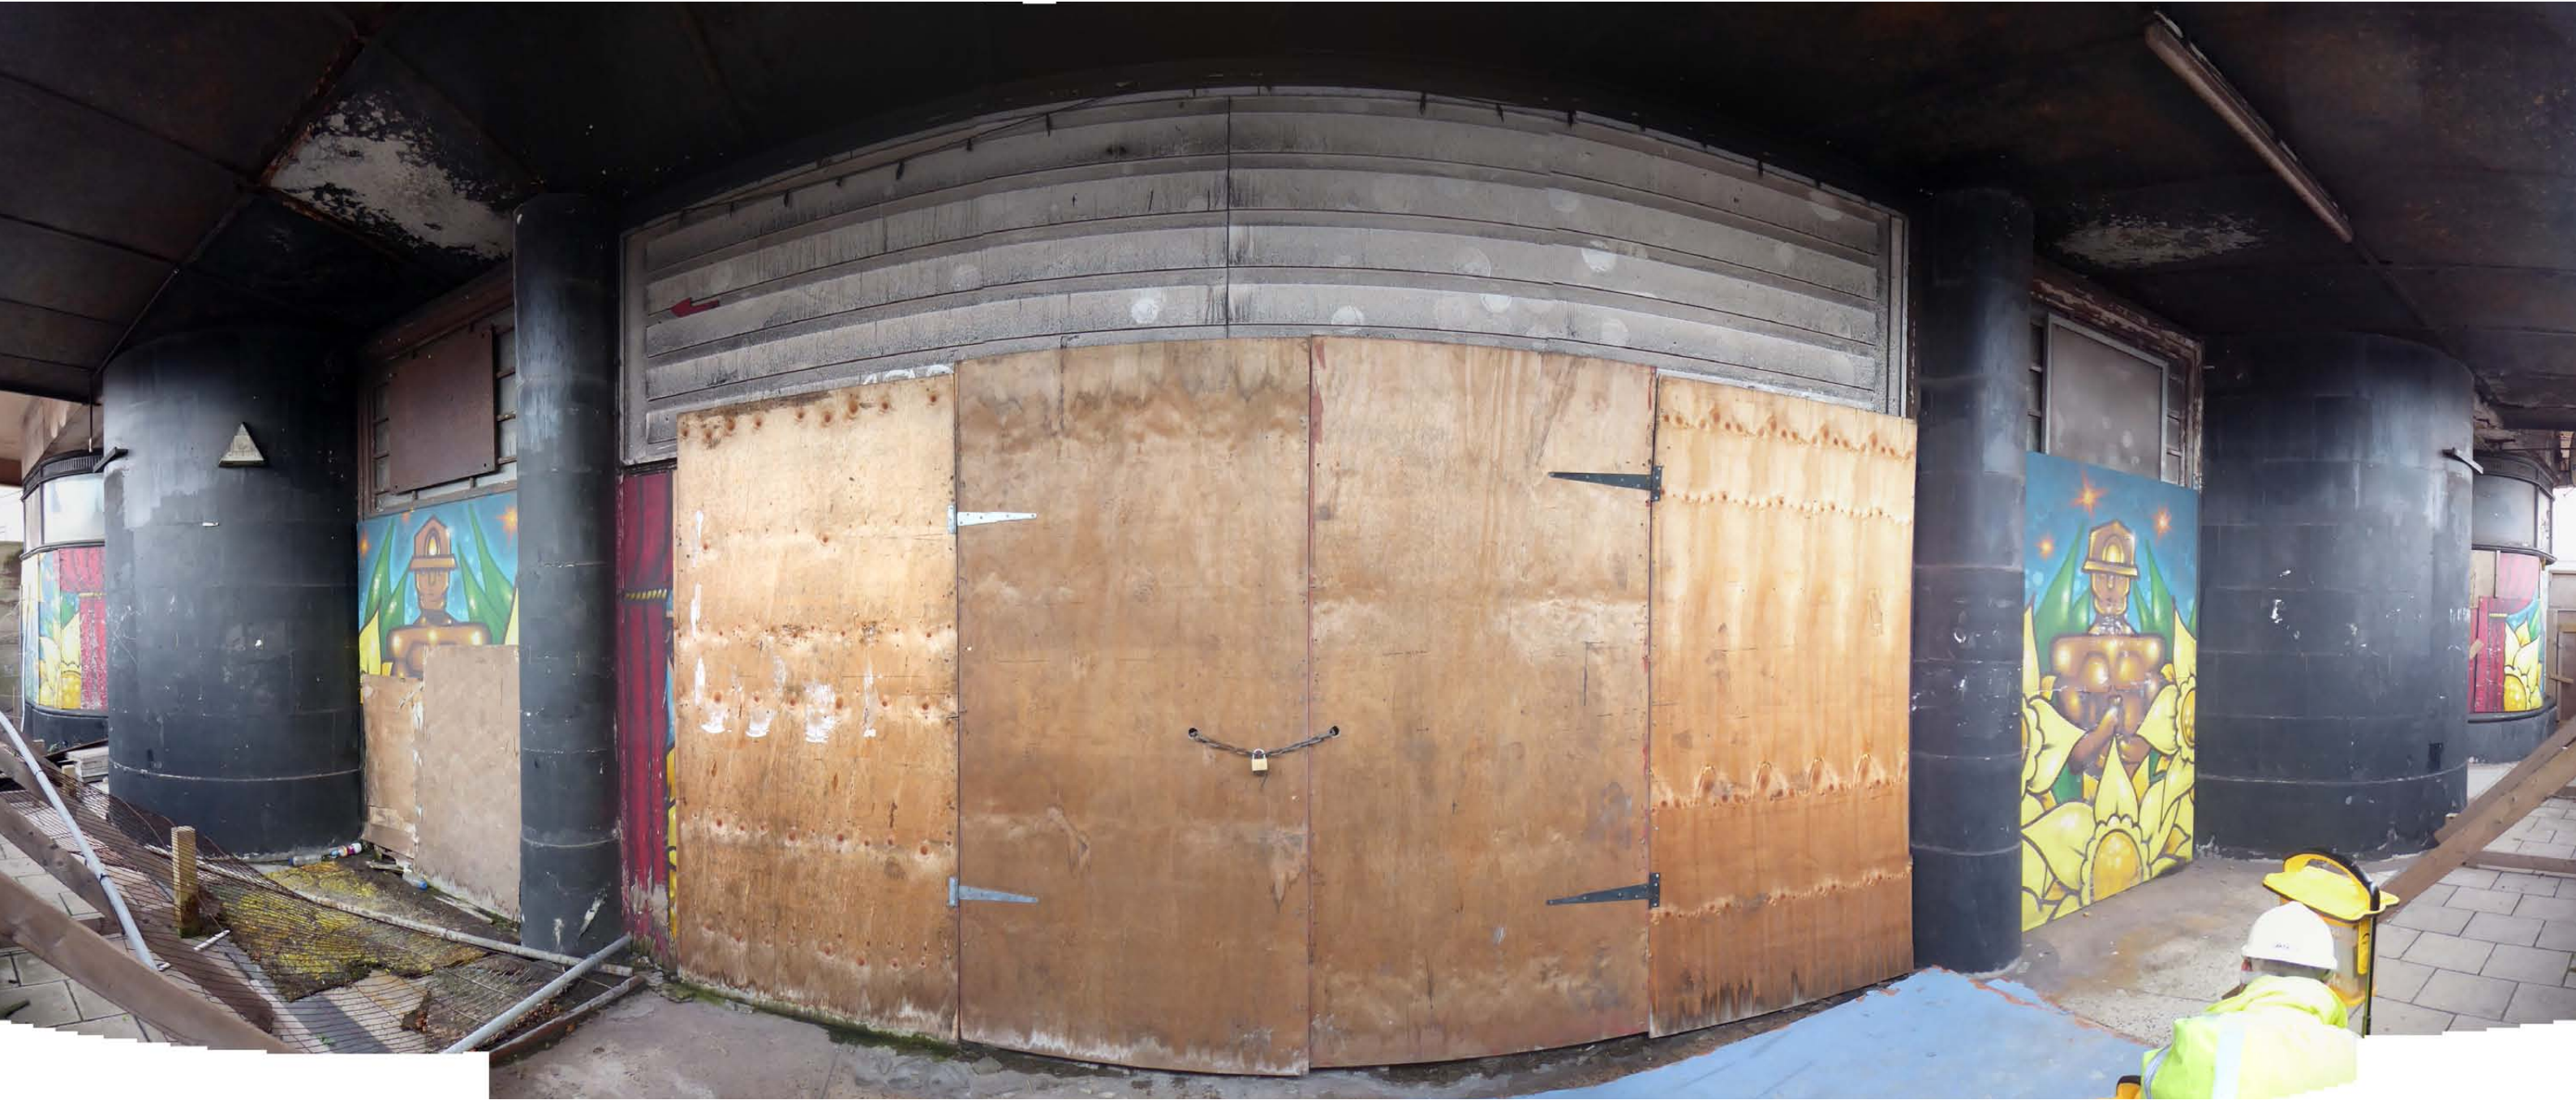
The mark up to the right and the list below describes the materials to the lower section of the front elevation, as photographed below:

- F Thick single-glazed shopfront glazing with curved ends, within timber frame and rounded bronze cill over timber cill plate. Much of glazing broken or missing.
- G Timber-framed glazed entrance doors & overlights. Plastic louvres & metal plates currently covering outside face of the overpanels. Some glass panes are broken. Brass art deco handles lost.
- H Timber glazed doors to retail units, with timber-framed glazed overpanels. Some glass panes are broken.
- L Masonry stall riser with curved bays, rendered & painted black.
- M Reconstituted stone cladding panels to zone above openings, not painted. Some areas of lost pointing.
- N Areas of damage to masonry stall risers.
- U Metal downstand to canopy.  
Metal frame & panels severely corroded.

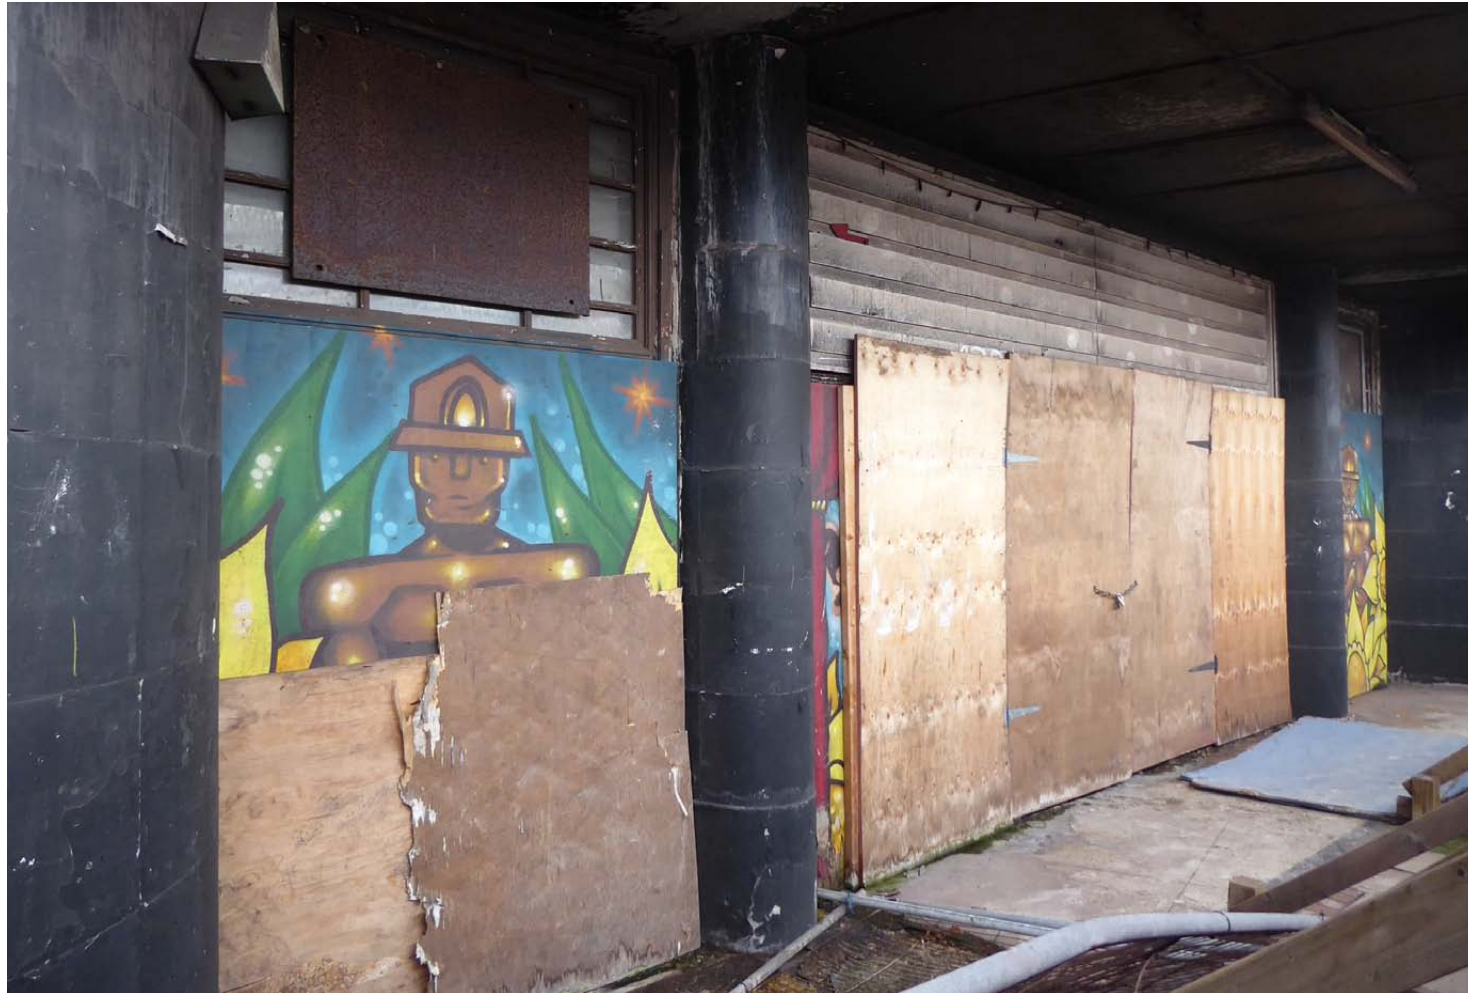
*View of the left hand side of the bank of main entrance boarded up*

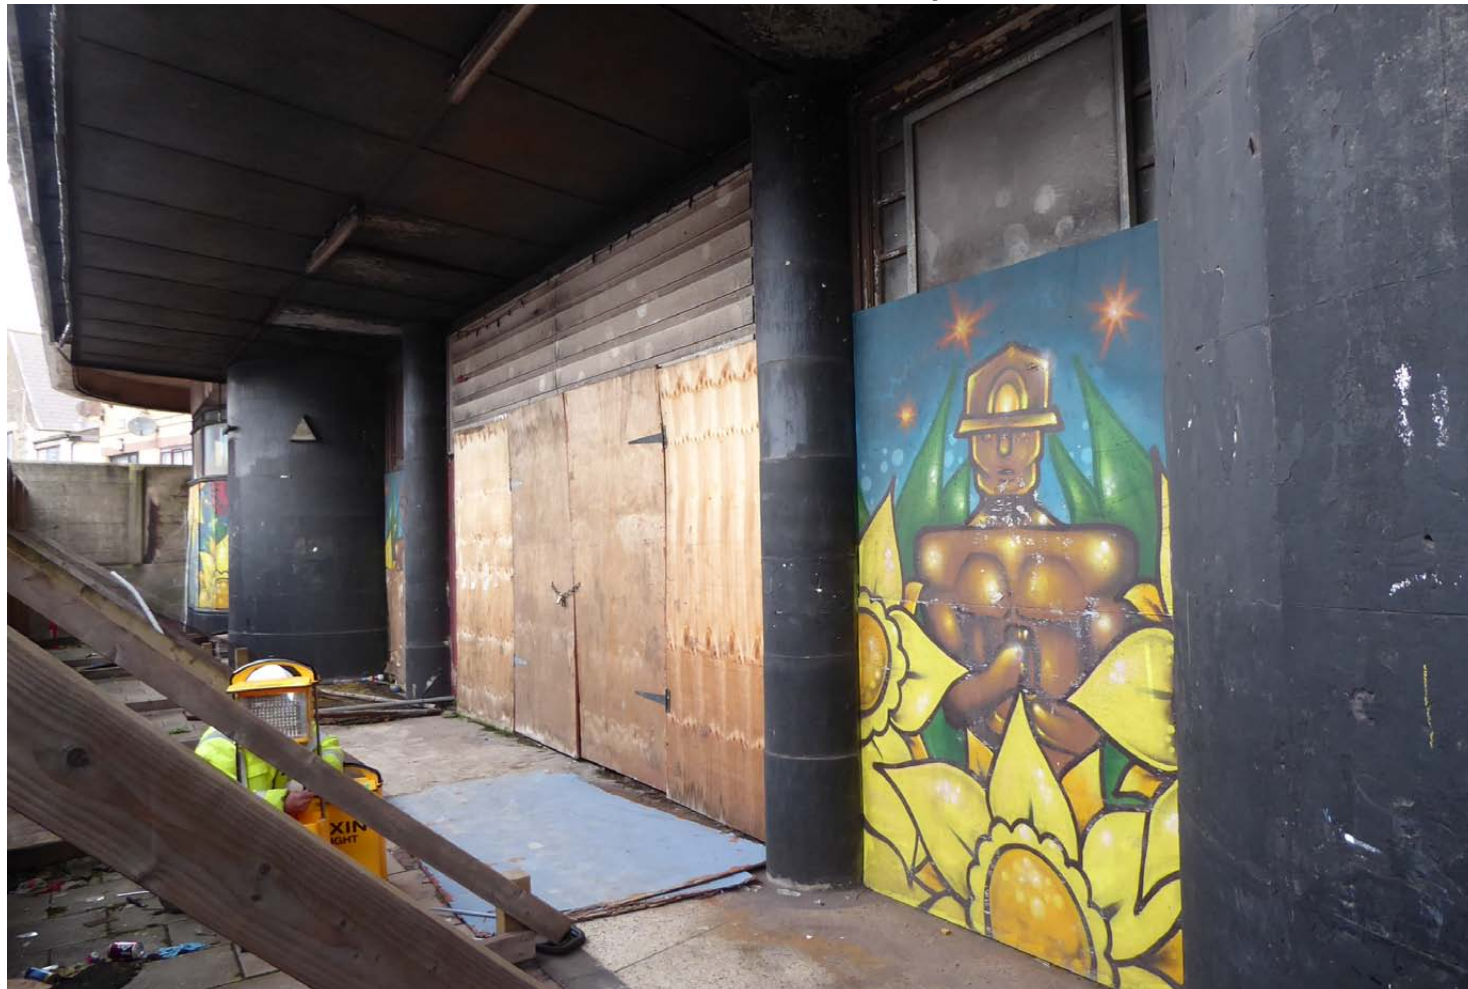
*View of the right hand side of the bank of main entrance boarded up*

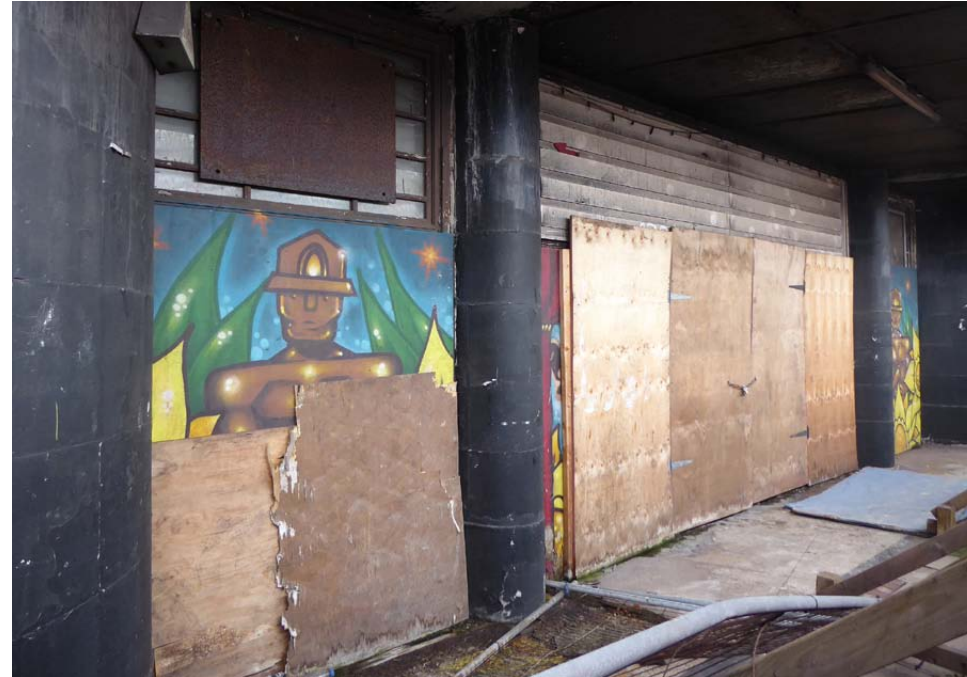
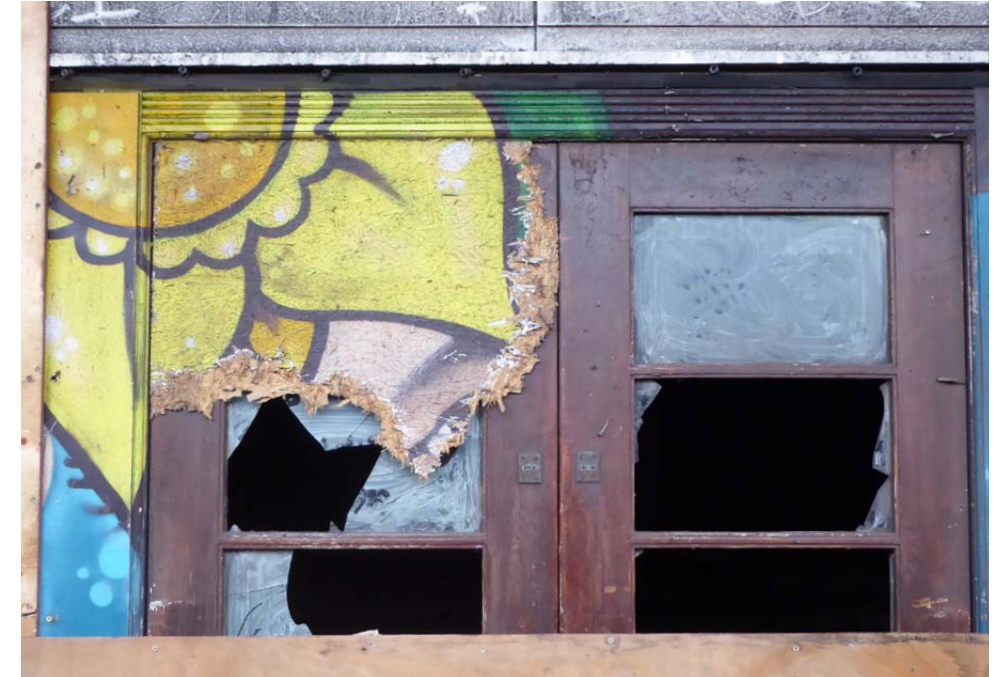
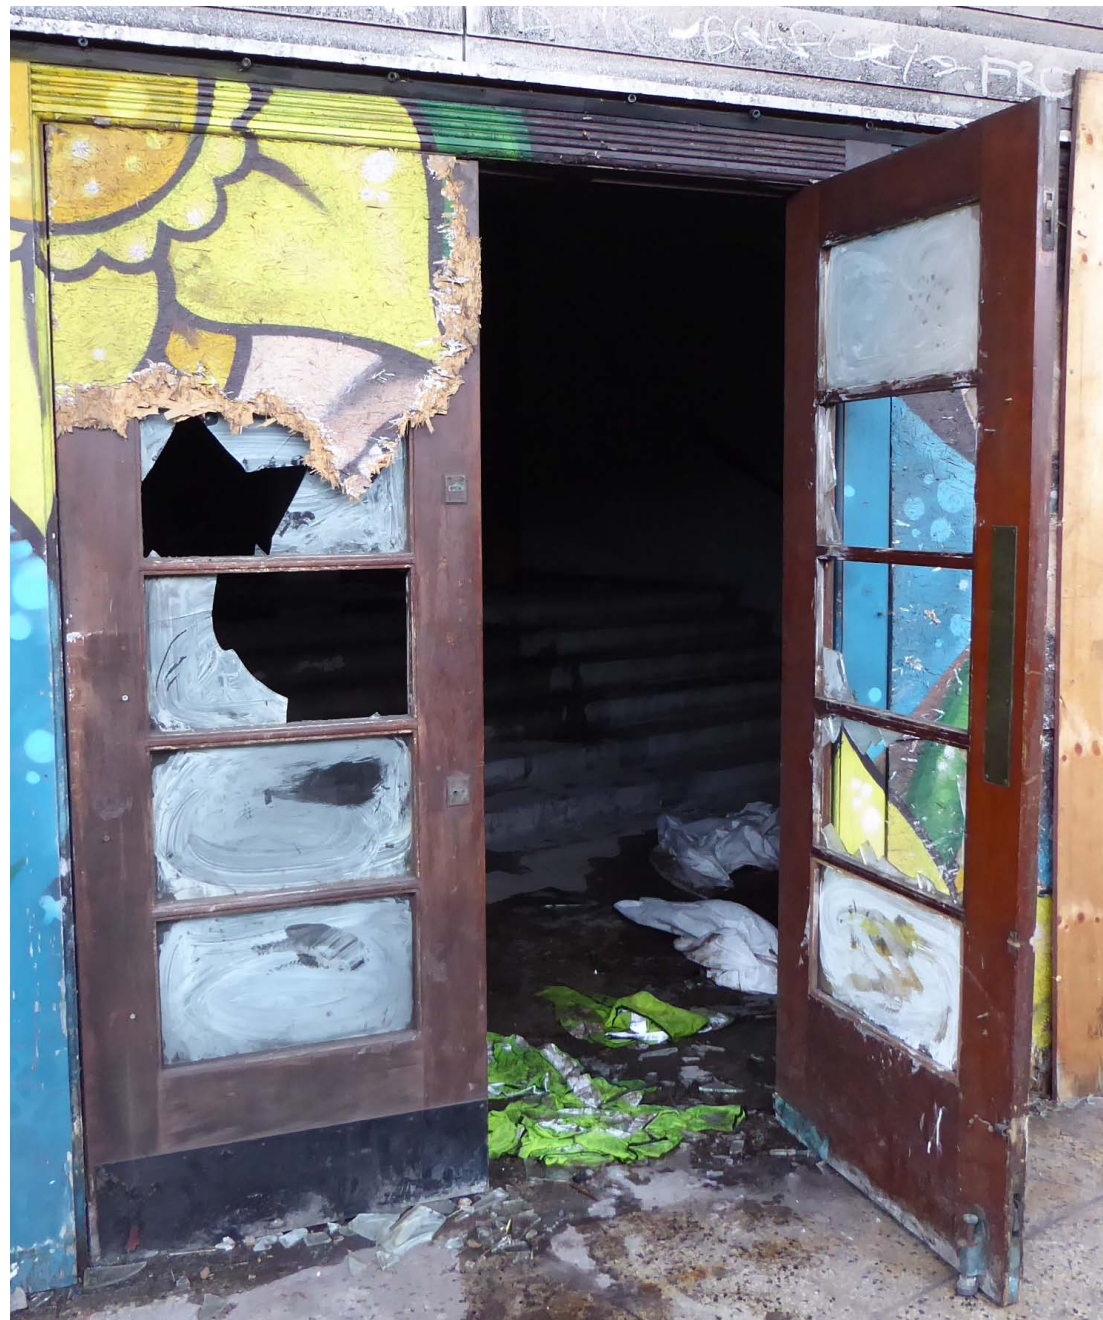
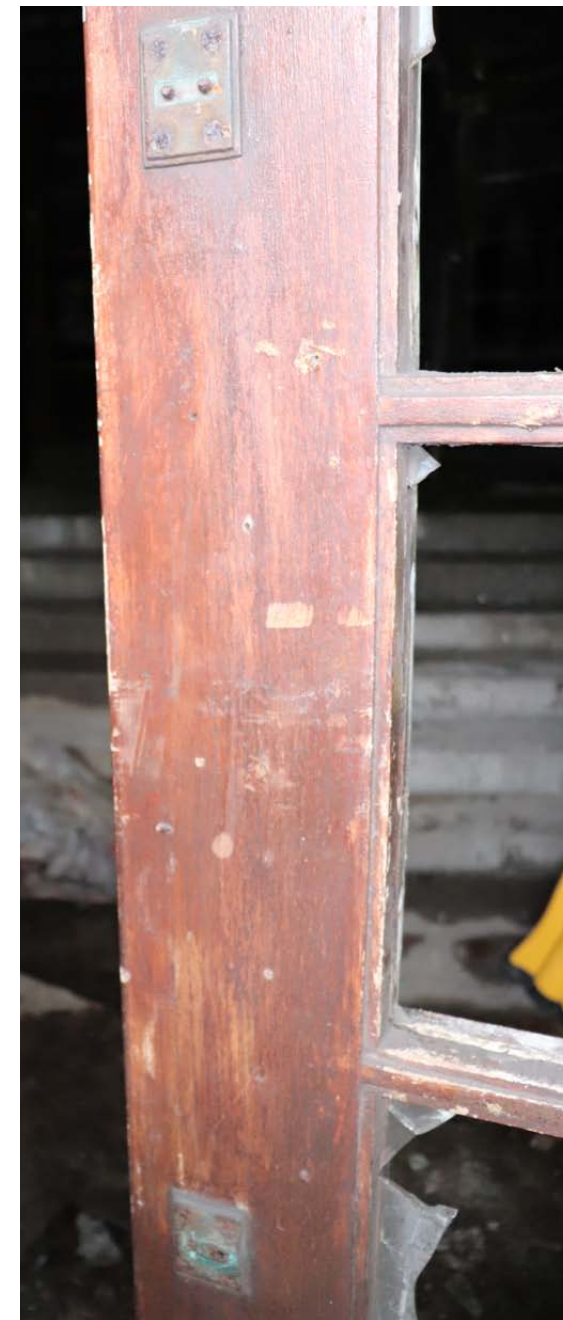
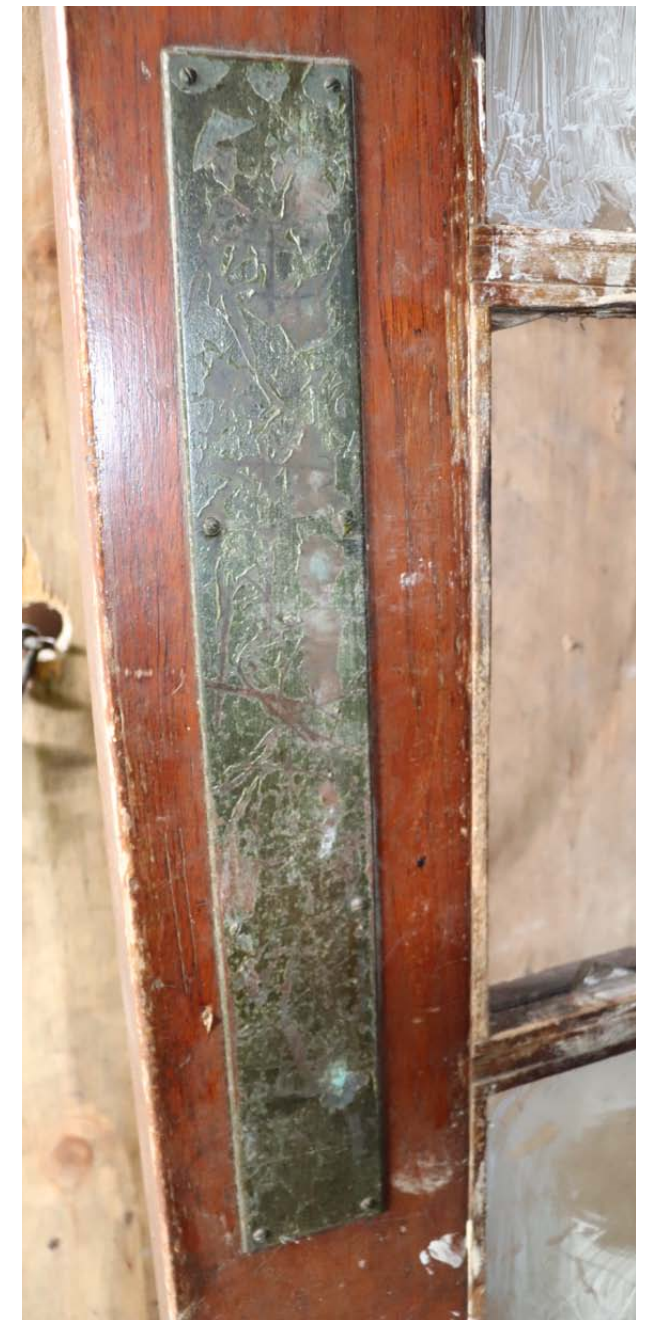
On this page are photographs of the details of the front main entrance timber-framed glazed doors with the 5no. horizontal panes.

Note that the brass push plates remains, however the pull handles have been lost.

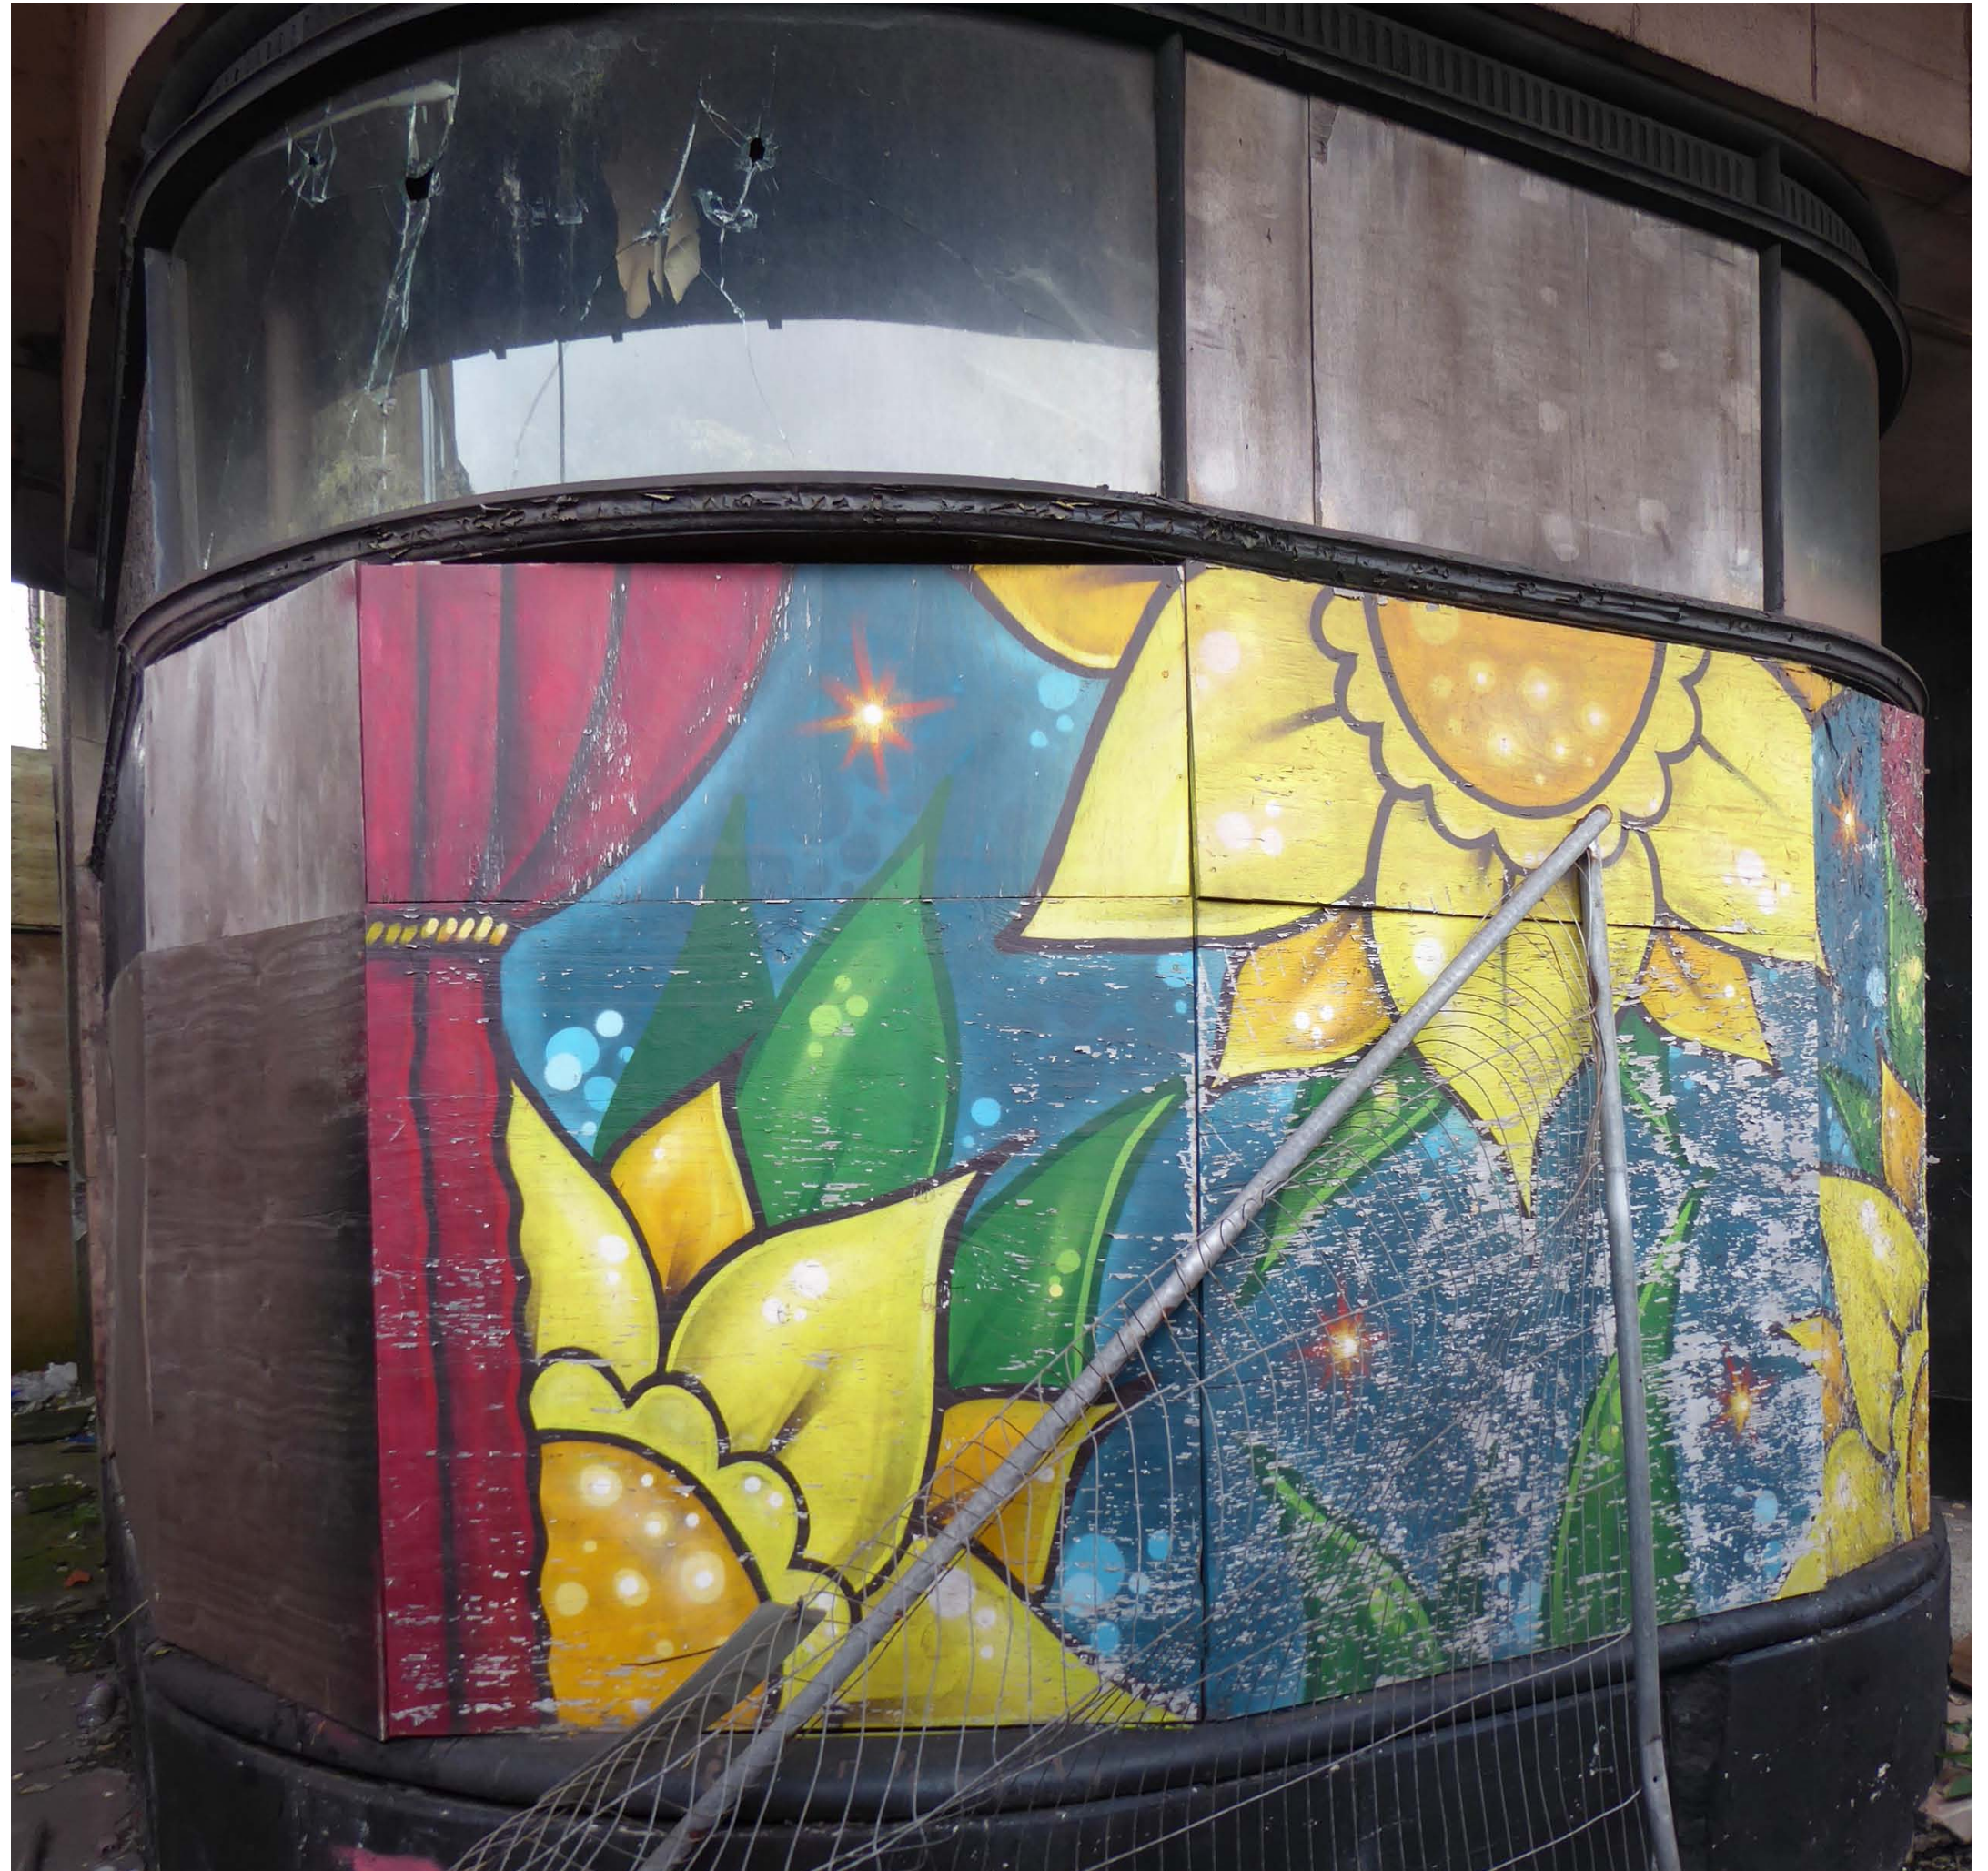
On this page is a photograph of the front of the curved timber-framed glazing to the smaller (left-hand) Retail unit.
