**Plaza, Port Talbot**

**HISTORIC BUILDING RECORDING**

(385)1902-GWP-A-2A-HBR-P00

Date: 06.01.20

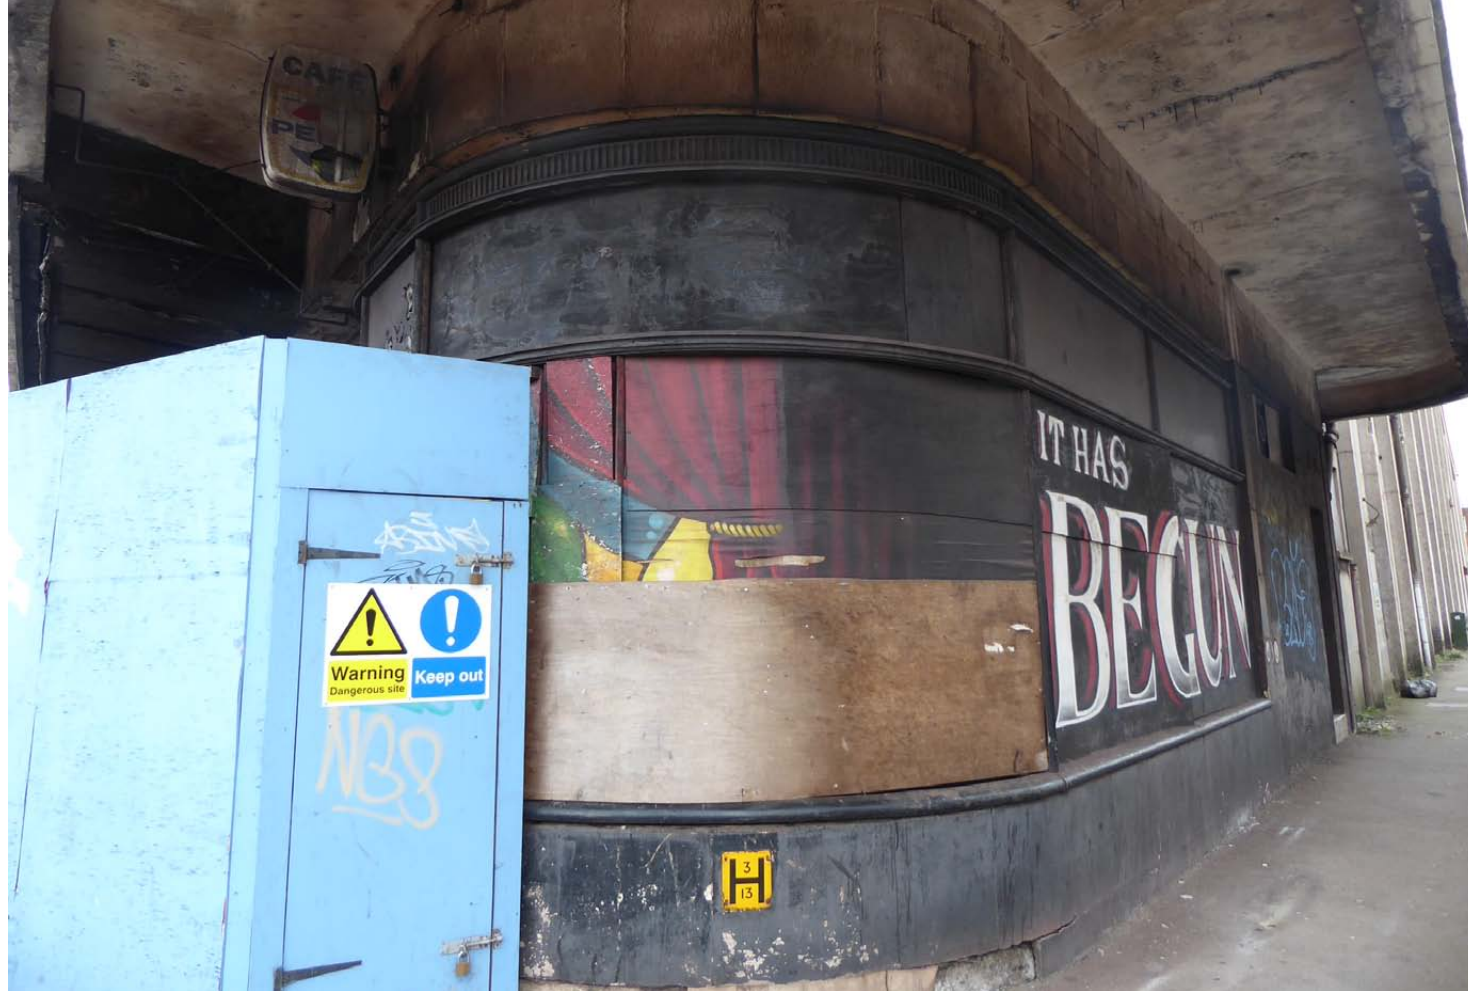
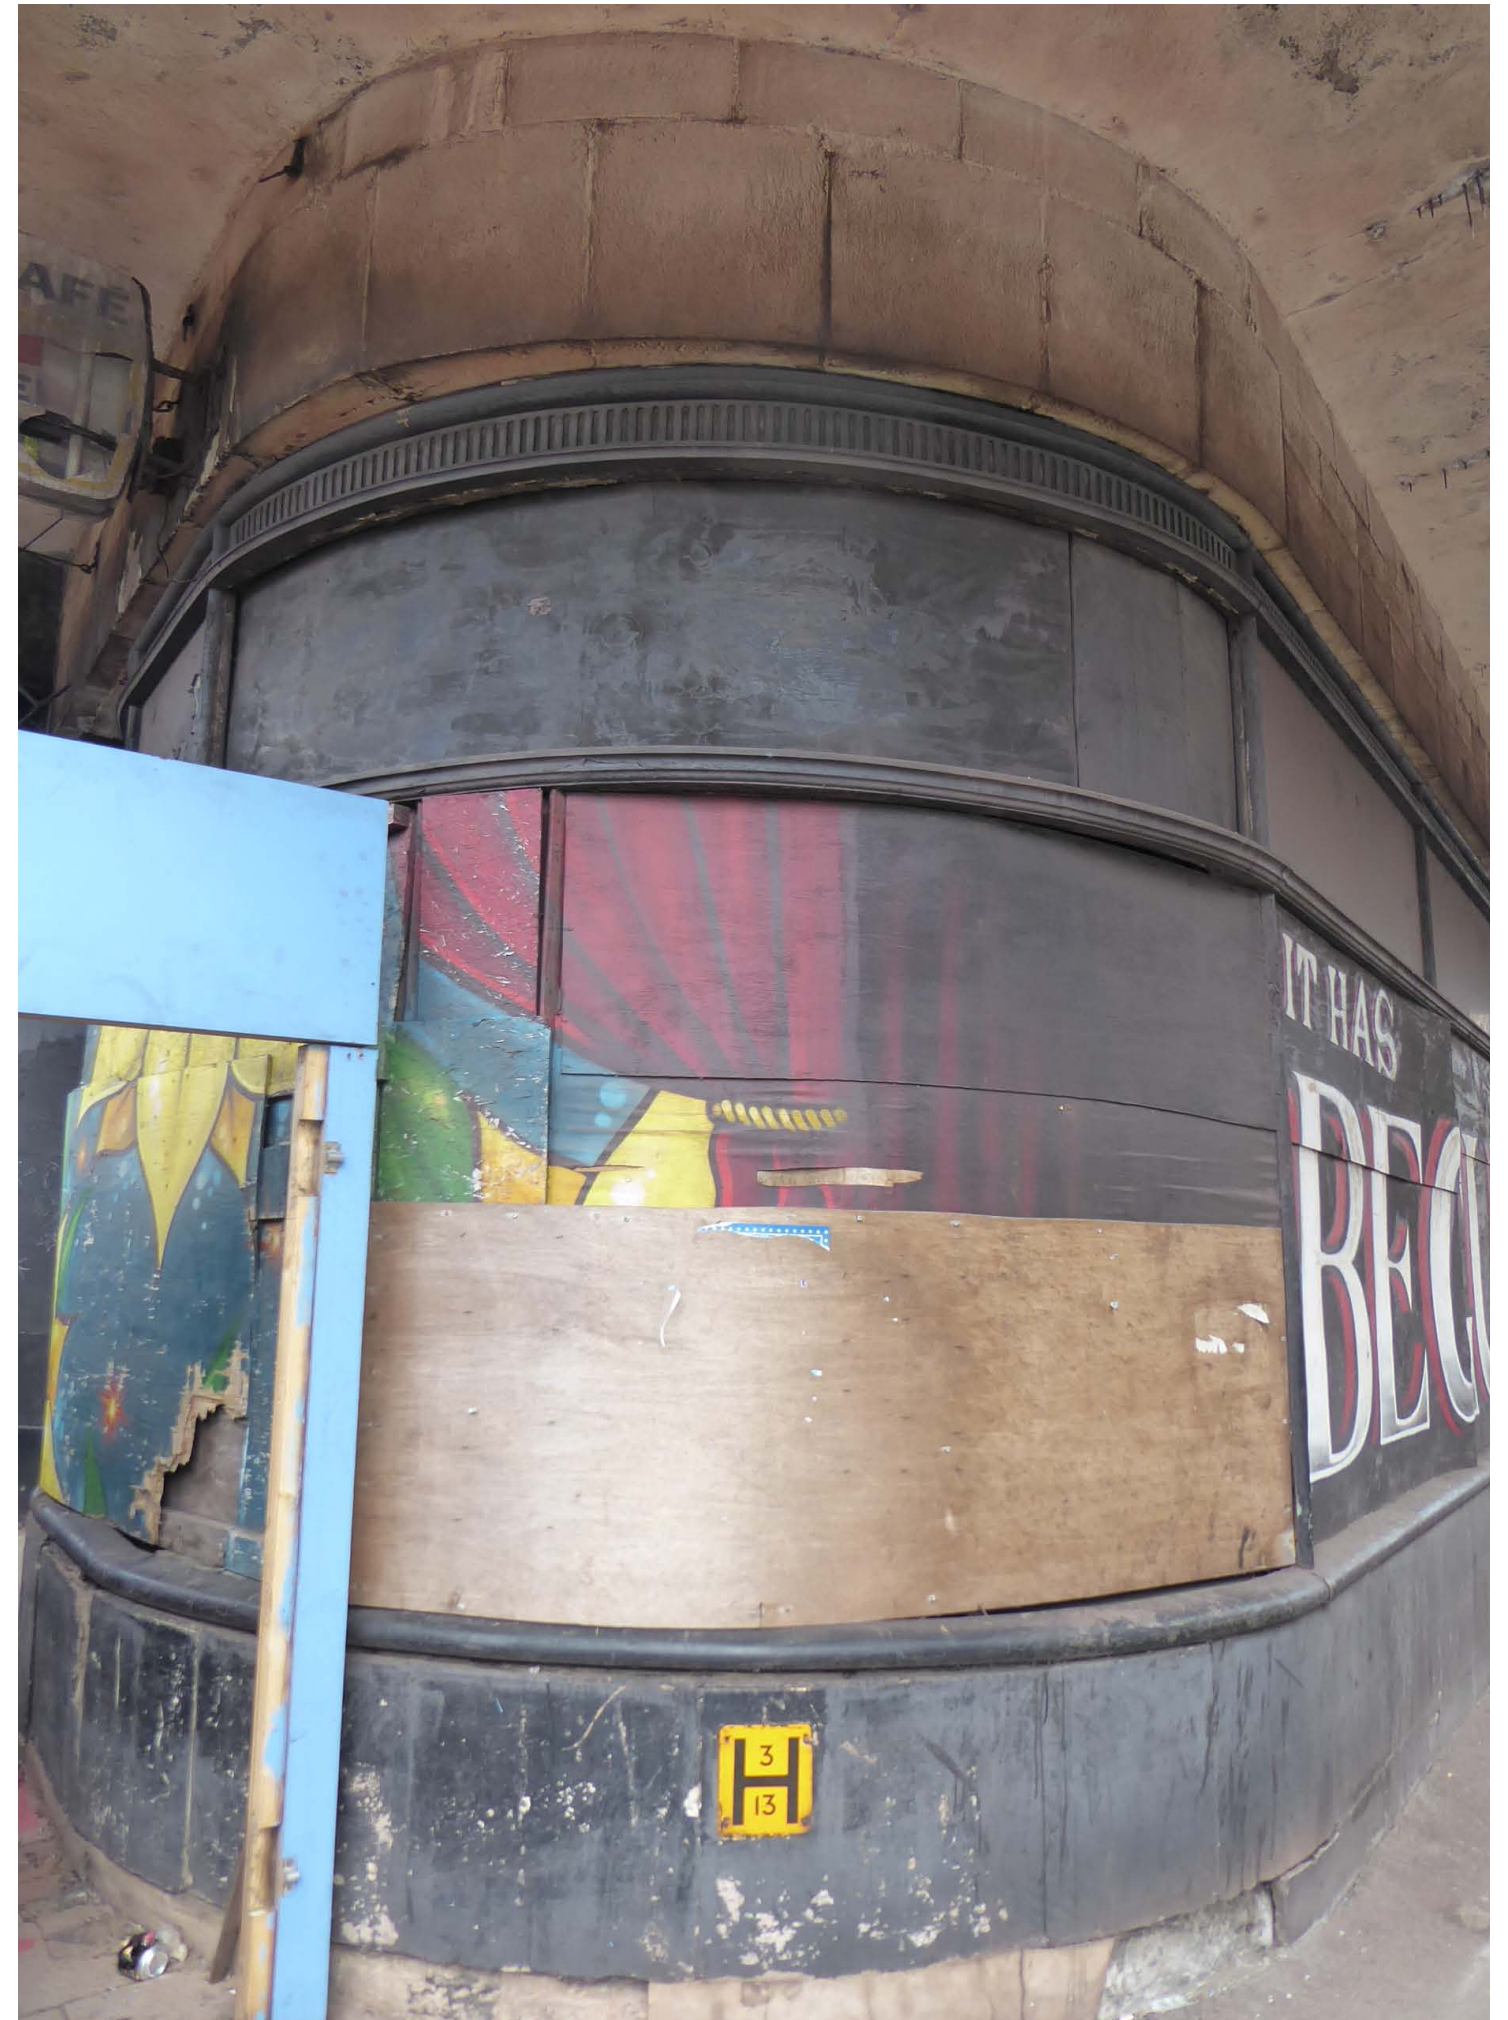
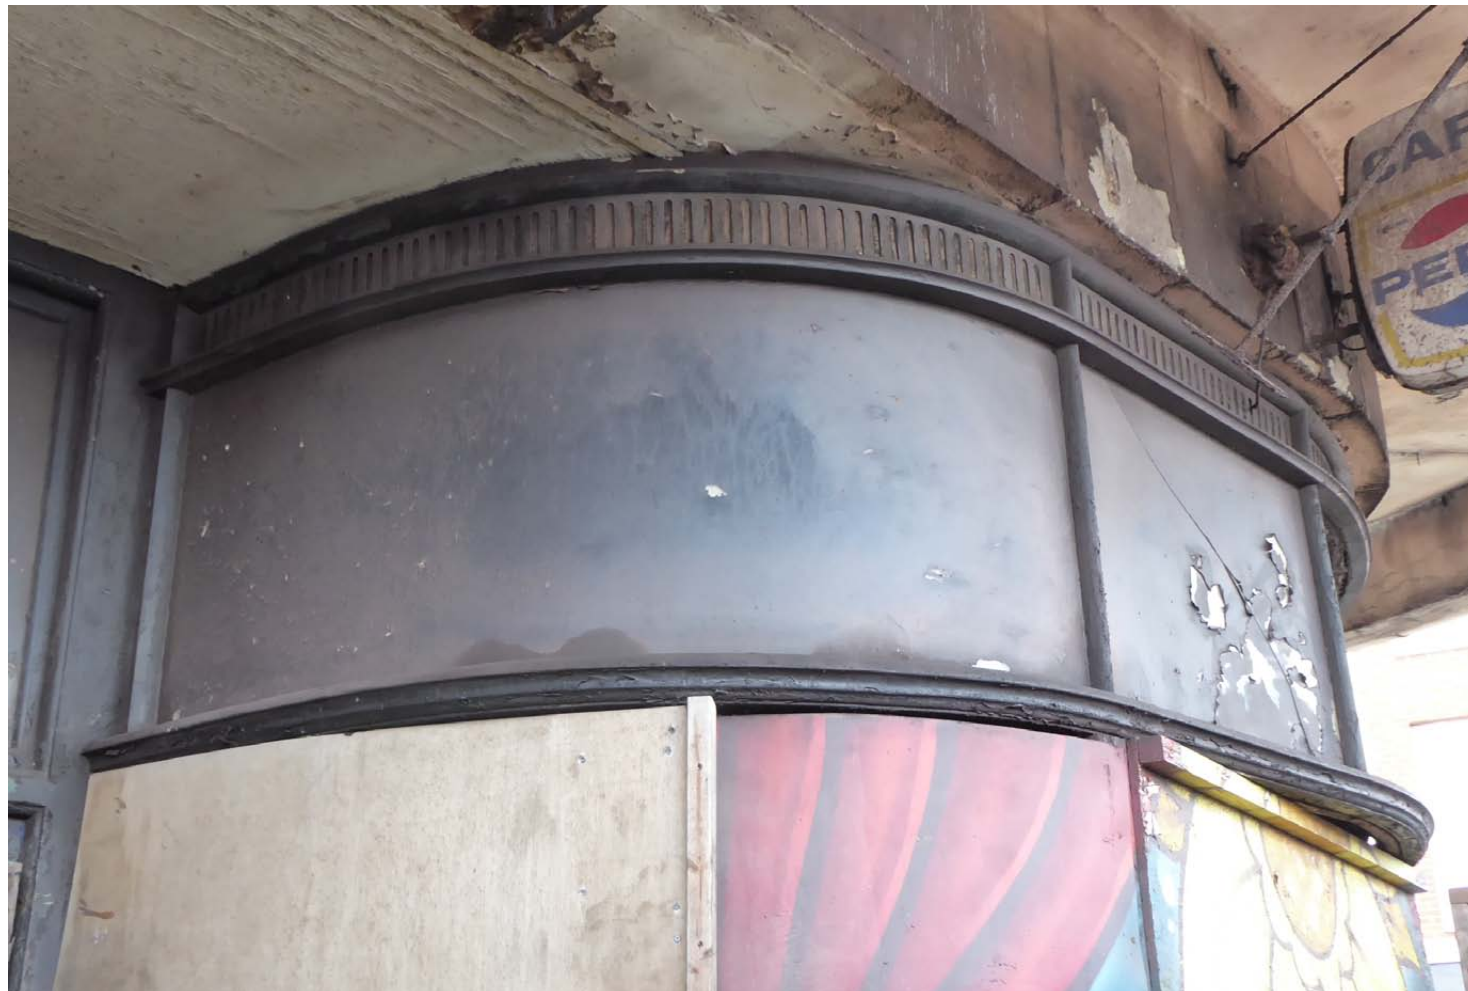
**6.1 The Exterior of the Plaza - the Frontage** - On this page are photographs of the curved and straight timber-framed glazing to the larger (right-hand) Retail unit.

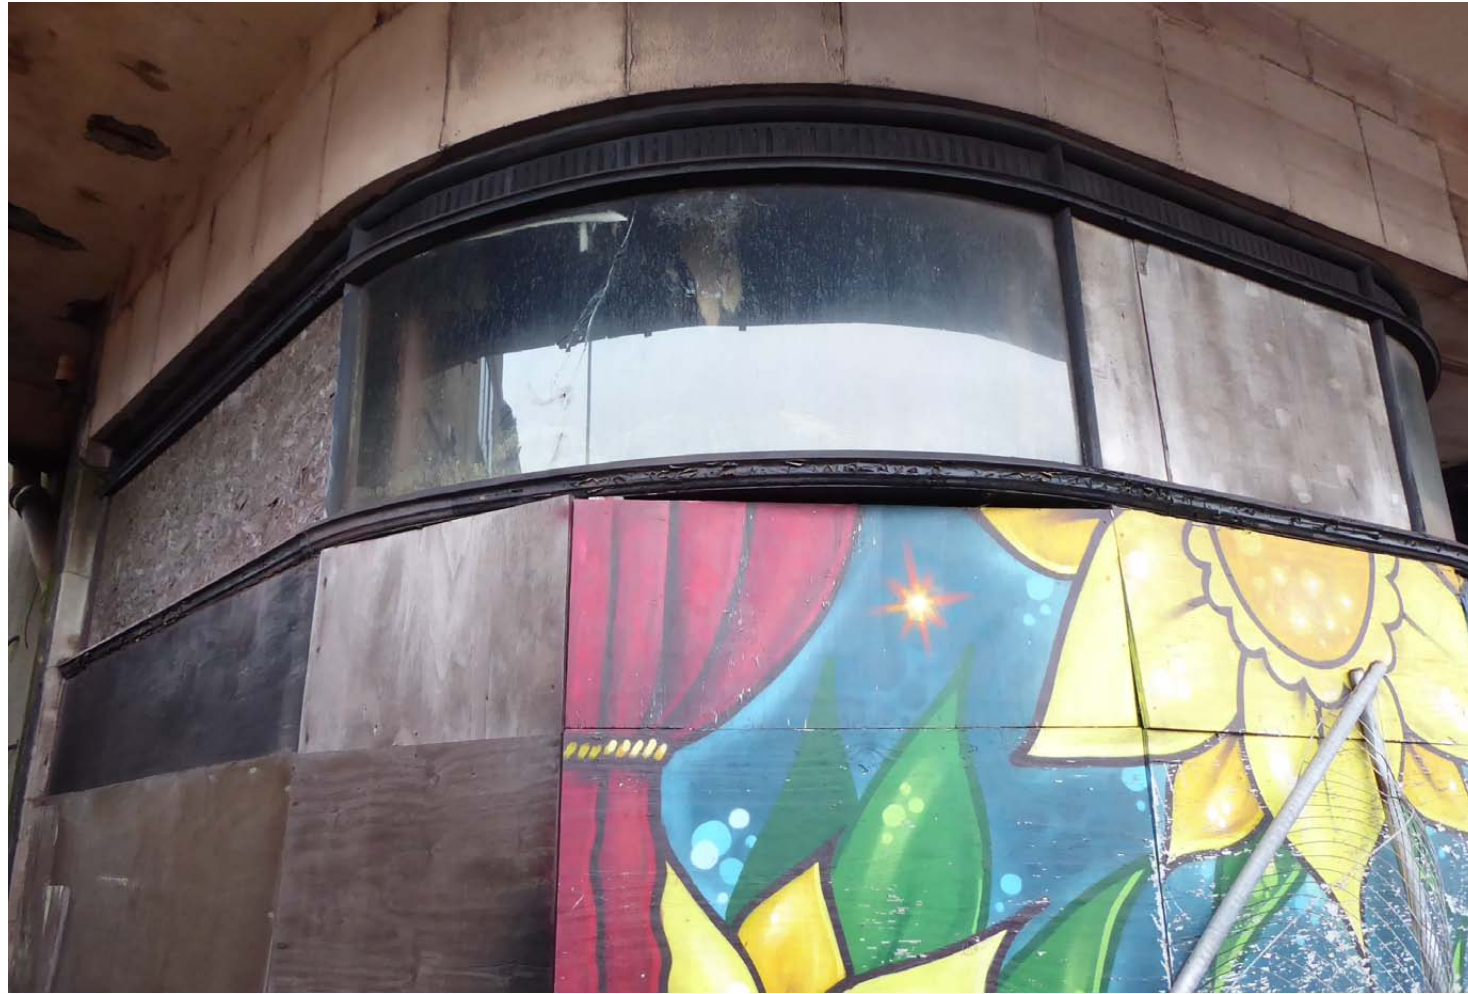
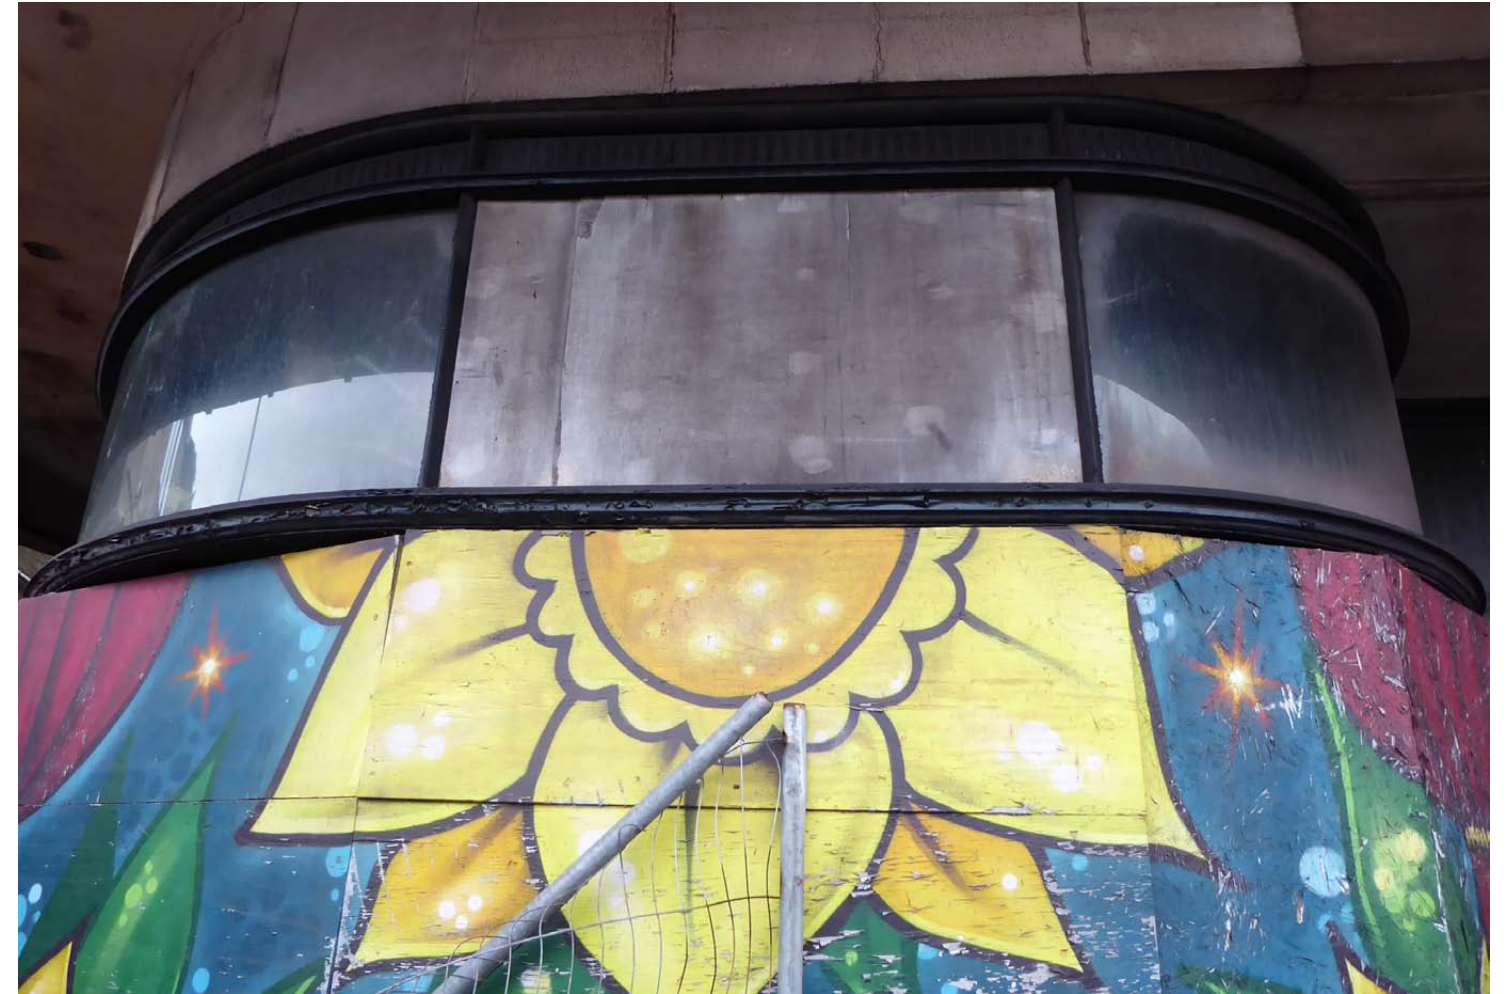
Views of top of curved frontage to timber-framed glazing to the smaller (left-hand) Retail unit, showing curved glass to corners & straight glass to ends and sides, with middle sections boarded up due to loss of glass

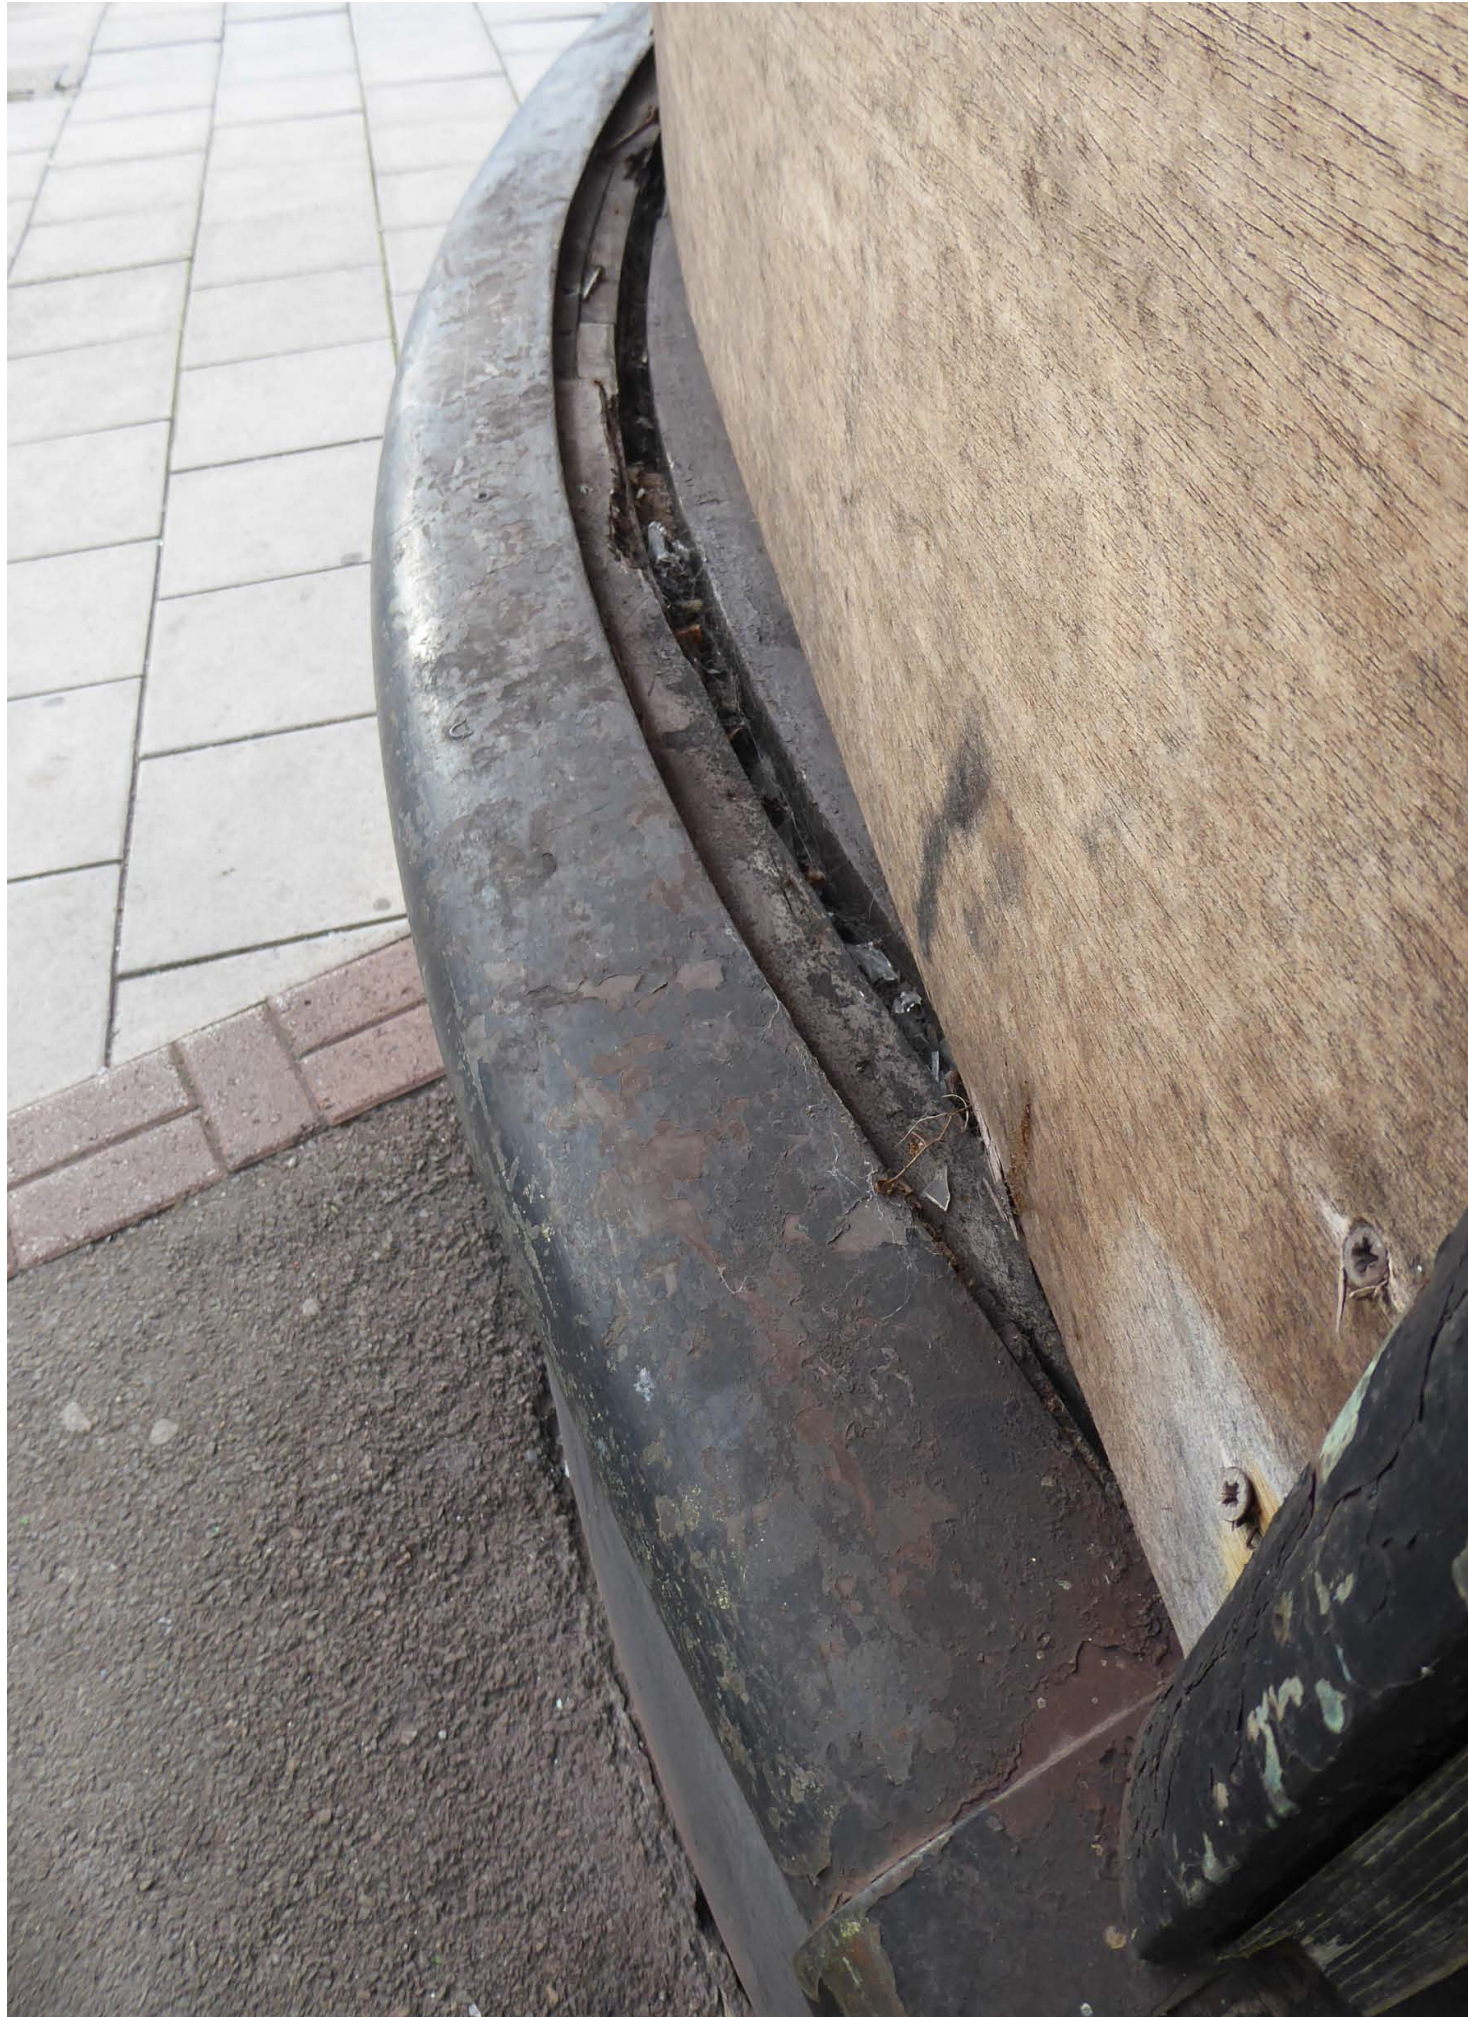
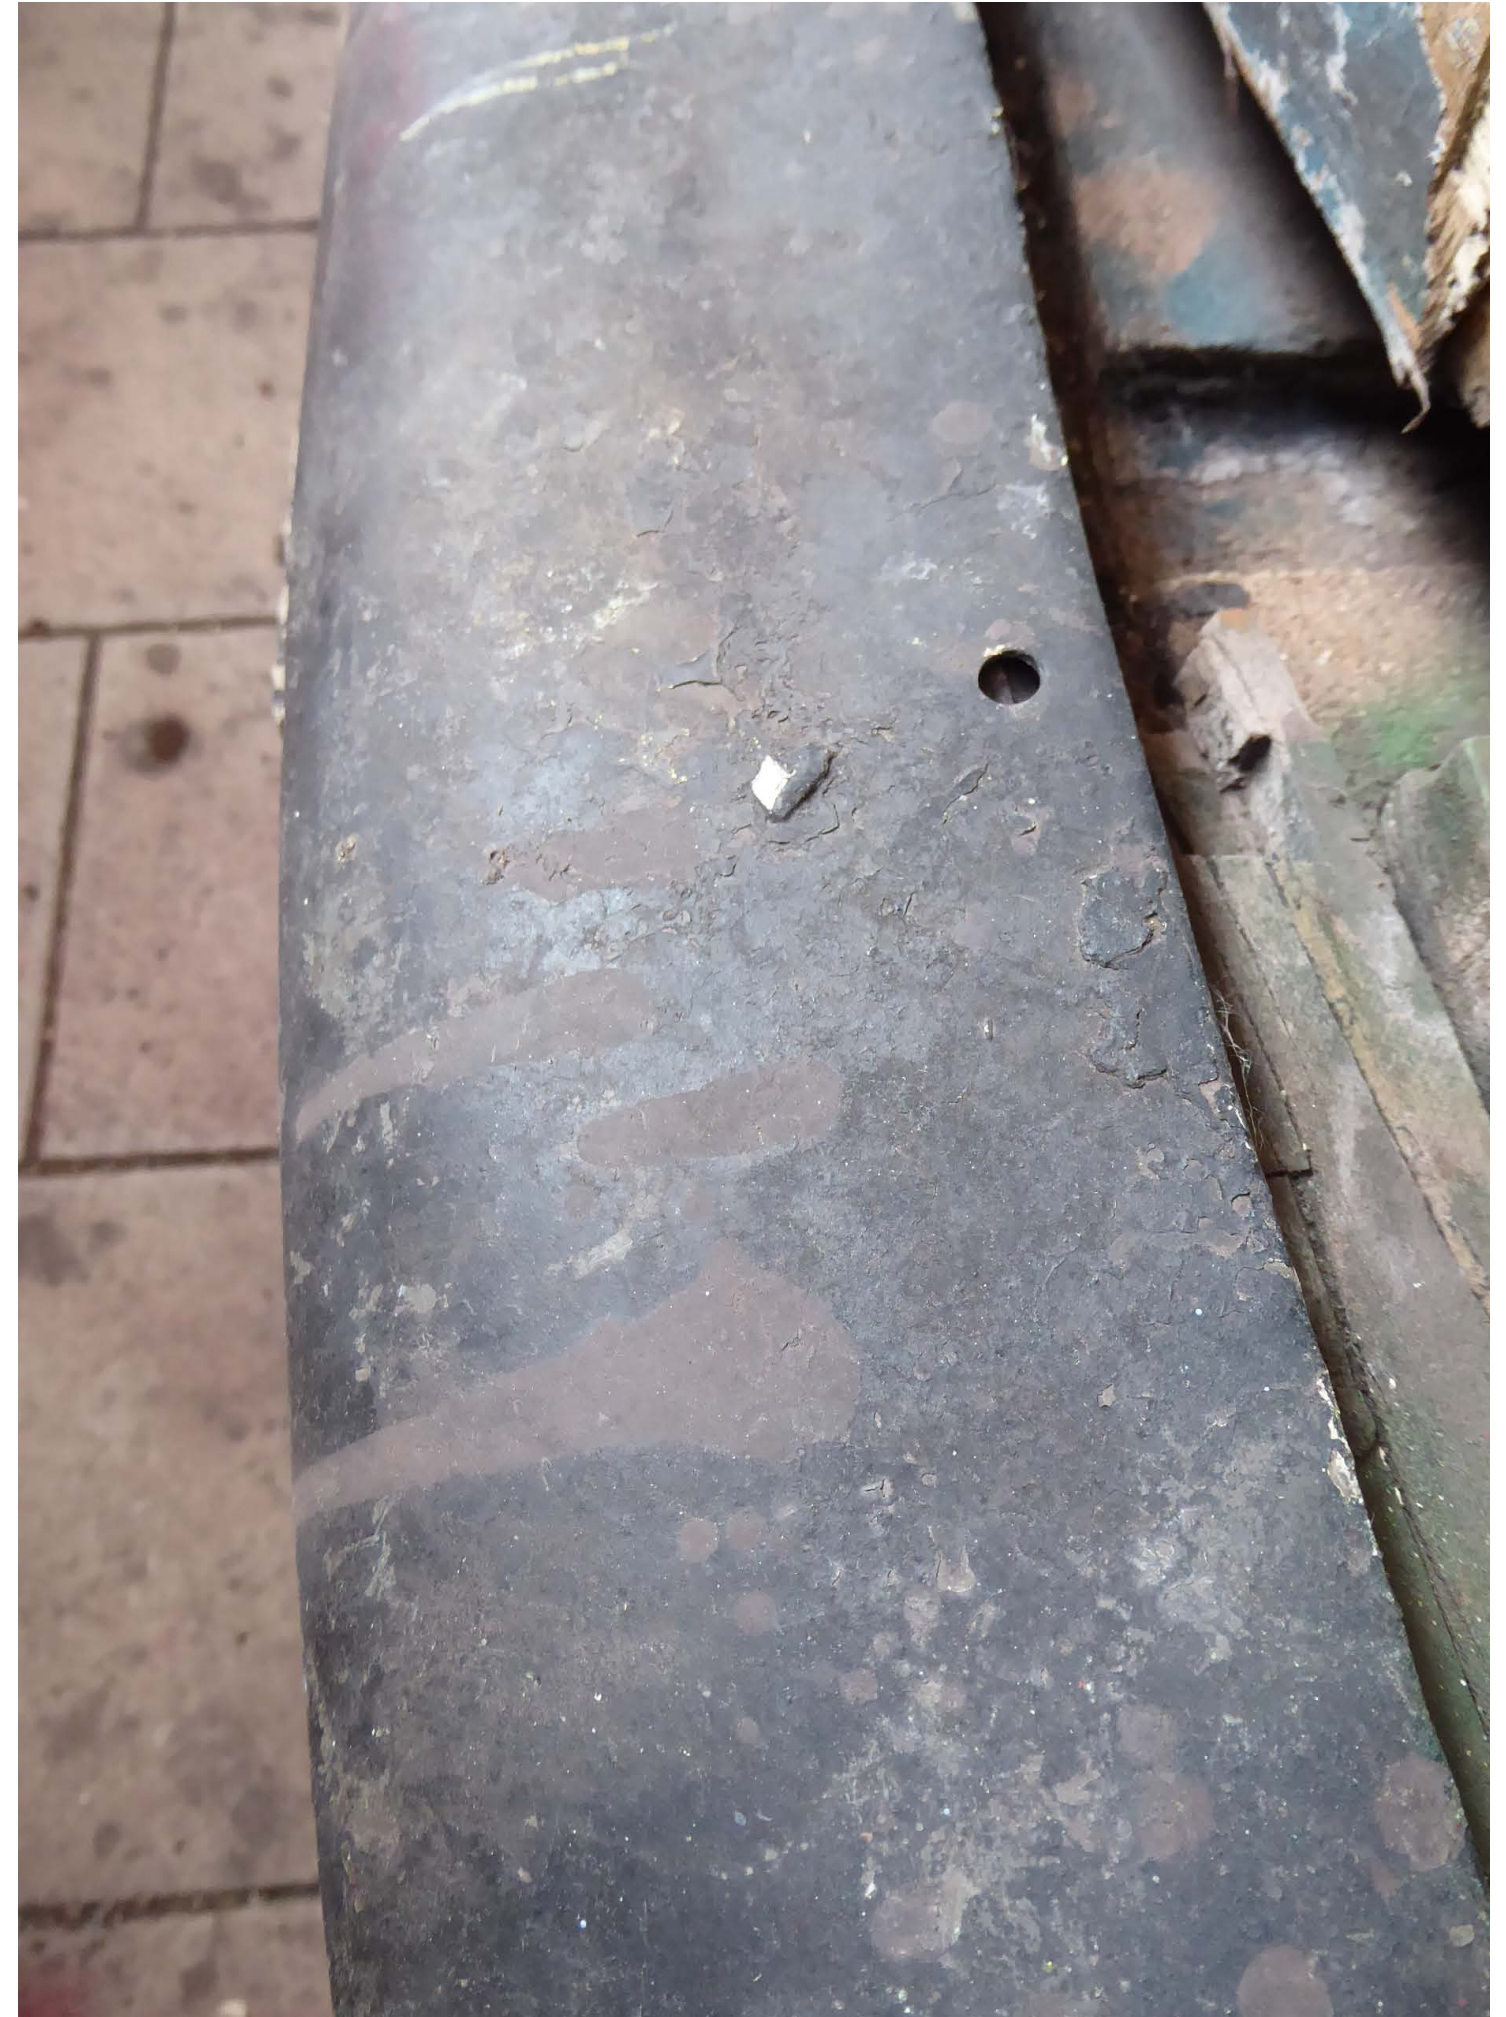
**6.1 The Exterior of the Plaza - the Frontage** - These photographs show the black painted reconstituted stone / concrete curved plinth underneath the metal cill which is cracked & damaged in a number of areas

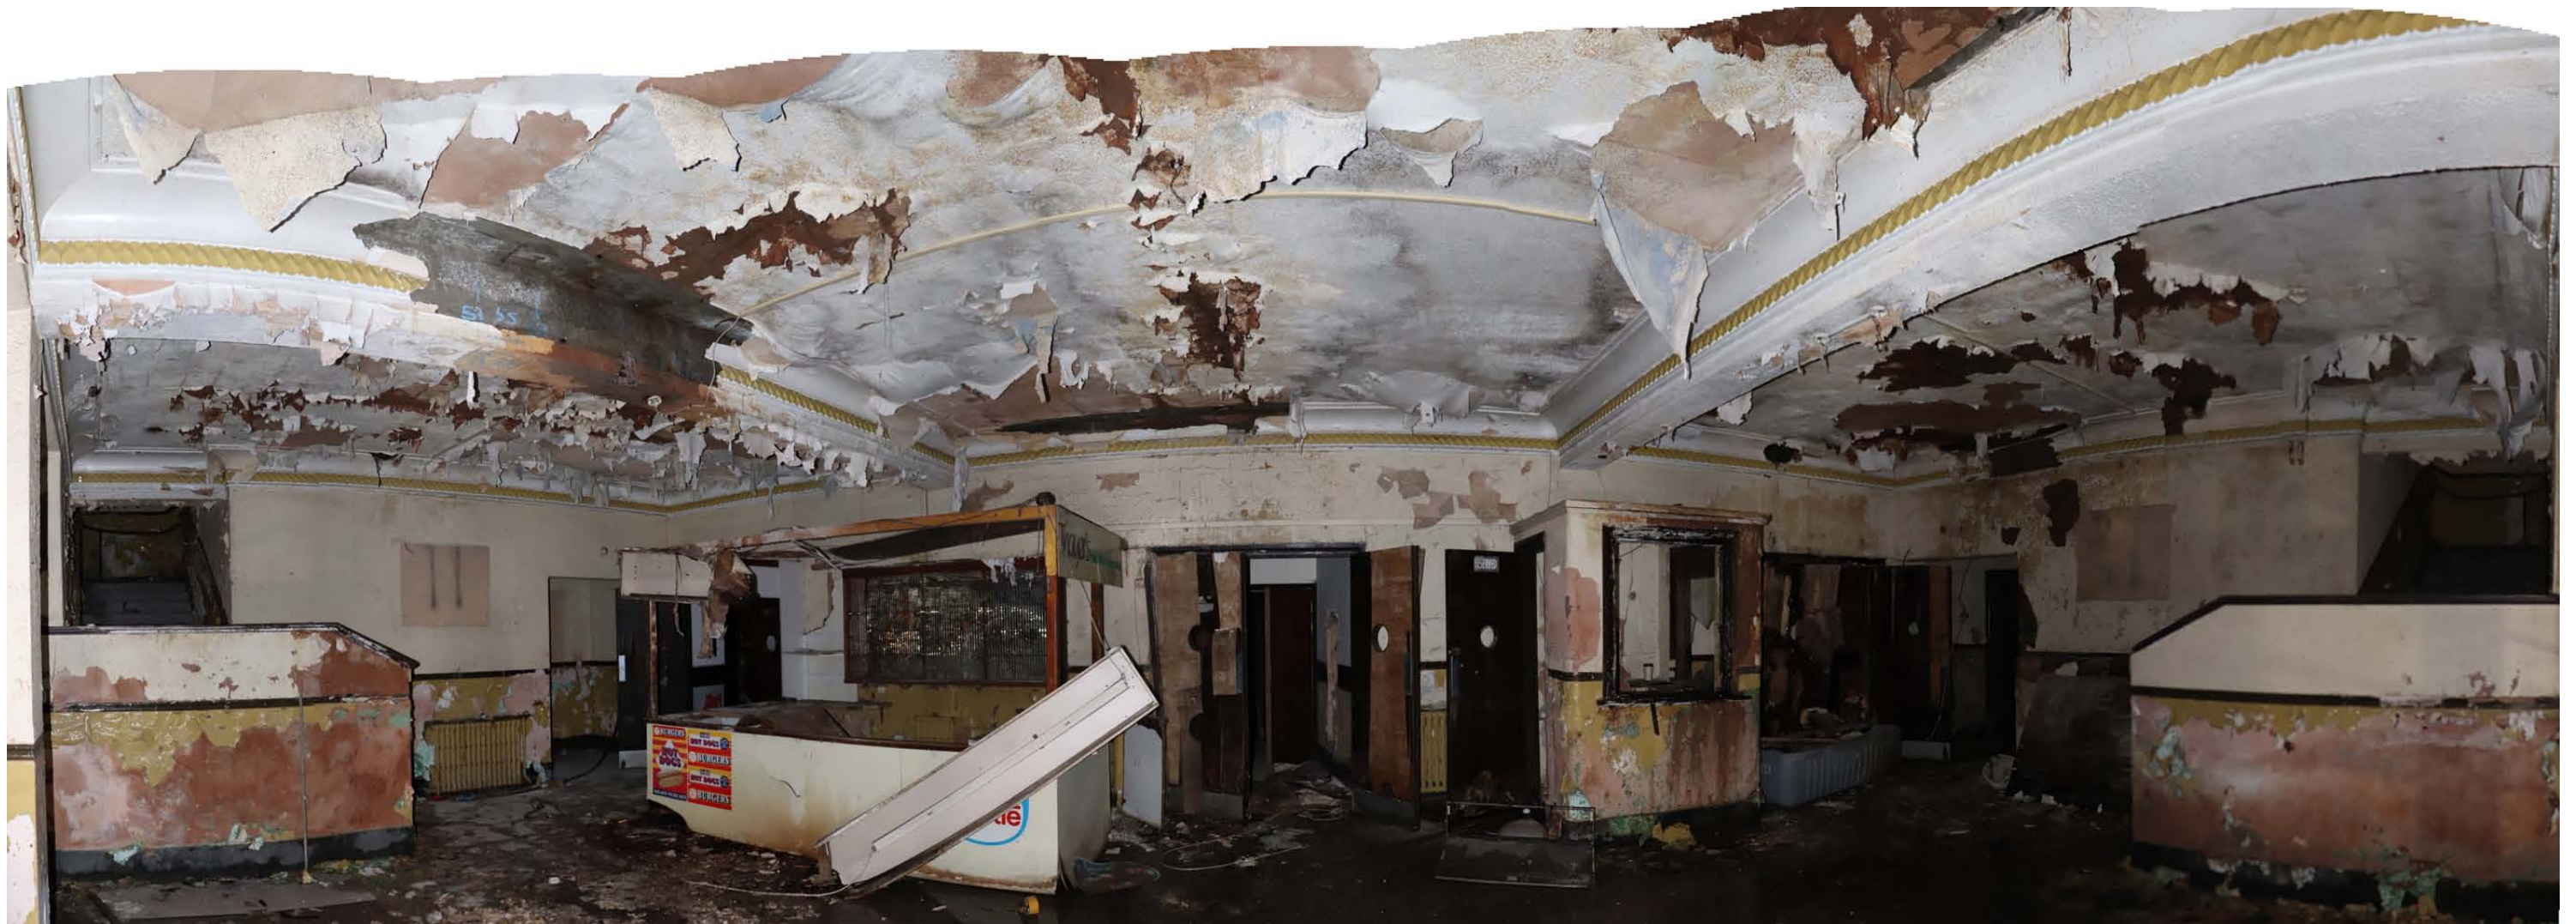
In between the central and right hand doors is a small box office enclosure, which is likely to be original to the building. It is in a poor condition.

In between the central and left hand doors is a larger ice cream stall, which is not likely to be original to the building. It is in a poor condition.

*View of the Foyer looking northwards towards the doors to the main auditorium and the 2no. cinemas, with the box office enclosure to the right and the ice cream stall to the left*

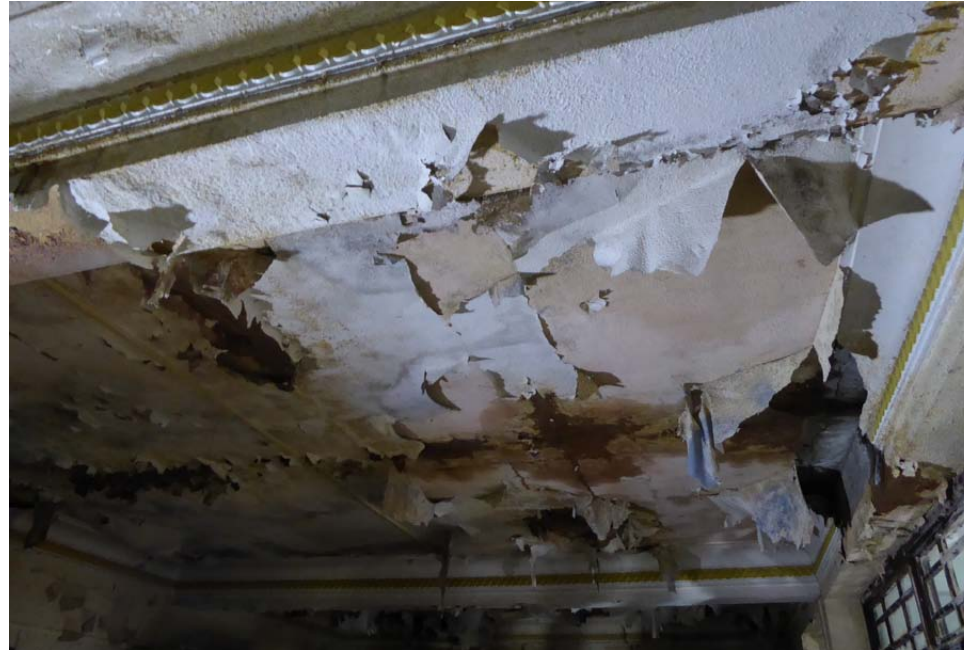
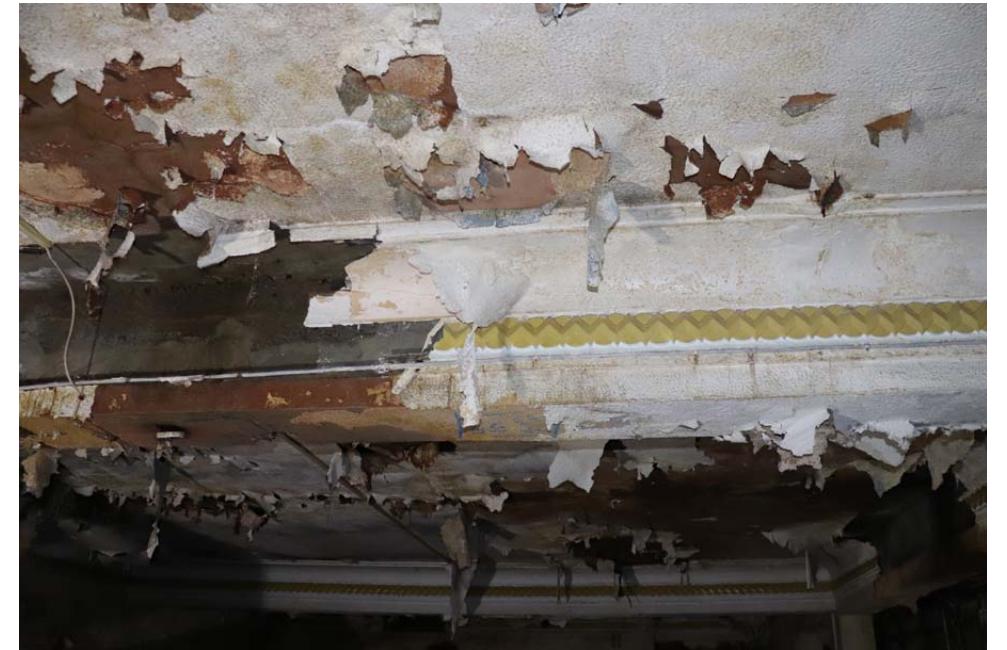
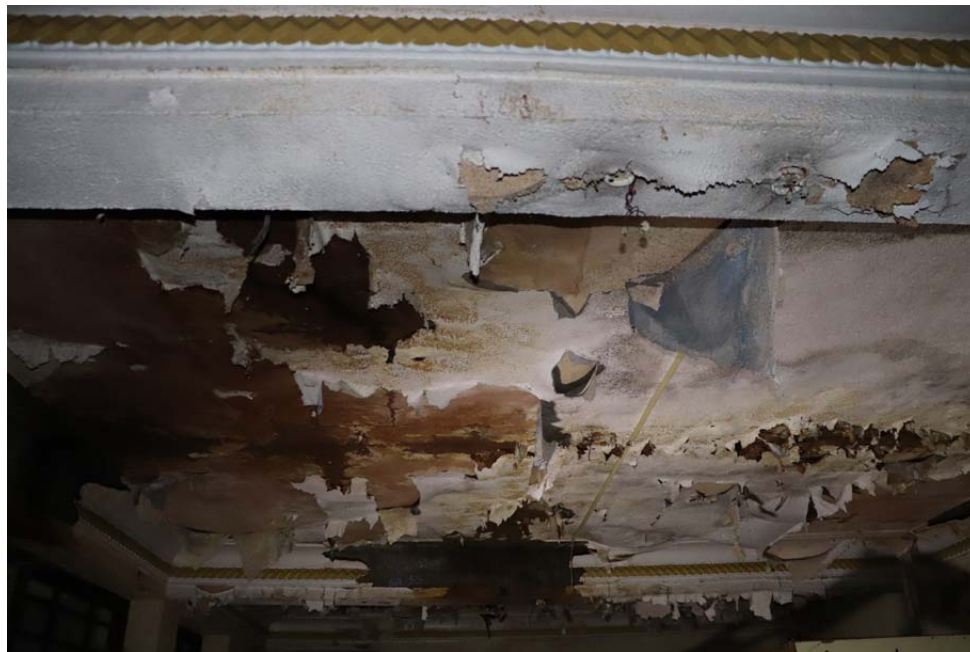
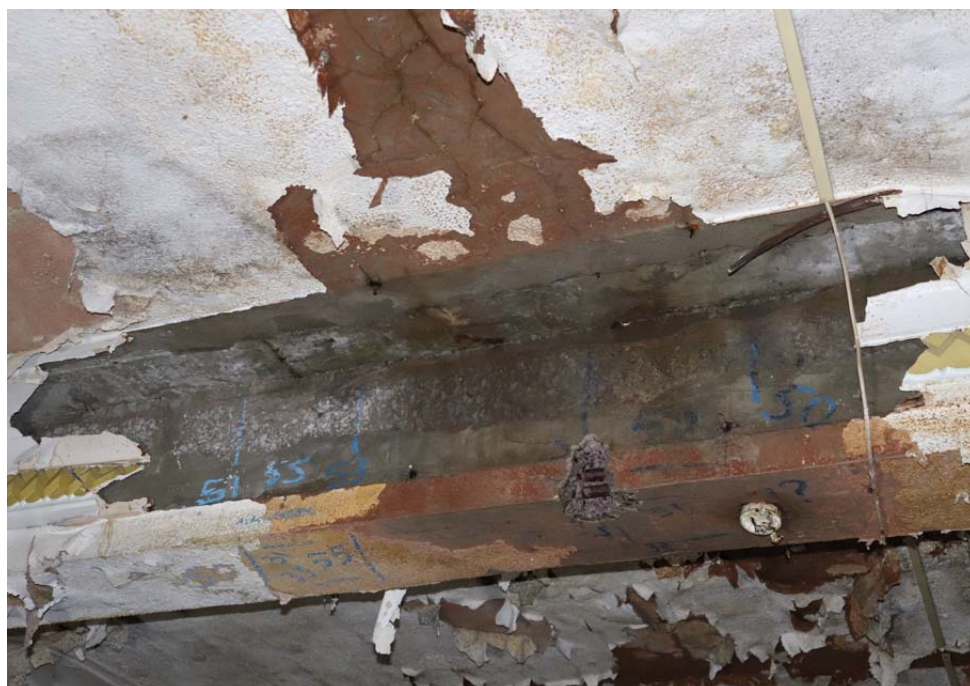
**G8 - Foyer**

On this page is a series of photographs of the ceiling to the Foyer, showing the extent of peeling paint, damaged plaster and cracked and spalling concrete soffit and downstand beams caused, in the main, by water ingress from above.
