**Plaza, Port Talbot**

**HISTORIC BUILDING RECORDING**

(385)1902-GWP-A-2A-HBR-P00

Date: 06.01.20

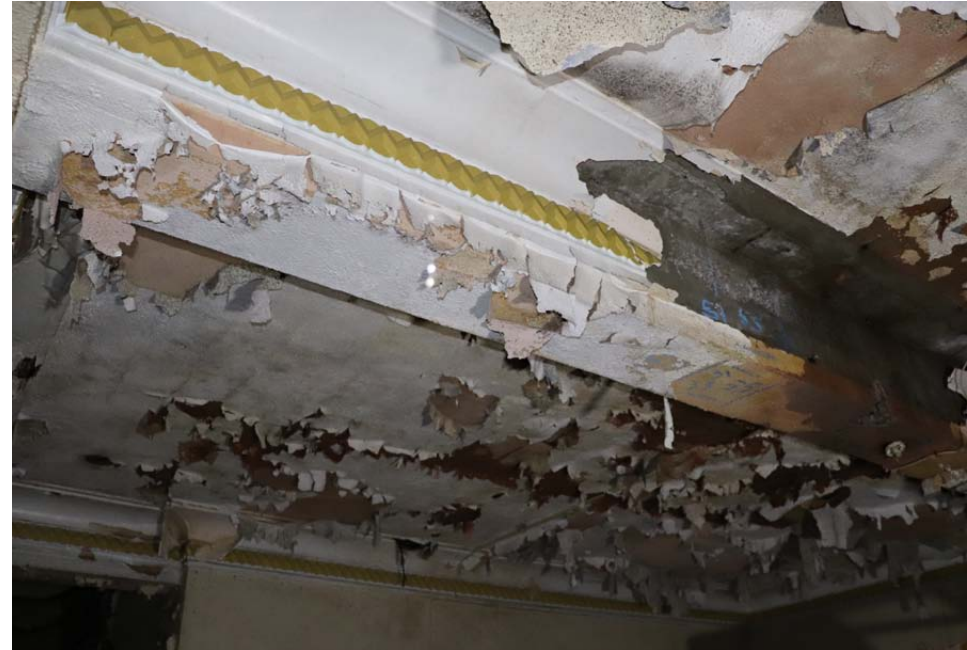
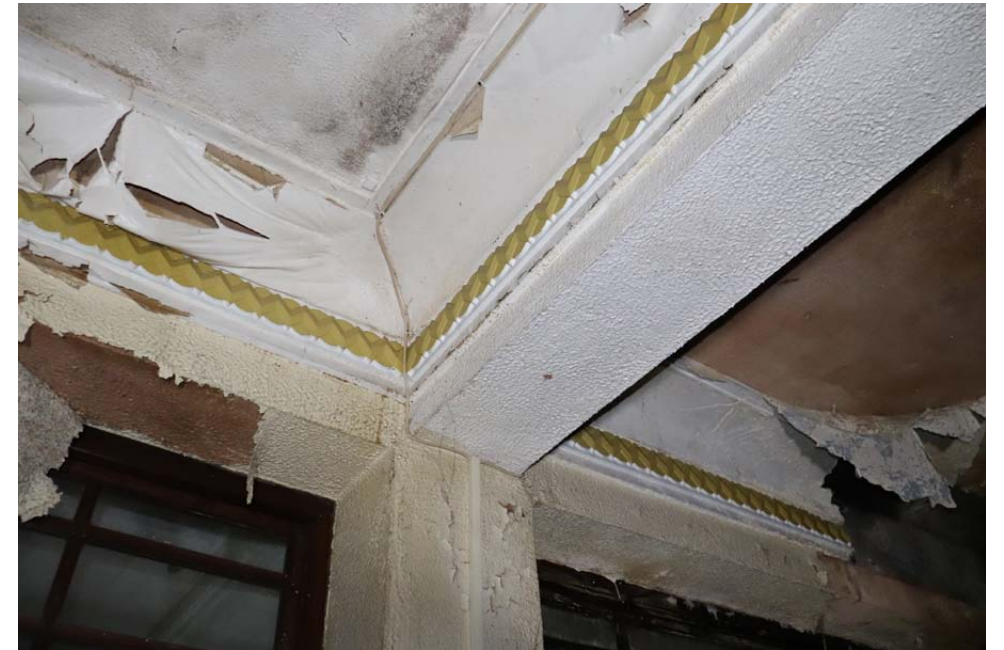
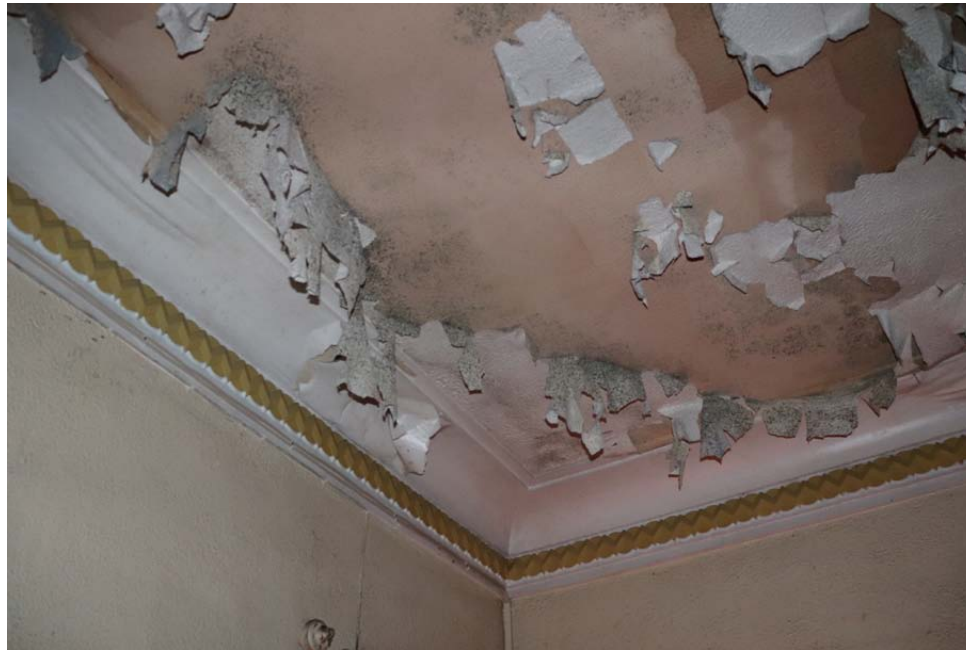
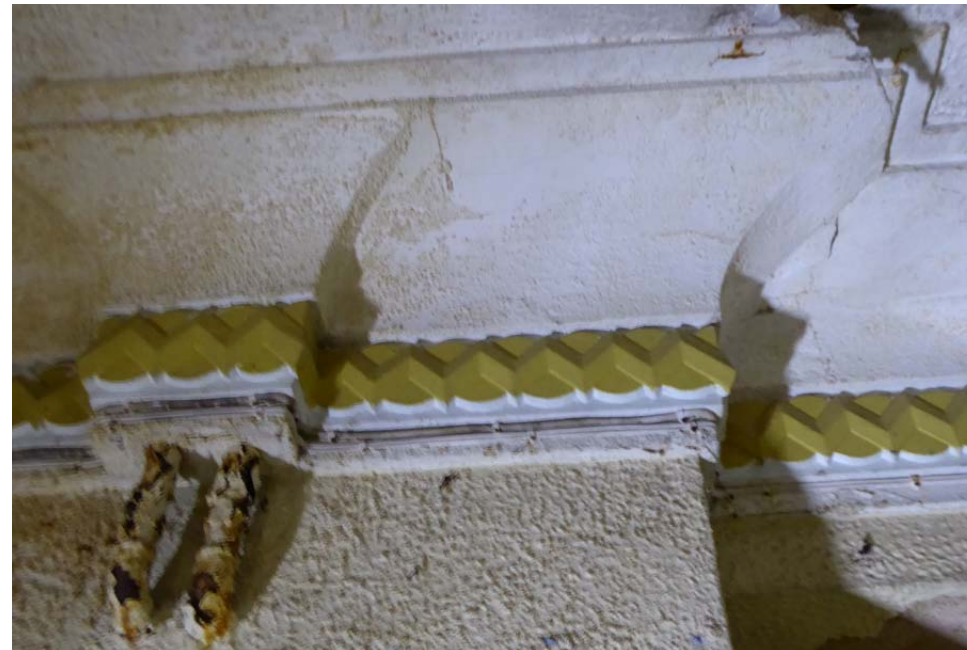
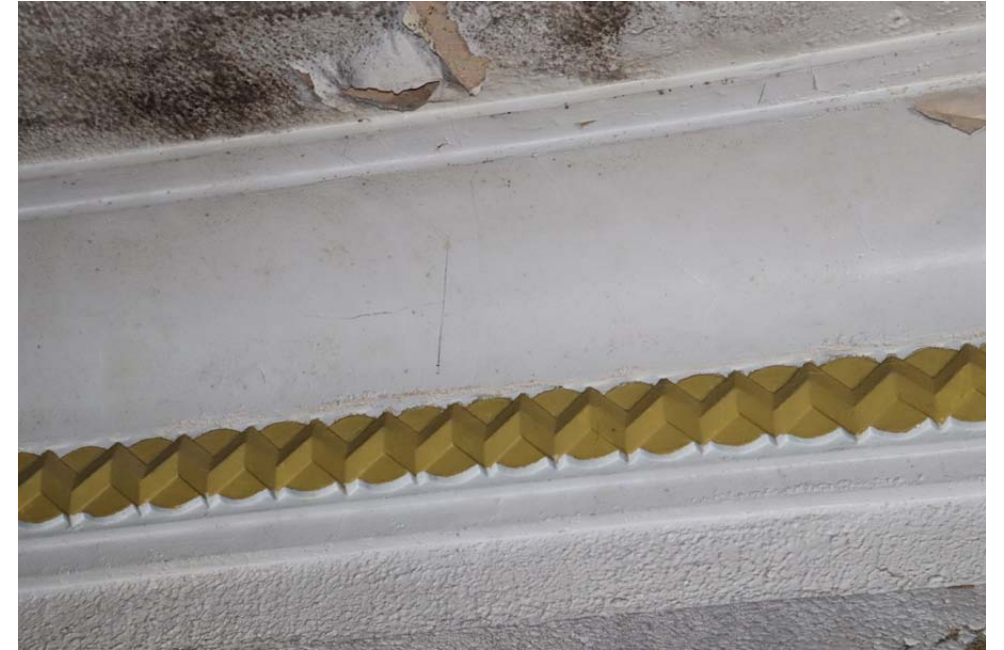
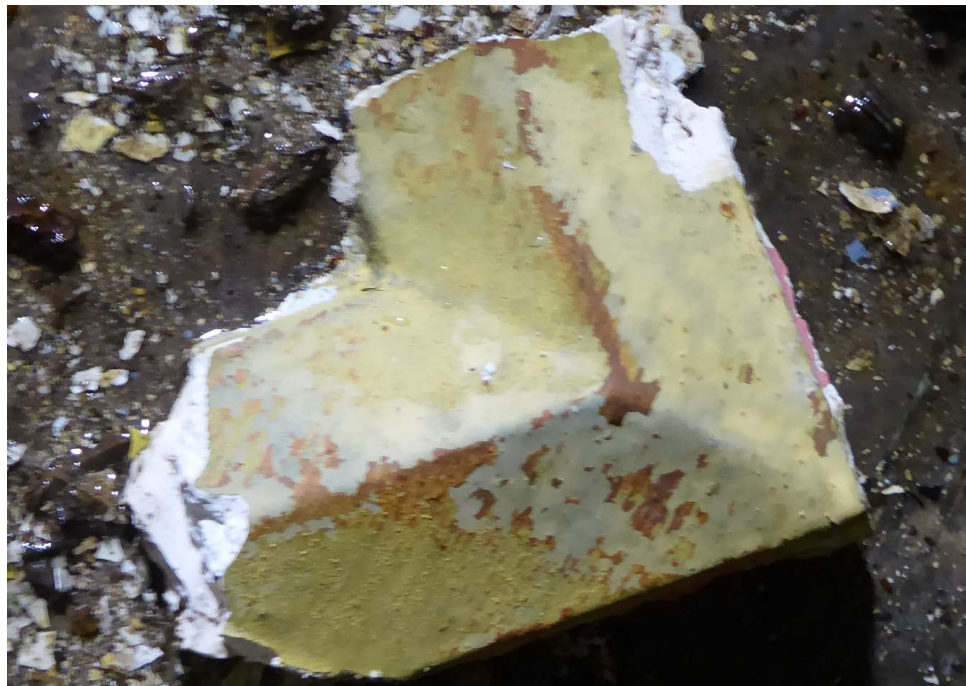
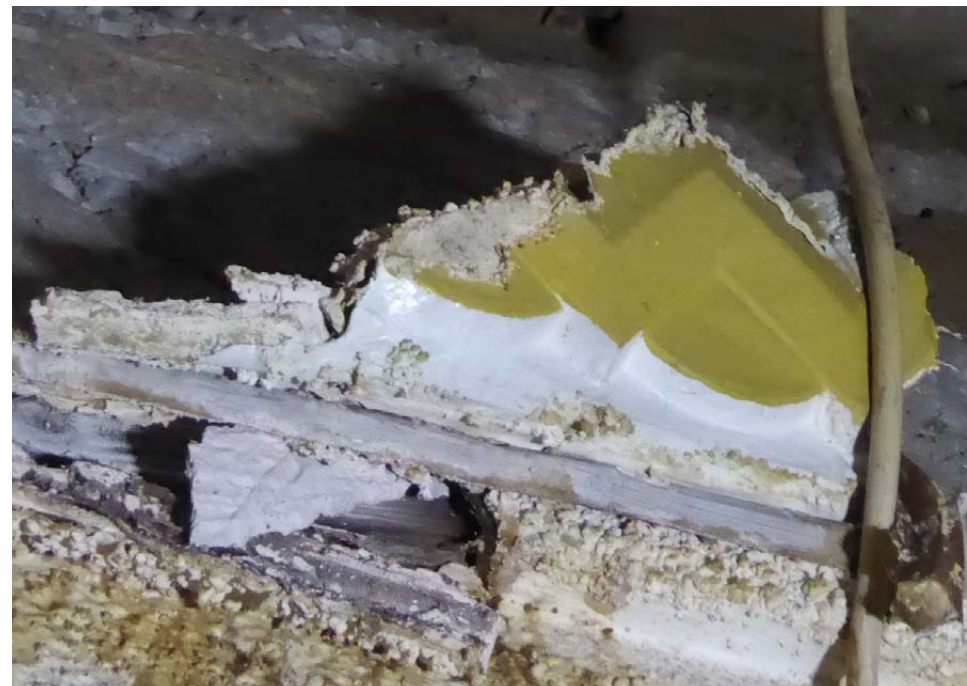
**G8 - Foyer**

On this page is a series of photographs of the chevron profiled frieze (gold / yellow in colour) below the curved coving (white in colour).

Whilst the top two rows of photographs show the frieze principally intact, much of it has been lost throughout the rest of the foyer.

The lower row of photographs shows the profile of the chevron as well as the fact that the gold / yellow paint on the plaster (which appears to comprise two separate coats) appears to have been preceded by a red colour.

Section of chevron plaster with gold / yellow paint preceded by red

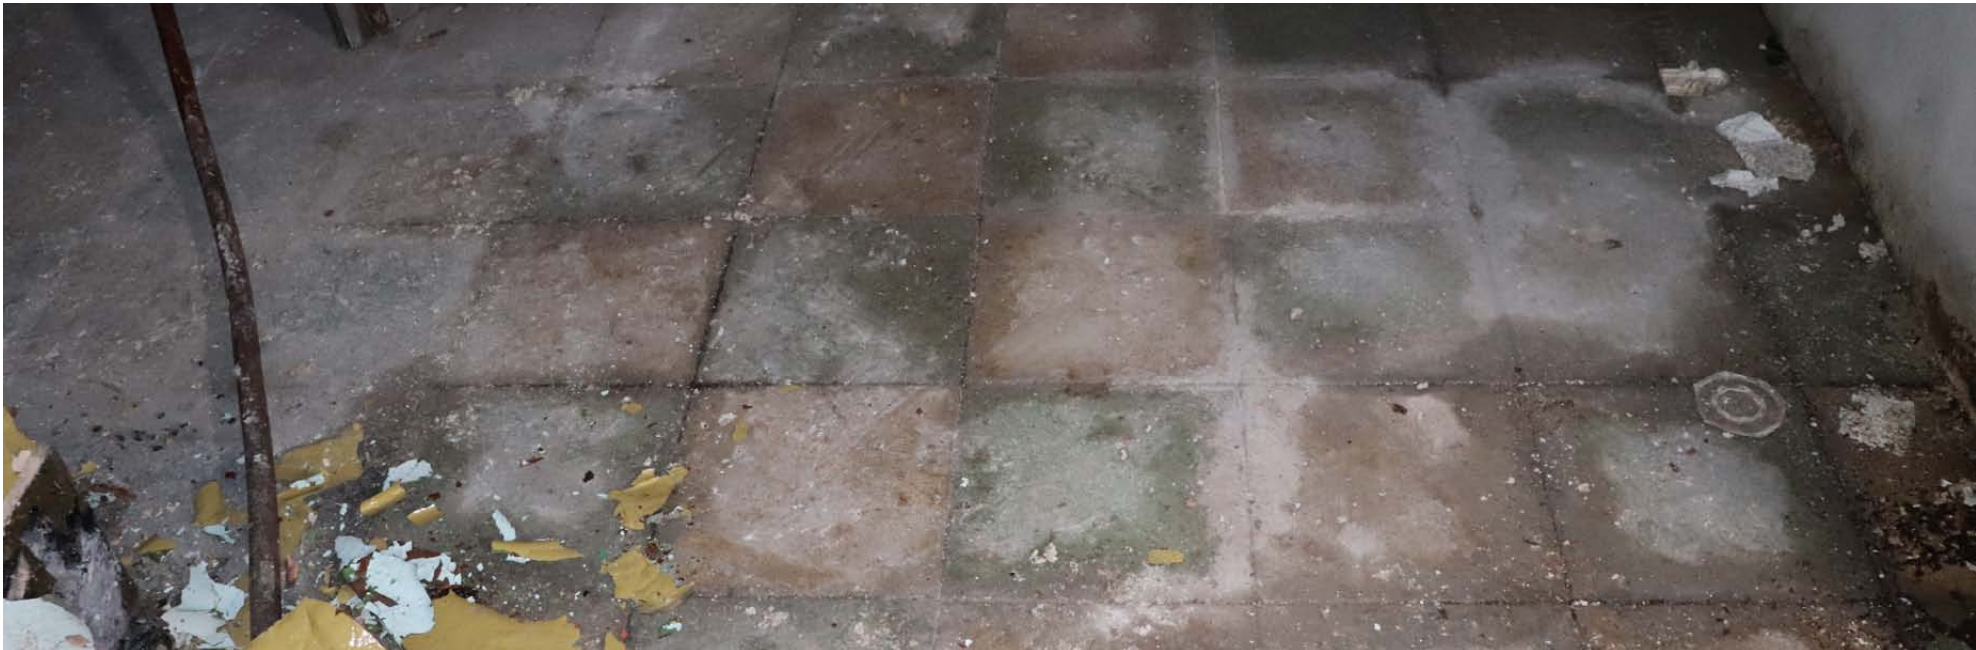
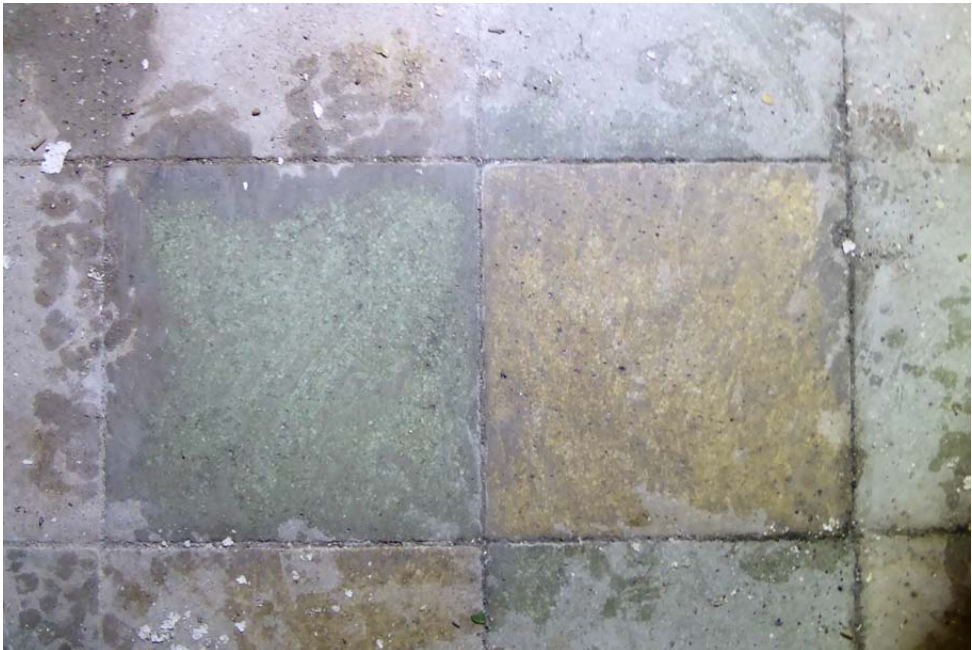
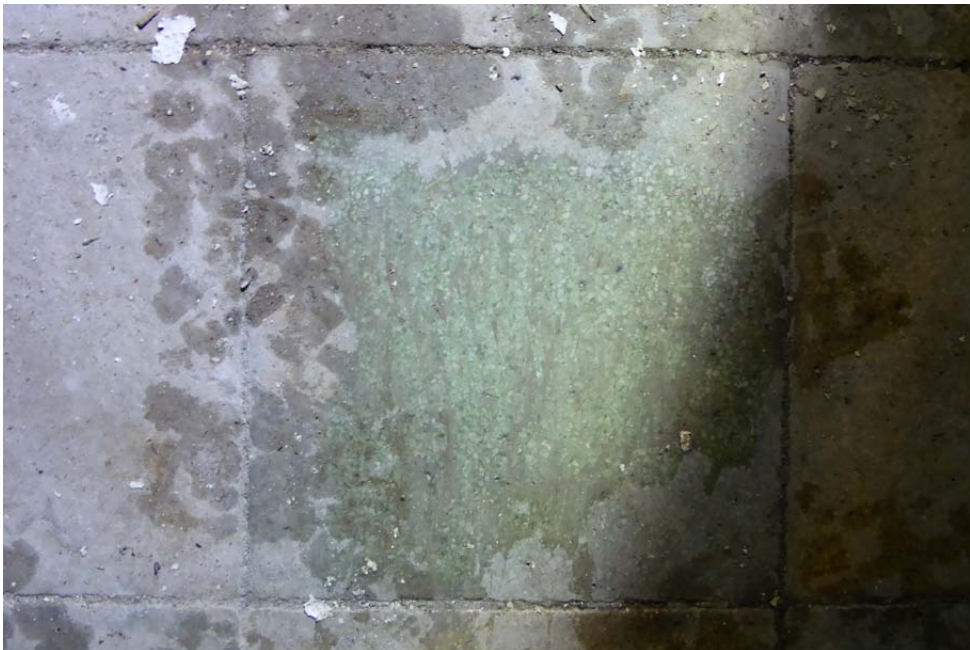
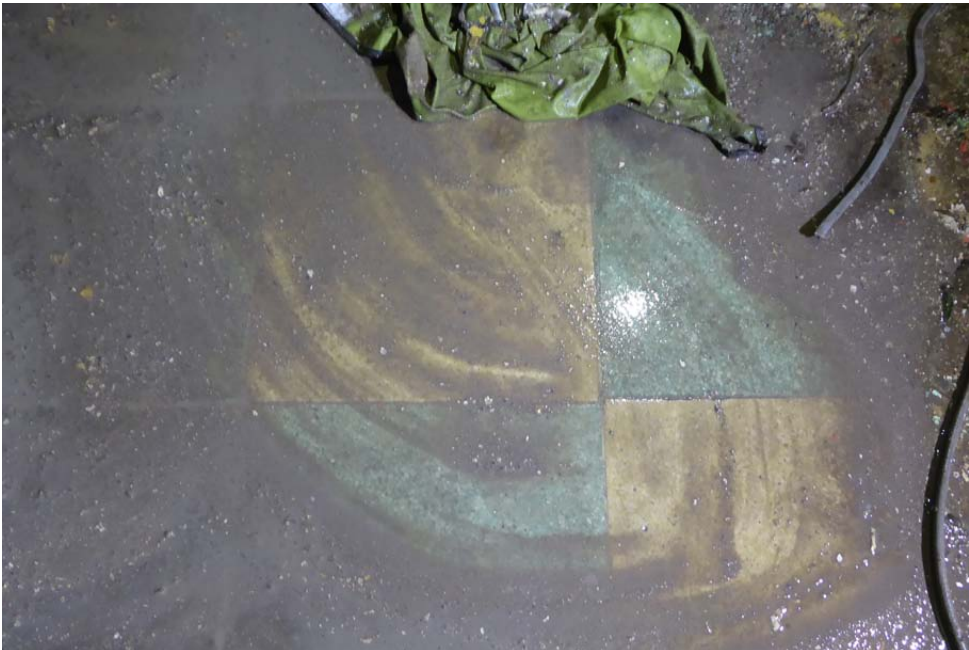
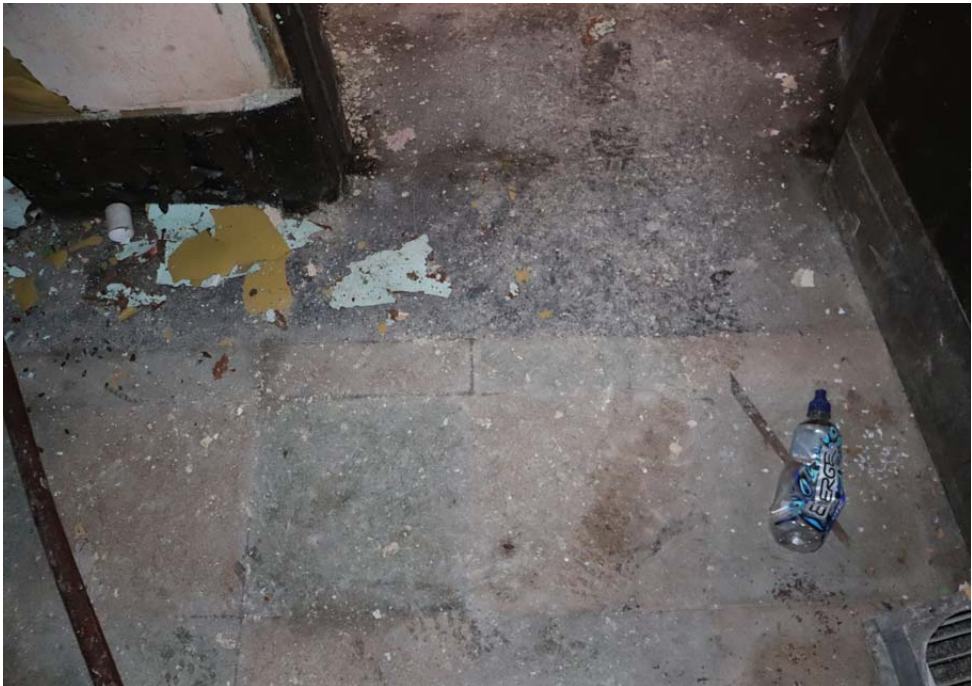
**G8 - Foyer**

As seen in the top two rows of photographs on this page, the Flooring is of terrazzo tiling, of a green (eau de nil) and yellow alternate (chequerboard) pattern. Whilst covered in debris from above, the terrazzo appears to be in a reasonable condition.

The bottom left photograph shows the green and yellow terrazzo tiling leading into an grey insitu terrazzo to the Toilet lobby.

*Views of green and yellow terrazzo tiling leading into an grey insitu terrazzo to the toilet lobby*

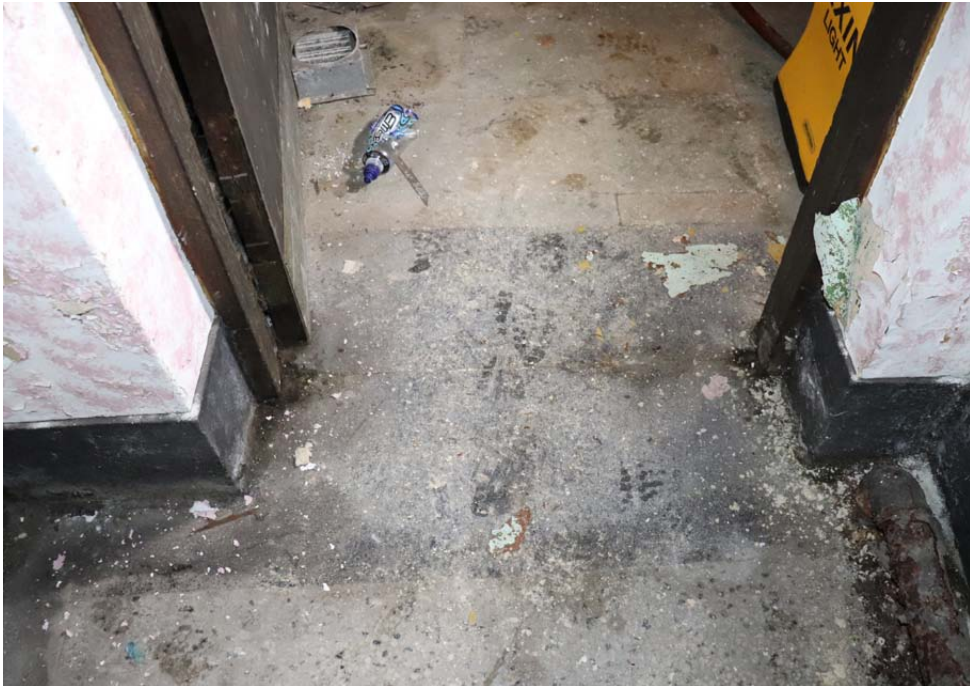
The bottom right photograph shows the grey insitu terrazzo to the Toilets.

*View of grey insitu terrazzo to the toilets*

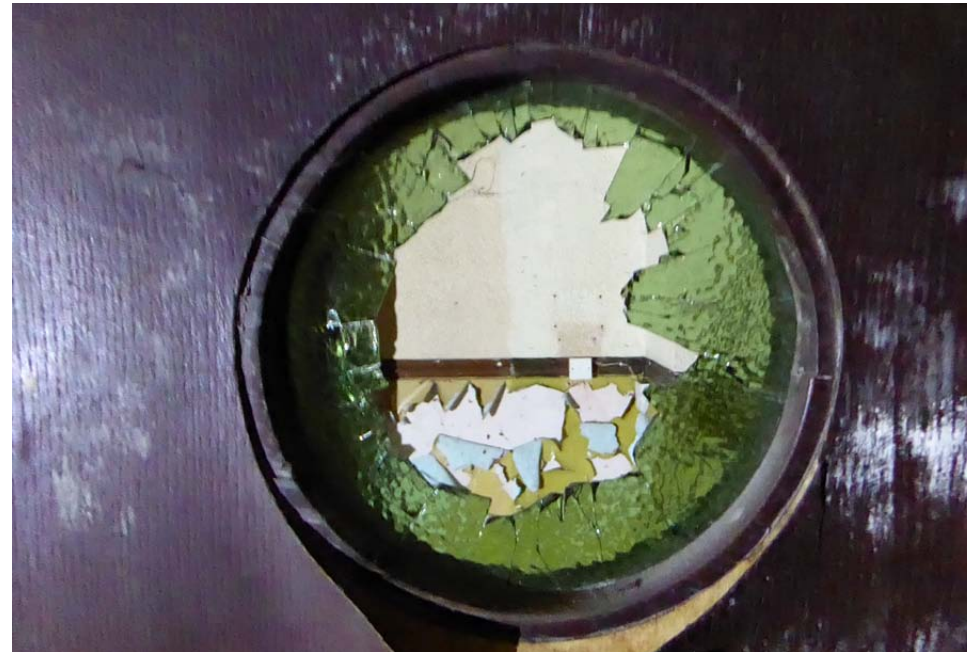
The 3no. sets of double doors leading from the Foyer to the Auditorium and the 2no. Cinemas are dark timber veneered solid core doors with a single small circular vision panel in each door. All of the vision panels have been damaged, however, it is apparent that they used to be of semi-translucence, green in colour - see photograph to right.

*View green glazed circular vision panel to one door*

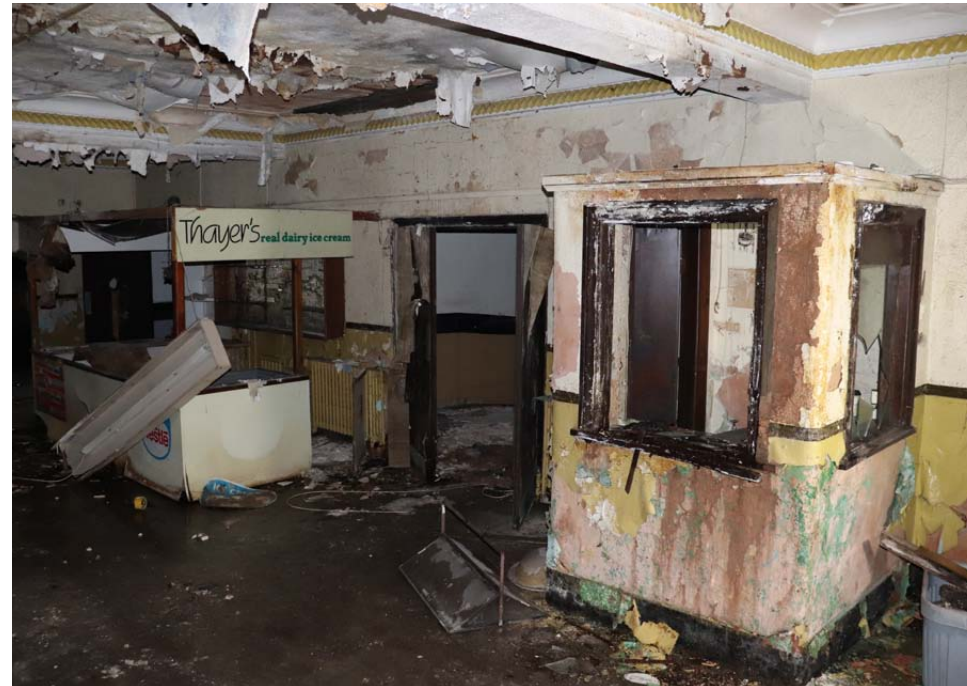
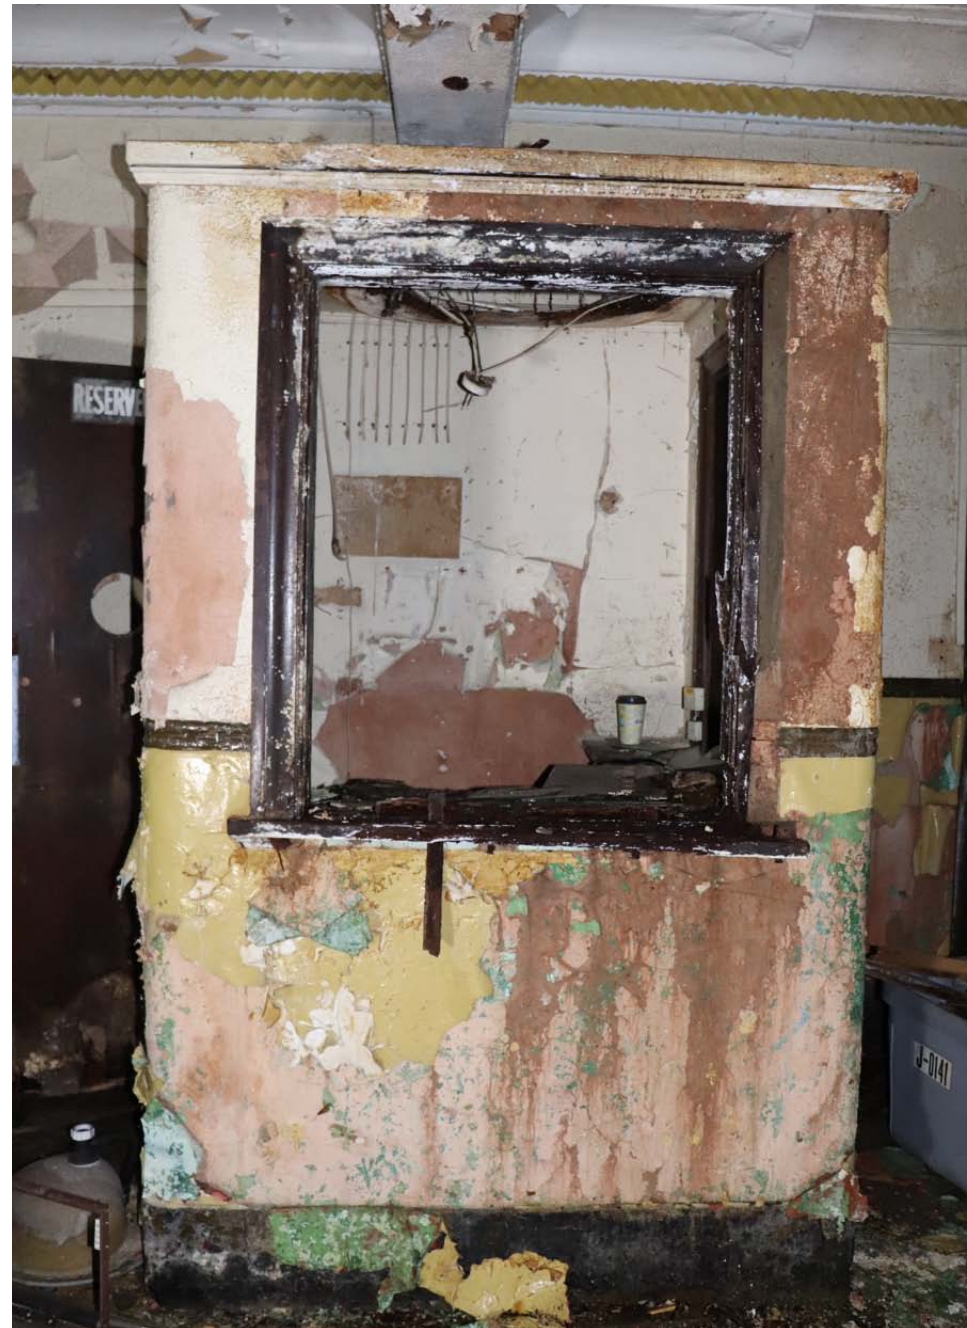
In between the central and right hand doors is a small box office enclosure, which is likely to be original to the building. On this page are photographs of this structure from all sides.

Formed of plastered masonry (treated as the other walls, with a profiled dado) with timber-framed openings to each of three open sides (a door to the west and large window openings to the south and east), it is in a poor condition.

*View of the box office enclosure from the west*

*View of the box office enclosure from the south*

*View of the box office enclosure from the east*

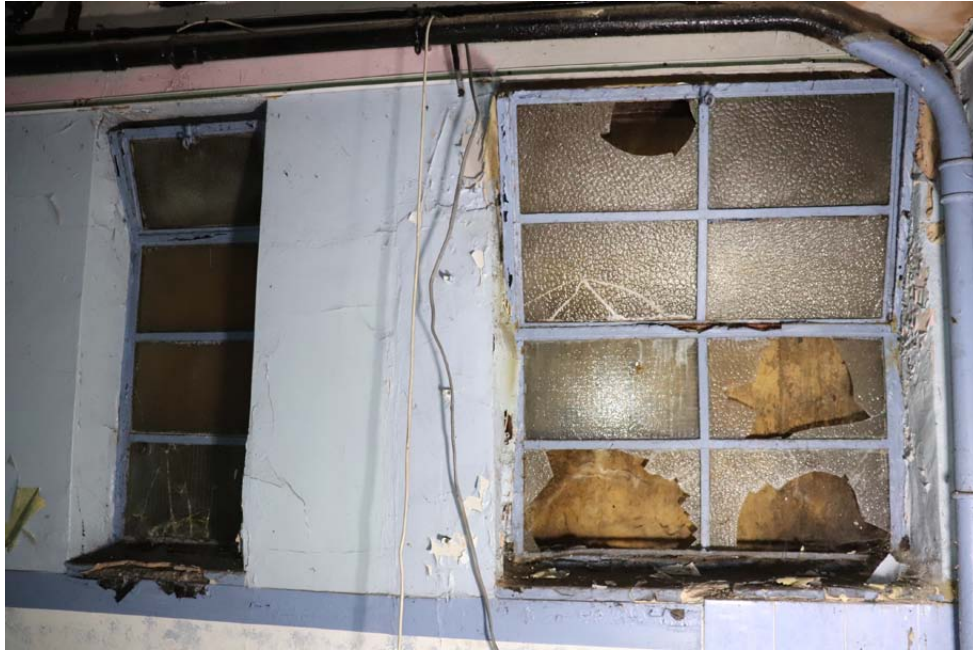
There are 2no. windows to the east elevation (one two panes wide and one one pane wide), with a bottom-hung opener in the top half, of each with opaque glazing, much of which is broken and boarded up.

*View of the Windows to the east elevation*

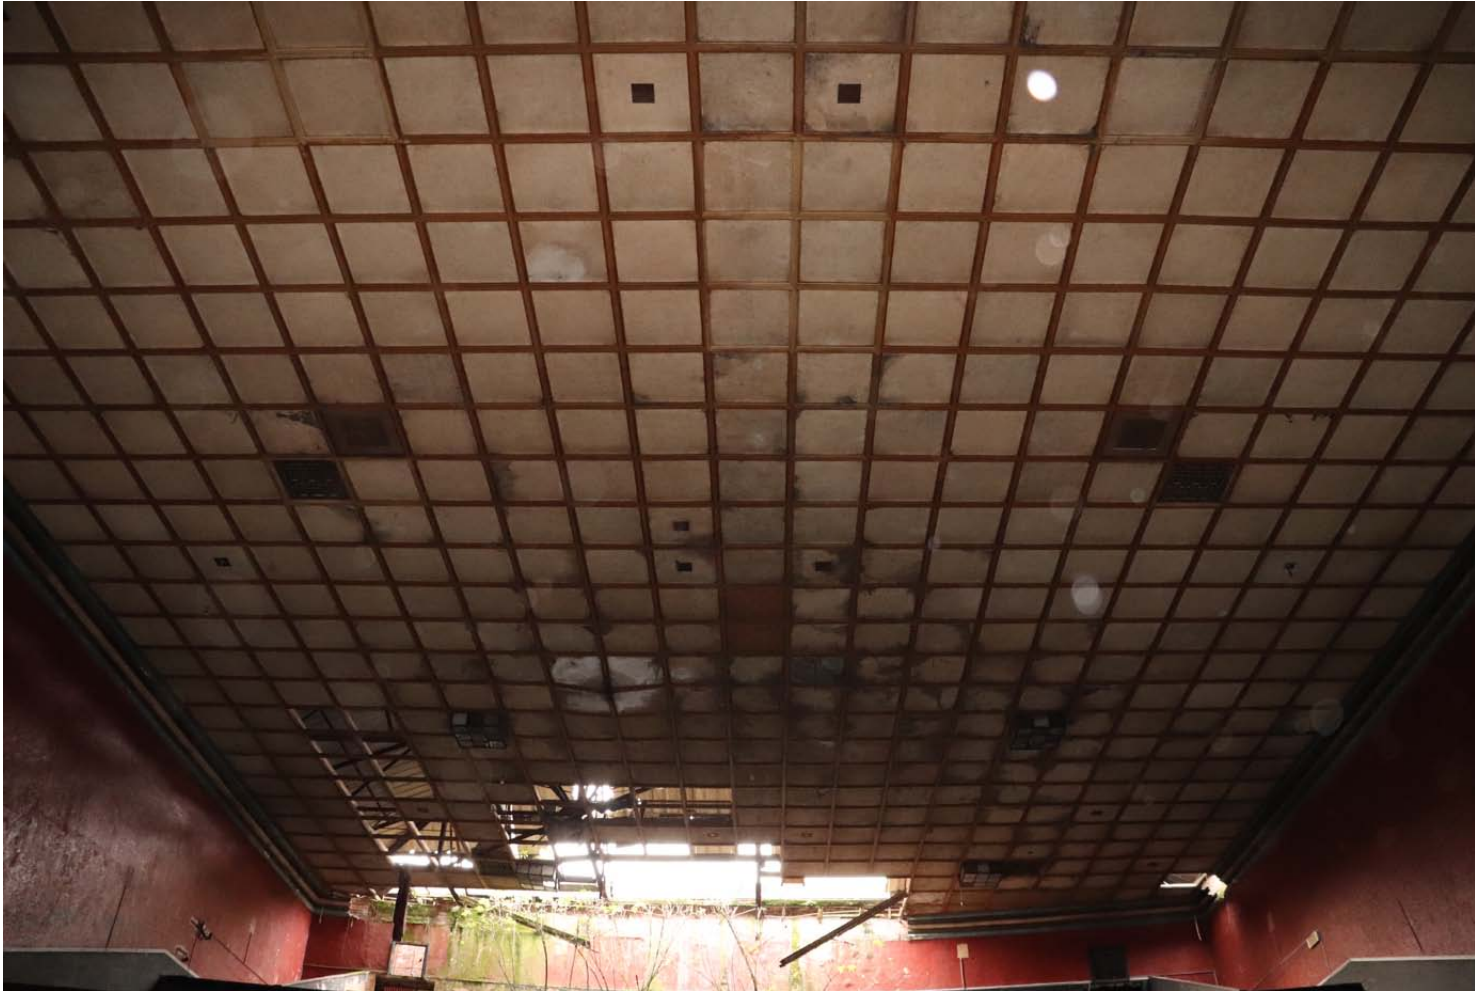
View of ceiling to Auditorium as seen from forestage with hole of roof at far end

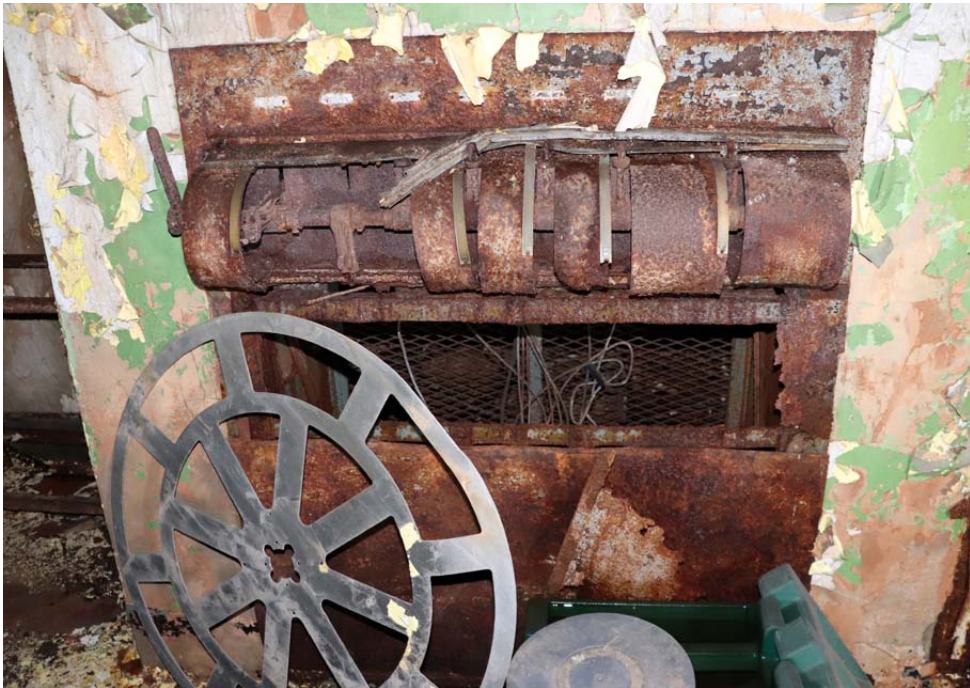
The Walls and Ceilings are of painted plaster, with paintwork in a very poor condition and areas of plaster damage.

View of part of kit in room

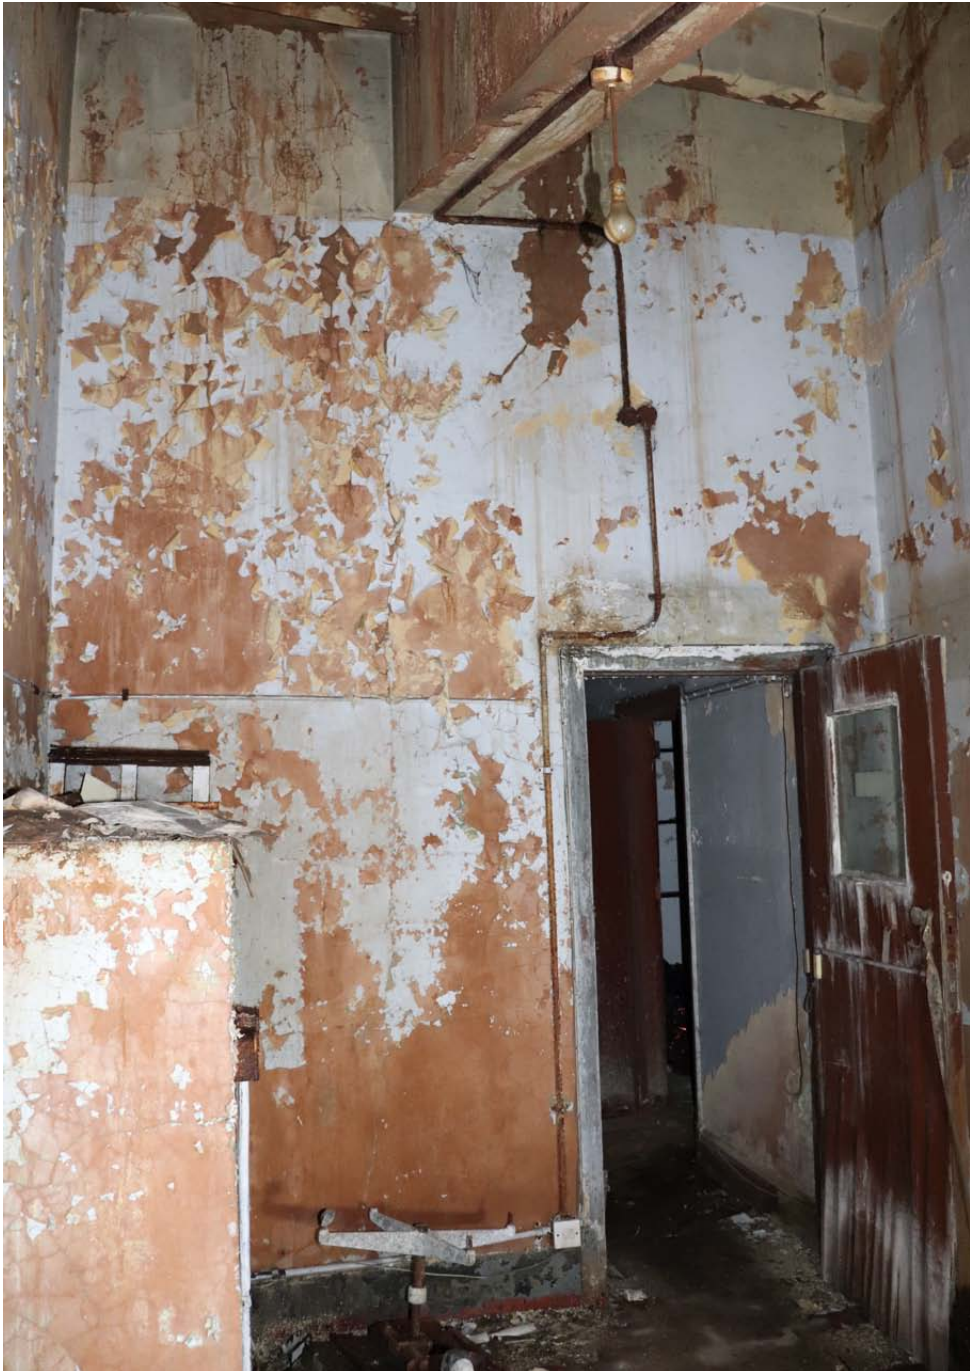
The Walls and Ceilings are of painted plaster, with paintwork in a very poor condition and areas of plaster damage.

*View of north wall*

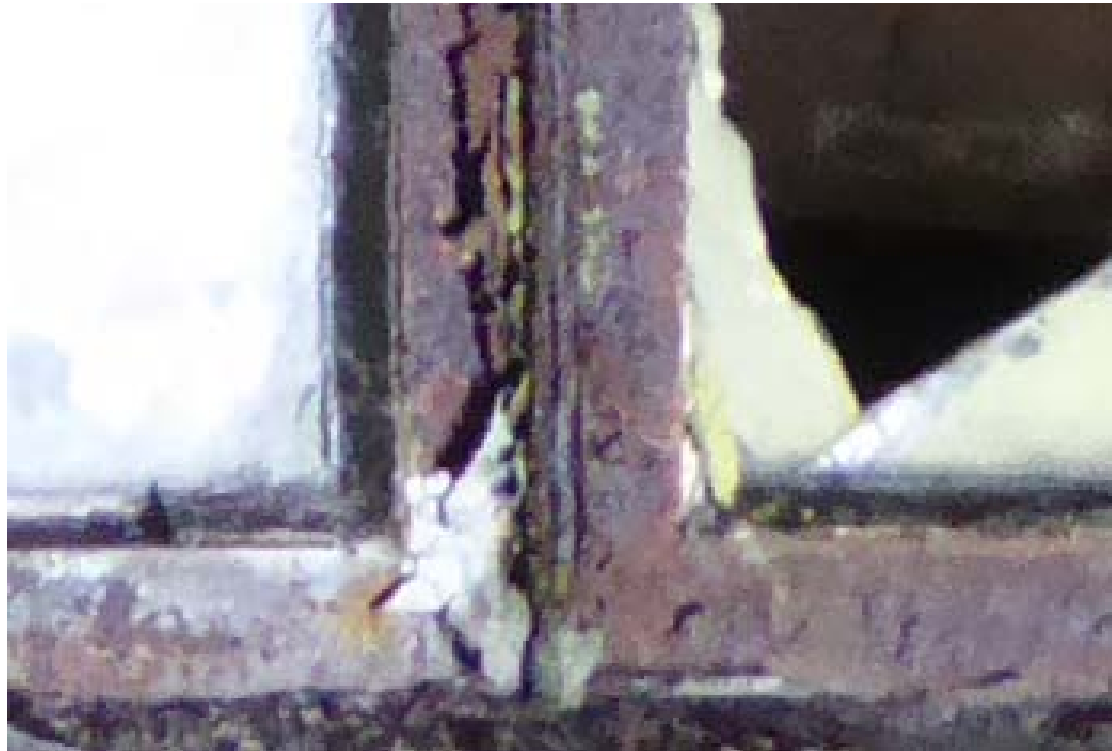
View of corrosion to steel frame sections at mullion

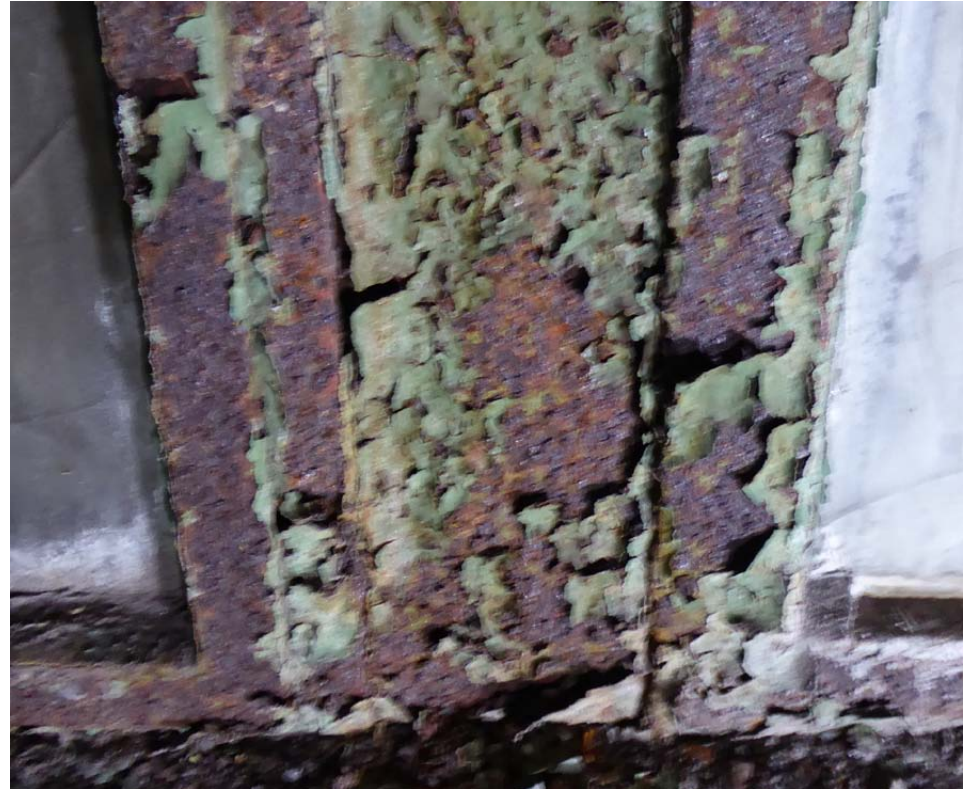
View of corrosion to steel frame sections at mullion

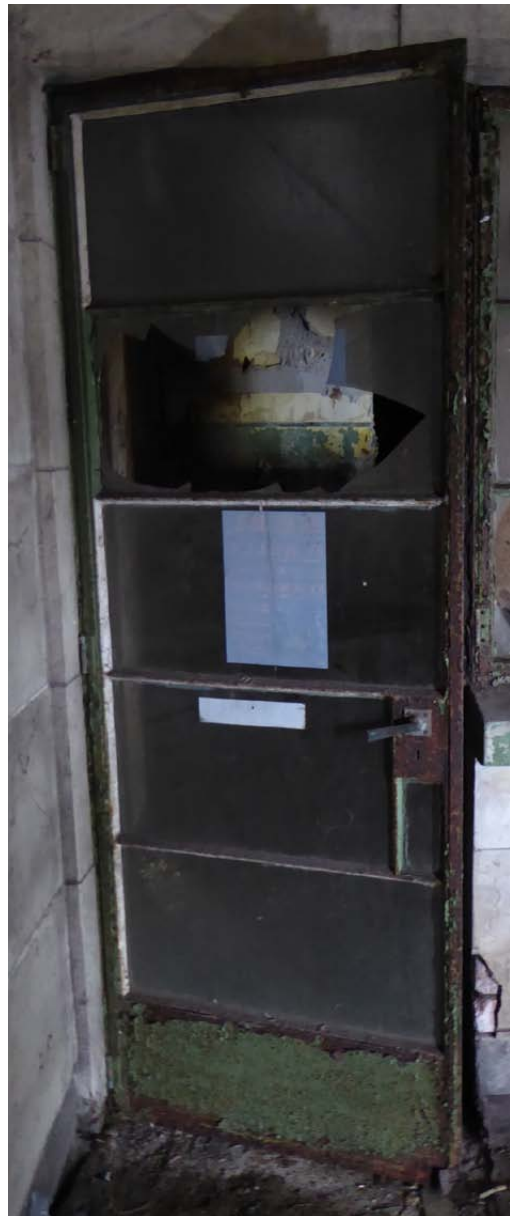
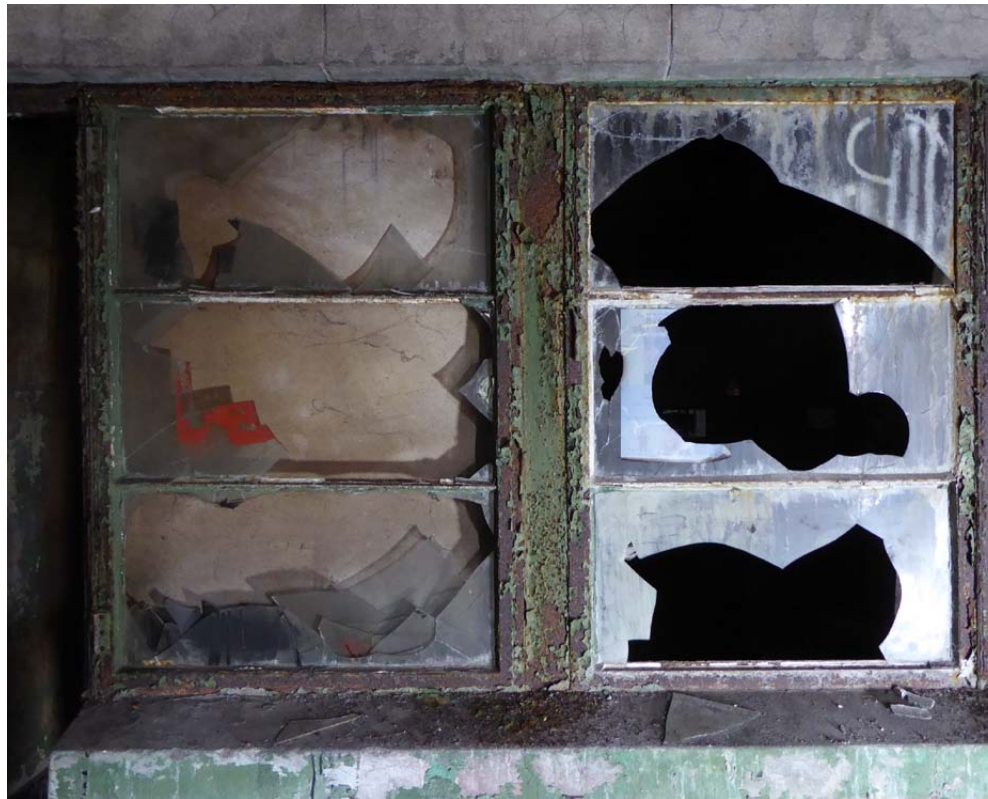
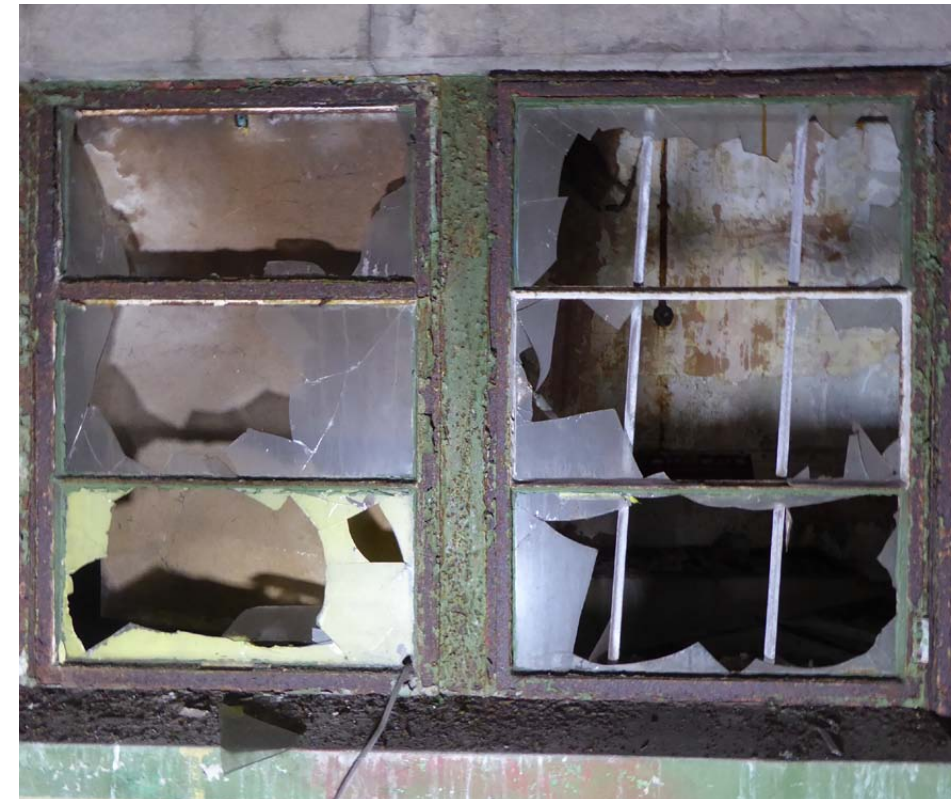
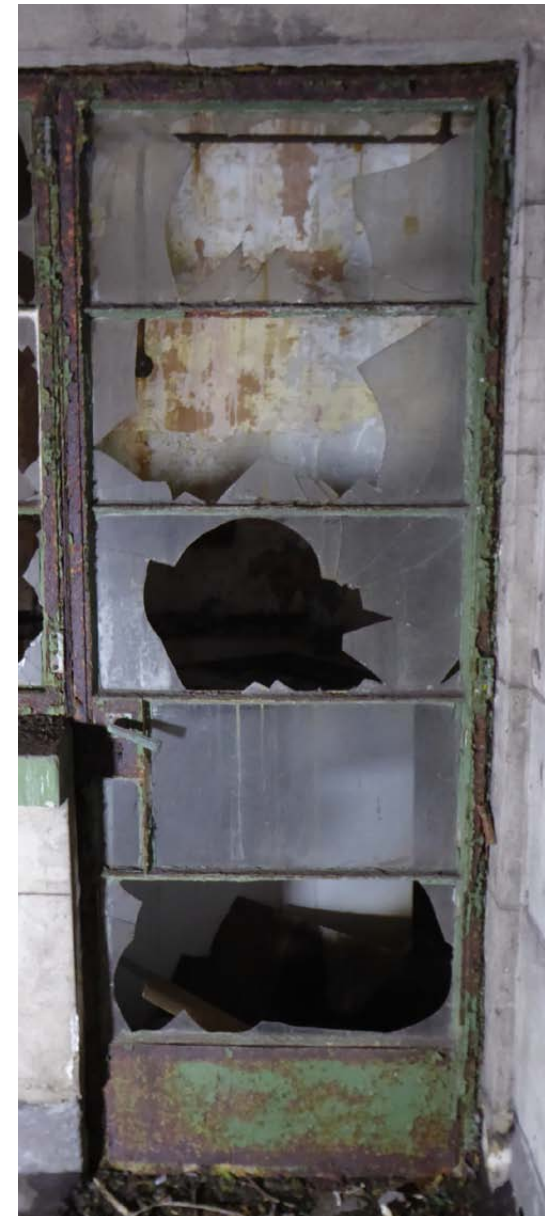
View of run of flat steel-section slender framed windows with doors at either end, manufactured by Crittall or similar, synonymous with the Art Deco architectural movement. Almost all of the glass panes are broken and much of the frame is corroded, as seen from the photographs on the top row. Note the Art Deco style handle to the doors to the top right.
