**Plaza, Port Talbot**

**HISTORIC BUILDING RECORDING**

(385)1902-GWP-A-2A-HBR-P00

Date: 06.01.20

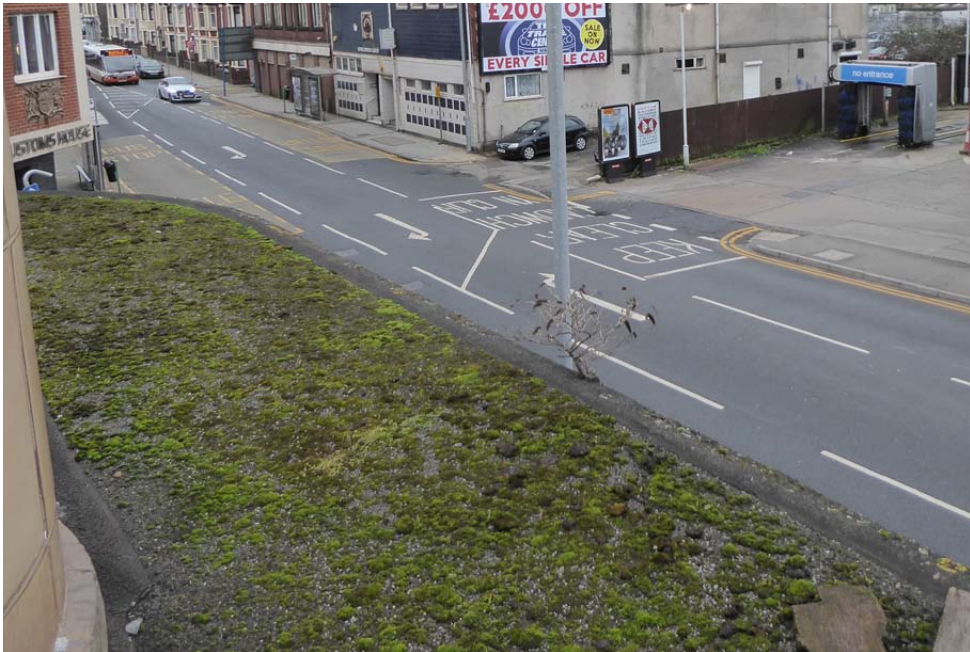
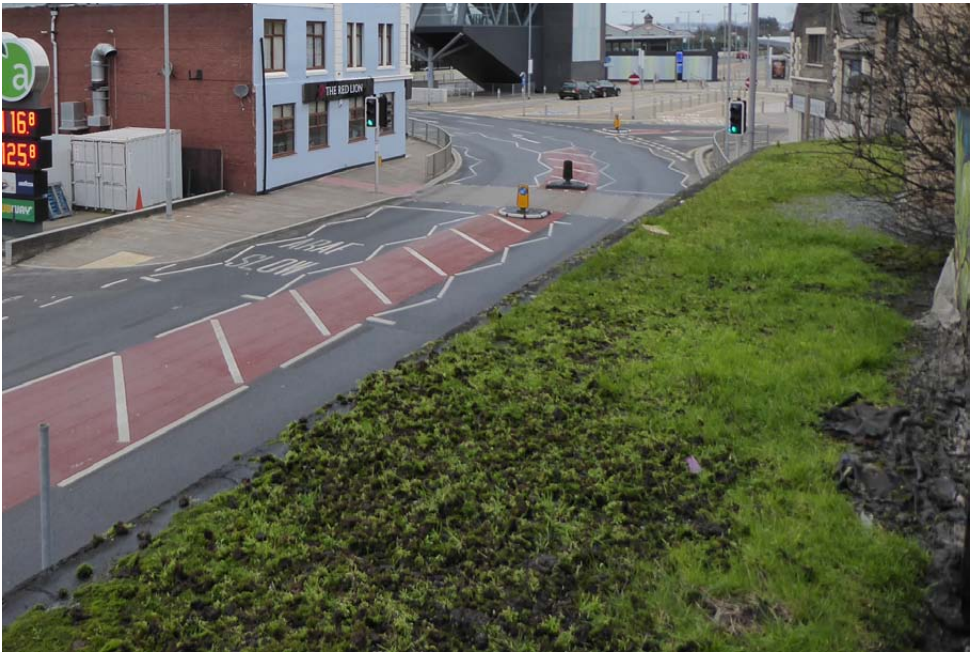
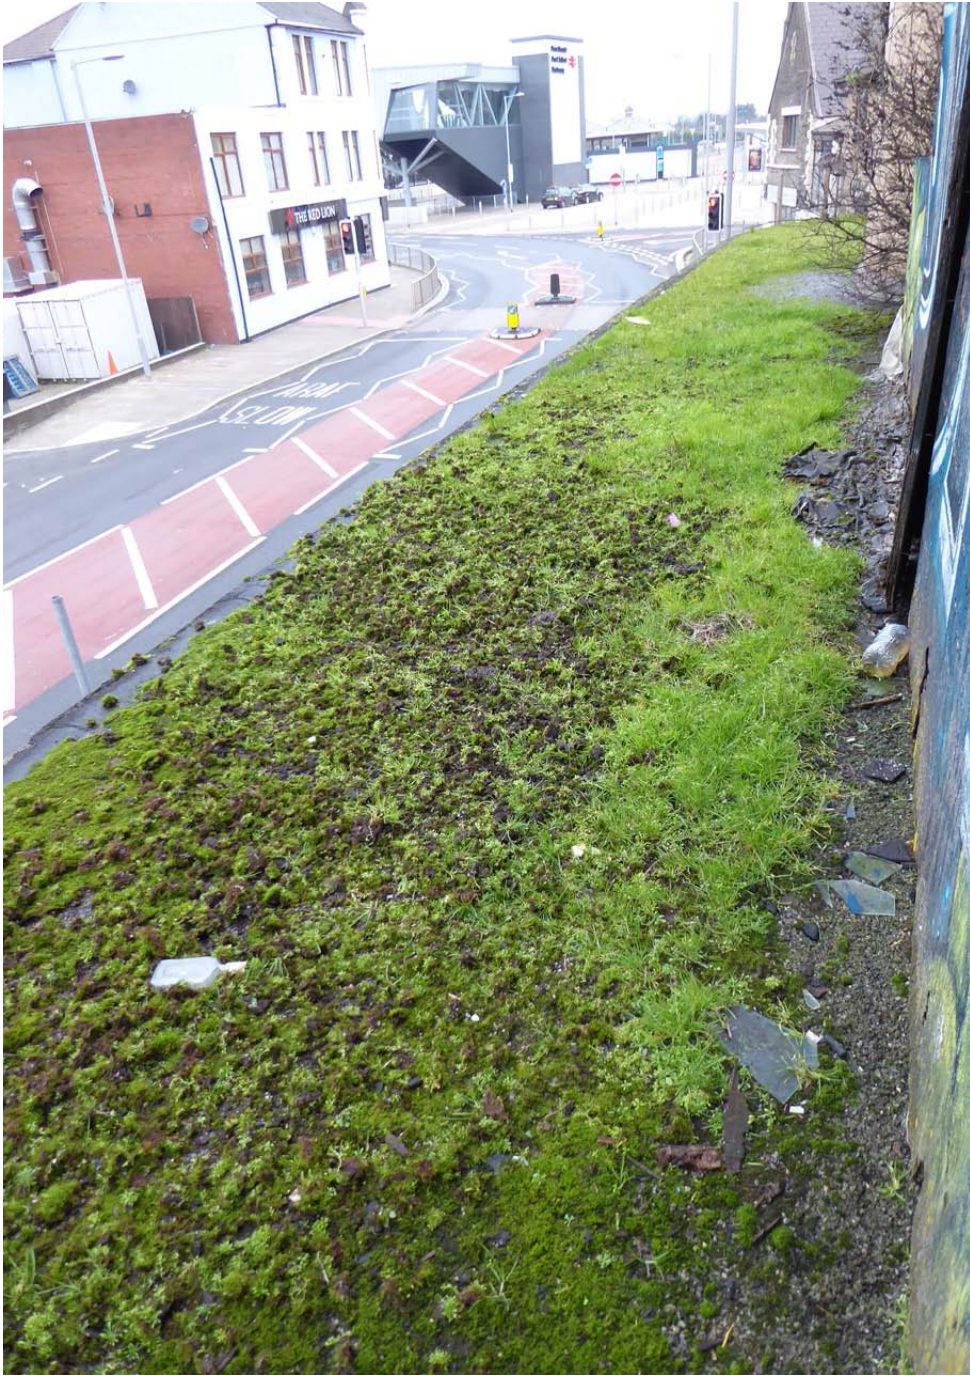
**F14 - Roof to Ground Floor Canopy**

These photographs are of the flat roof area in between and in front of the two round-ended faience-clad forms, which is the canopy over the entrance area. It used to form a balcony, which used to comprise a wrought iron railing, however no longer does.

The finish is asphalt, however, it has developed considerable vegetation over the years and the asphalt is in a poor condition.

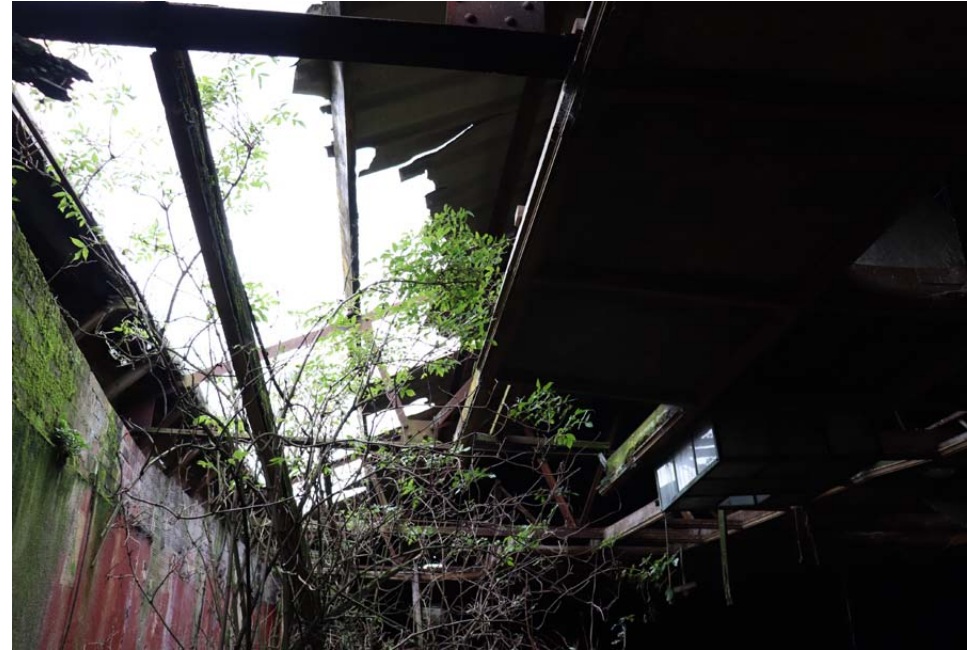
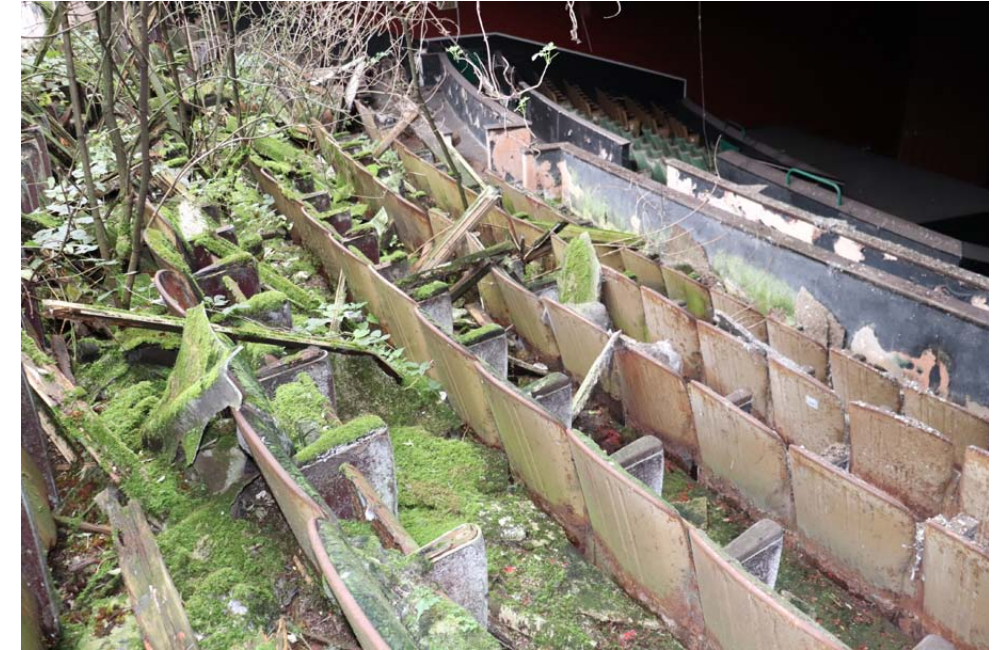
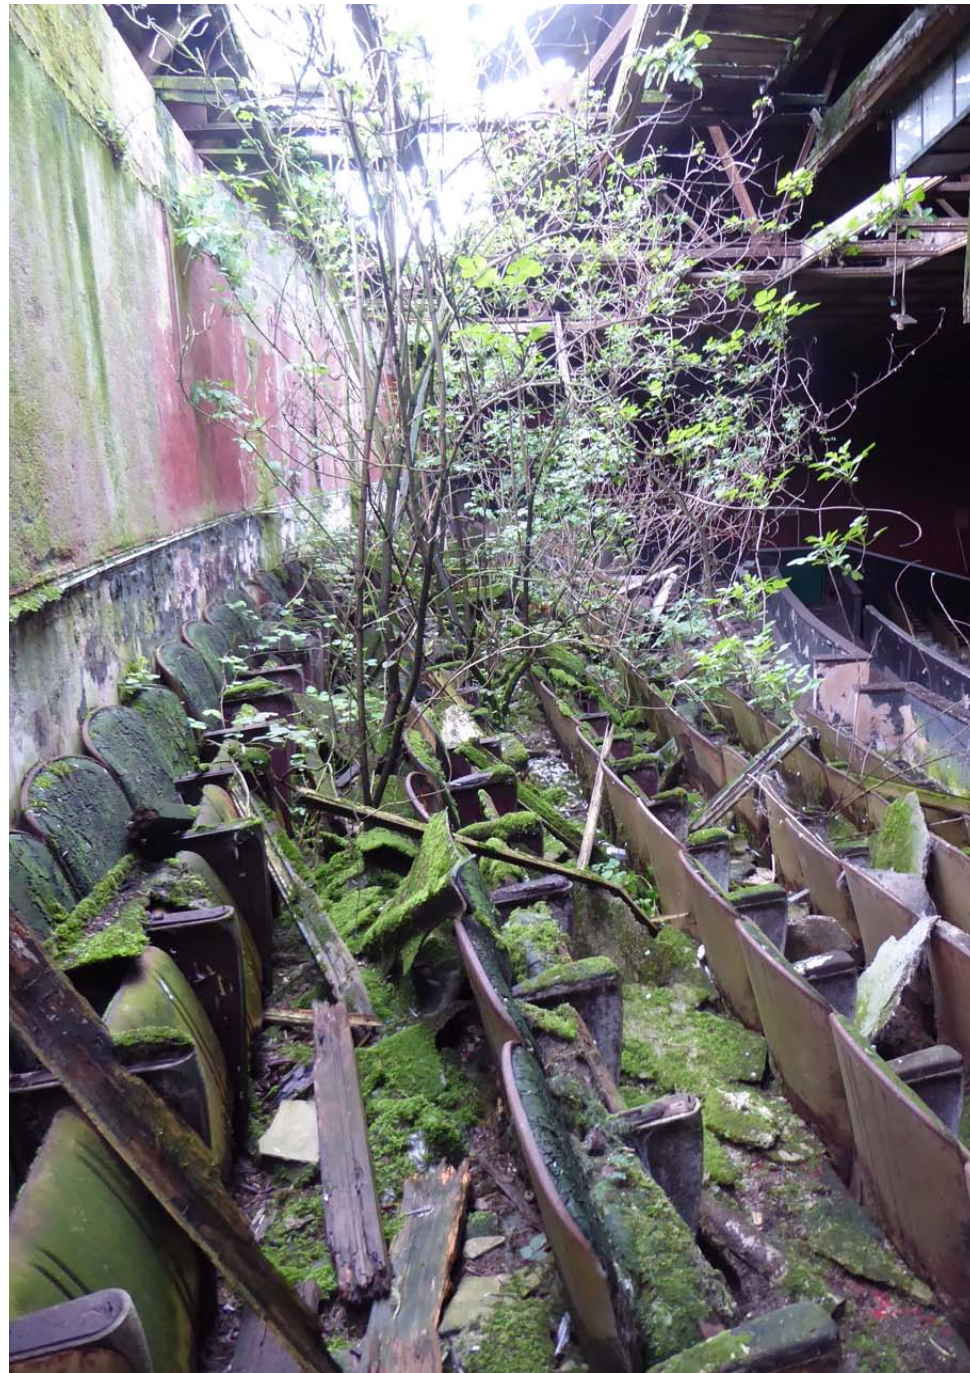
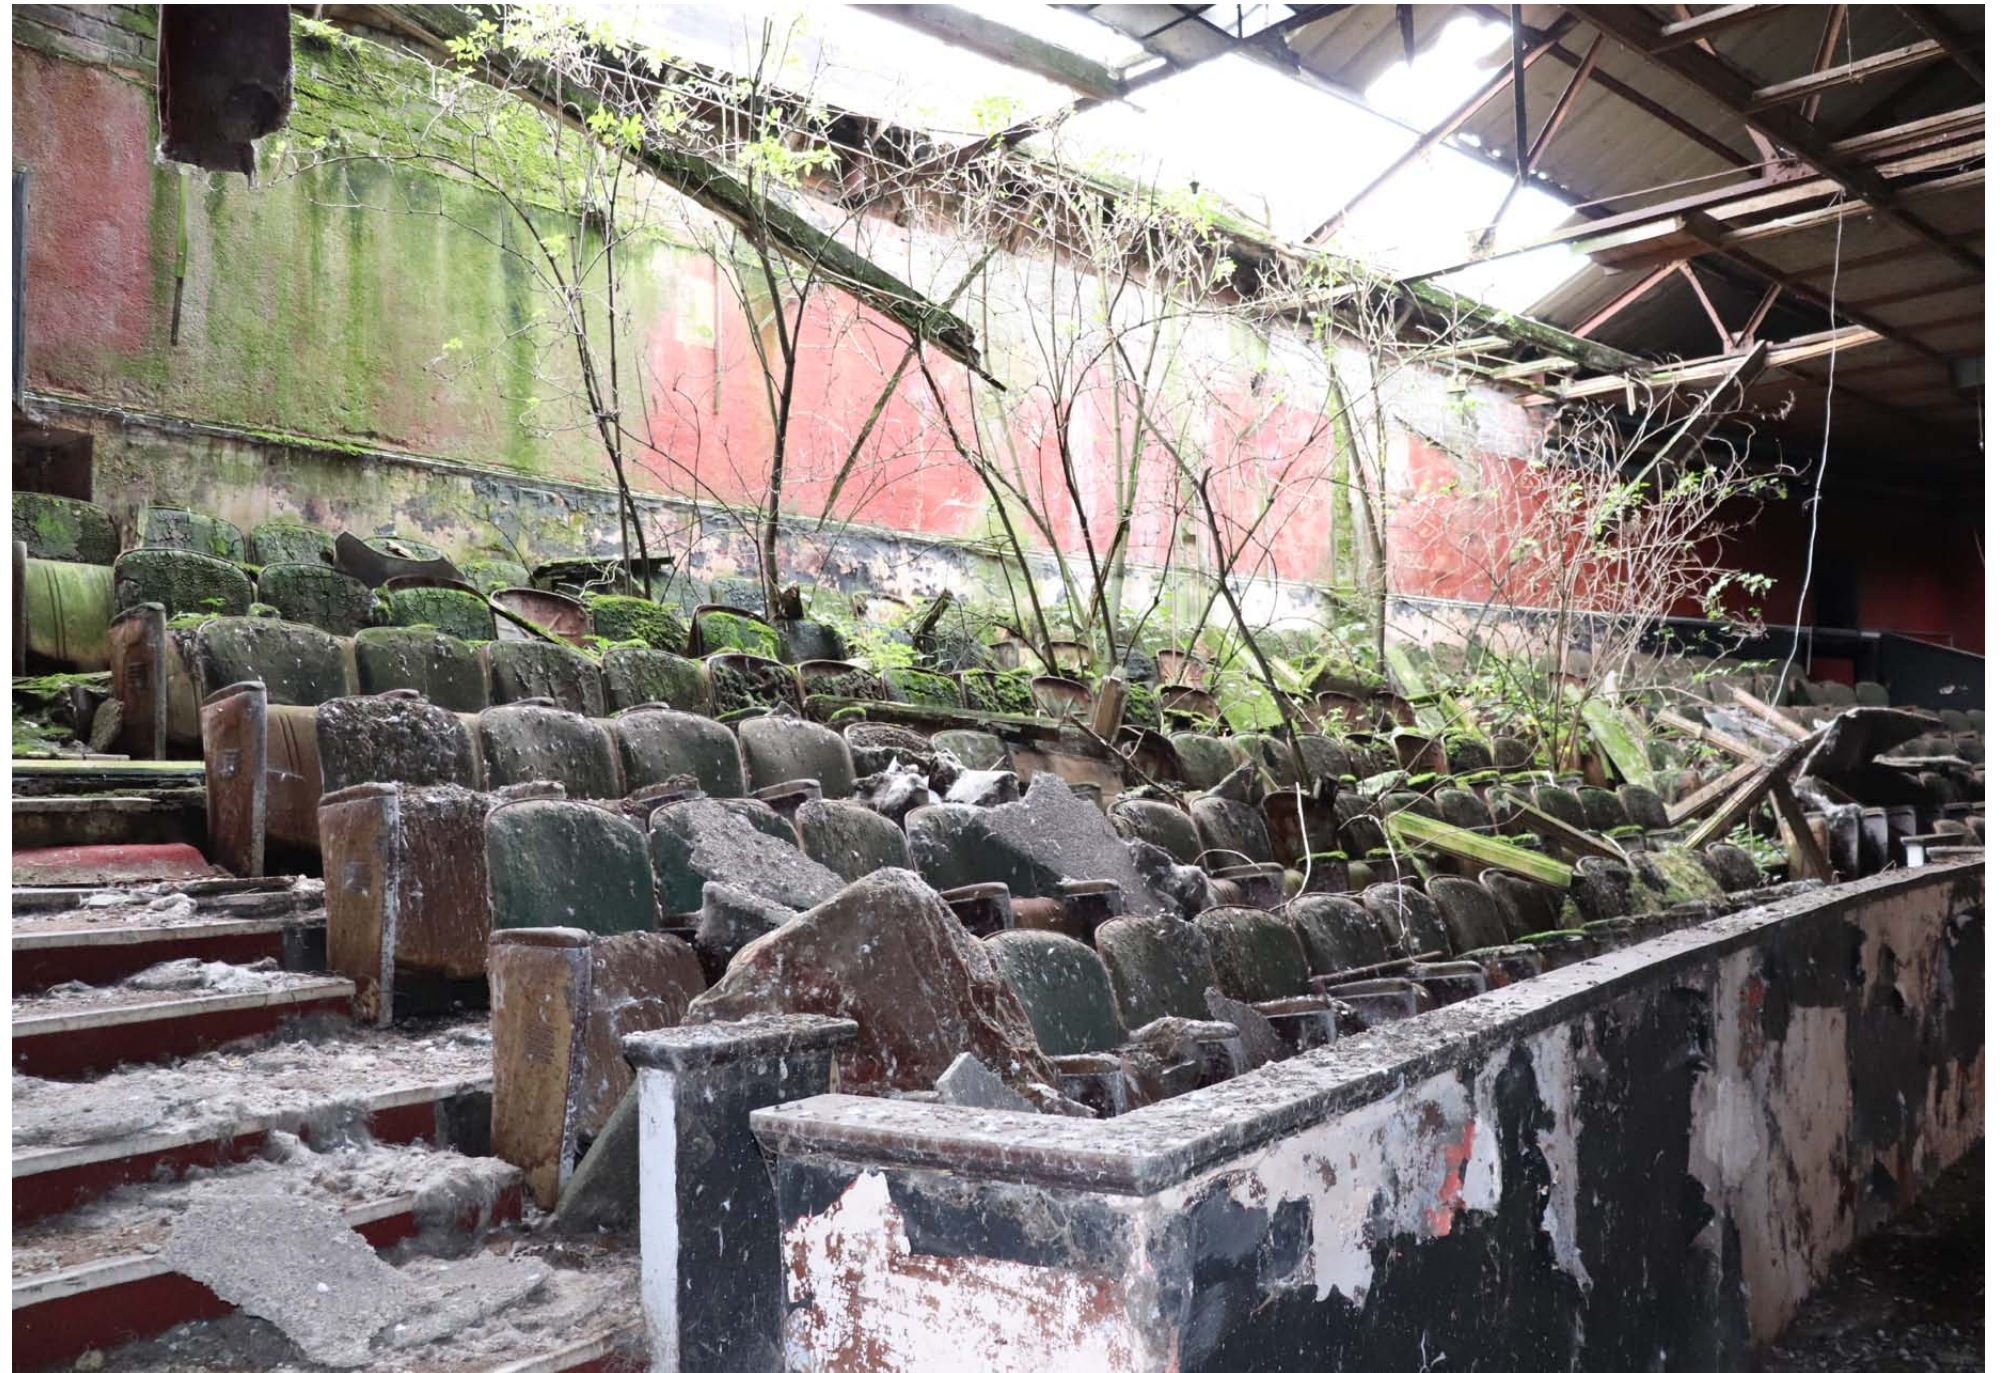
Note on this page the photographs of the large hole in the roof at the rear of the space which has spawned the growth of considerable vegetation amongst the seating.

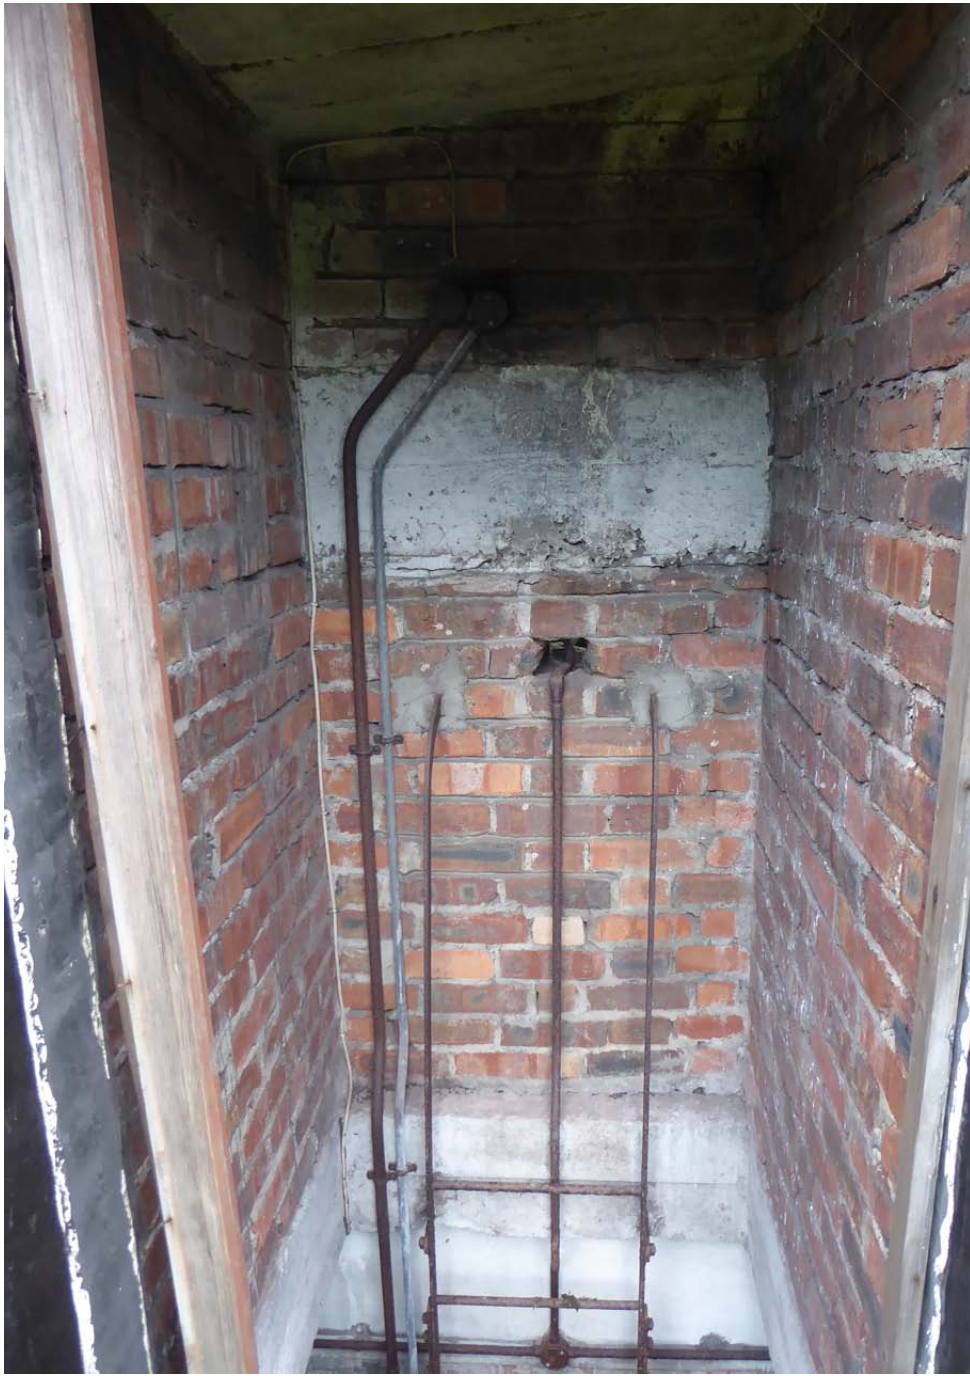
*View of interior of box construction to ladder access*
