Tidal Lagoon (Swansea Bay) Plc

**Tidal Lagoon Swansea – Onshore GI**

**Ground Investigation Interpretive  
Report (Phase 1)**

March 2017

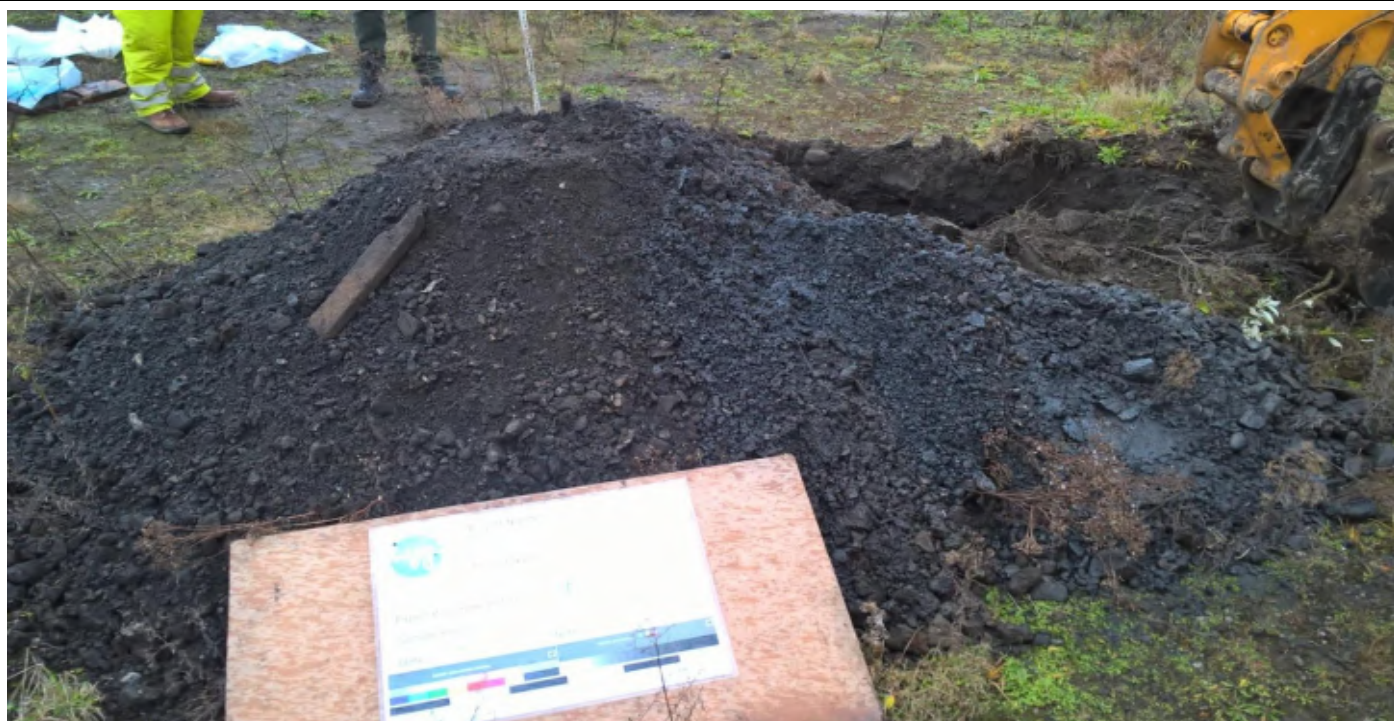
Plate 77

TP18
