## Plaza, Port Talbot

### HERITAGE IMPACT STATEMENT

Prepared for: Neath Port Talbot County Borough Council

(385)1902-GWP-Rev 01

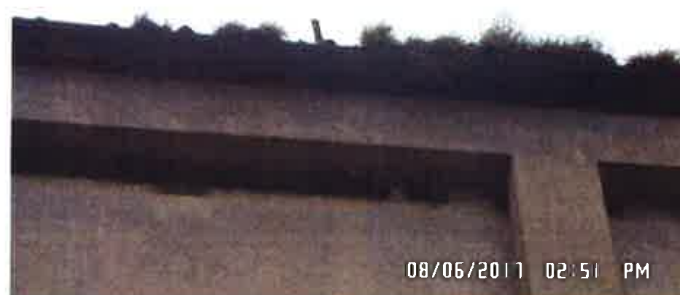
**High level asbestos cement guttering:** The guttering along Eagle Street was clearly overgrown with moss and vegetation. In one area it looked as though the guttering was sagging under the weight and if this were to fall onto a member of the public below it could cause serious injury. As a result the gutter has now been cleaned out and checked for damage including its support brackets via MEWP. The contractor has given assurances the gutter is secure. The rear and opposite side gutters were also cleaned and checked for damage. Whilst not immediately adjacent to a public highway they still pose a risk and a small length of guttering to the rear and side elevation had to be removed. See photographs below:

Overgrowth in high level gutters (June 2017) Overgrowth removed via MEWP (July 2017)

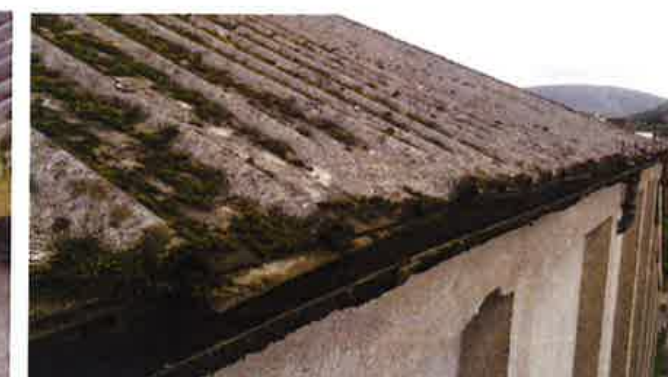
After clearing out (July 2017)

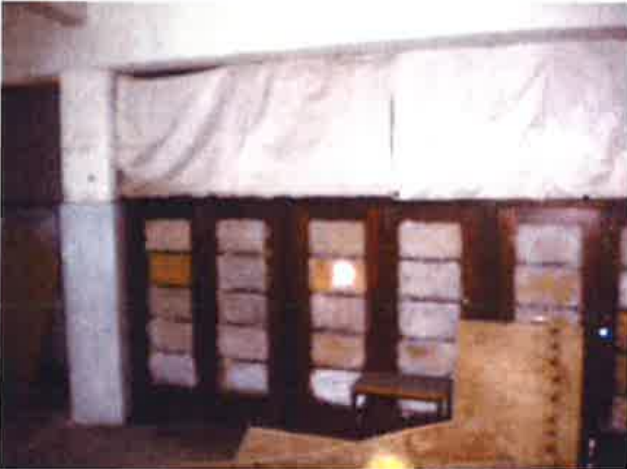
Photograph of entrance steps 2012

The paint is peeling off the reinforced concrete columns and beams. There are metal soffit panels to the front down stand beam that are badly corroded and on one side dangerously hanging loose. The Concrete frame and roof slab, however, do not show any evidence of rust staining or spalling. There is visual evidence of further deterioration in comparison to the 2012 report photographs, see below:

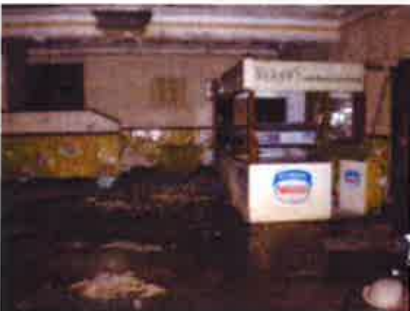
Foyer area (2012)

The paintwork to the soffit of the concrete slab, down stand beams and columns are peeling away badly in all locations. There is clearly standing water on the slab above as there are hairline cracks in the soffit with rust staining and damp areas. This area is clearly in a poor state of repair and has deteriorated further since 2012 with the majority of the feature cornicing breaking away from the ceiling. Refer to photographs below:

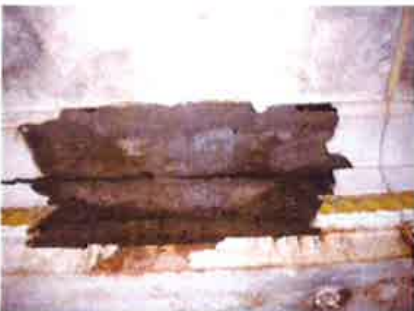
Downstand RC beam (2012)

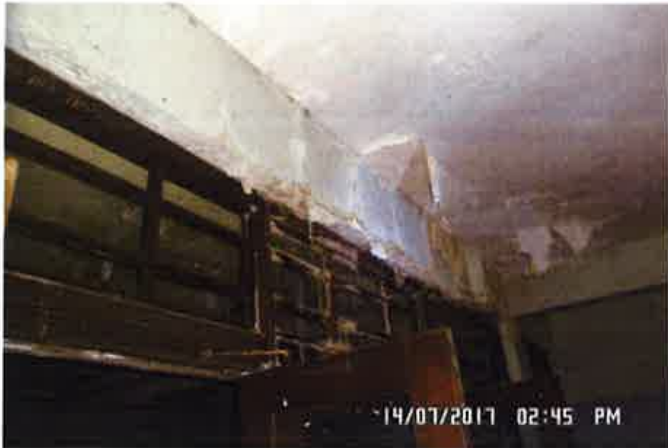
Foyer area doors, July 2017

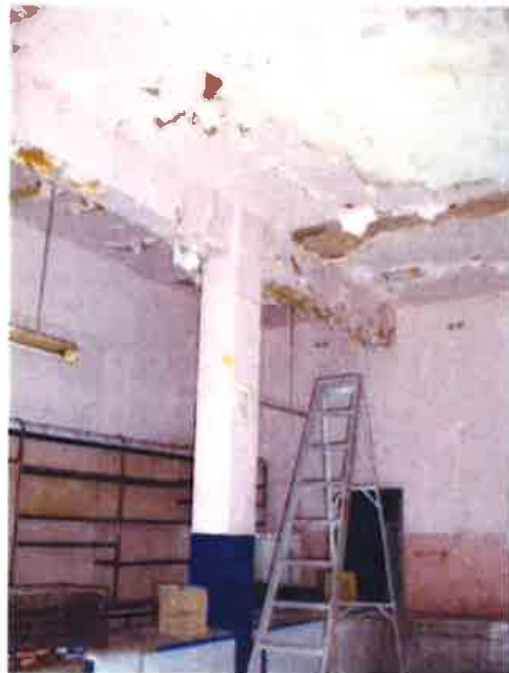
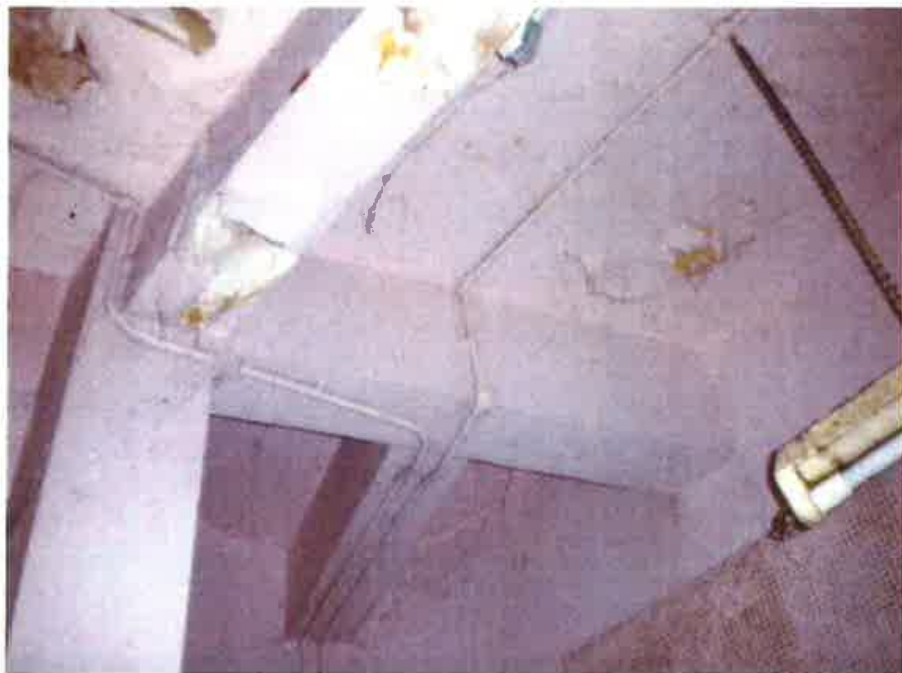
The 2012 report identified water ingress through the concrete roof slab revealing some corroded reinforcing bars. During the inspection it was clear that the paintwork to the concrete in general had deteriorated with almost all concrete surfaces peeling. Refer to photographs below:

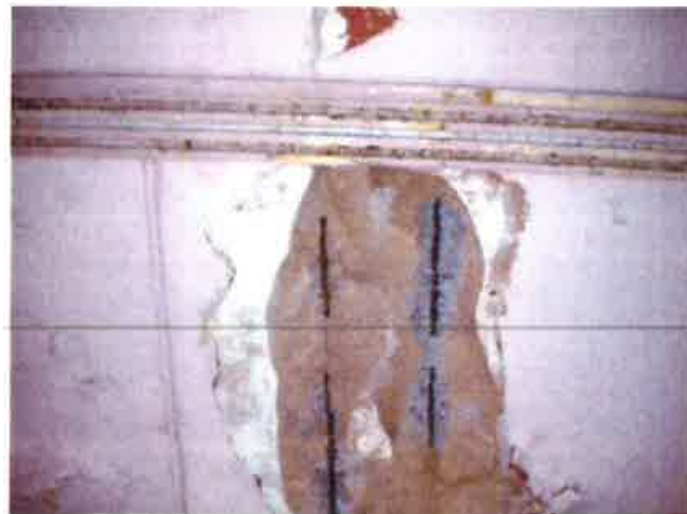
2012

The slab and down stand beams appear to be in a fair condition however the slab soffit displayed areas of additional hairline cracks and water staining with exposed/corroded reinforcement. There is clear evidence that the felt roof is letting in water and it is increasingly starting to affect the integrity of the slab. If this continues the slab will deteriorate to a point where spalling of concrete will occur and significant concrete repairs will be required.

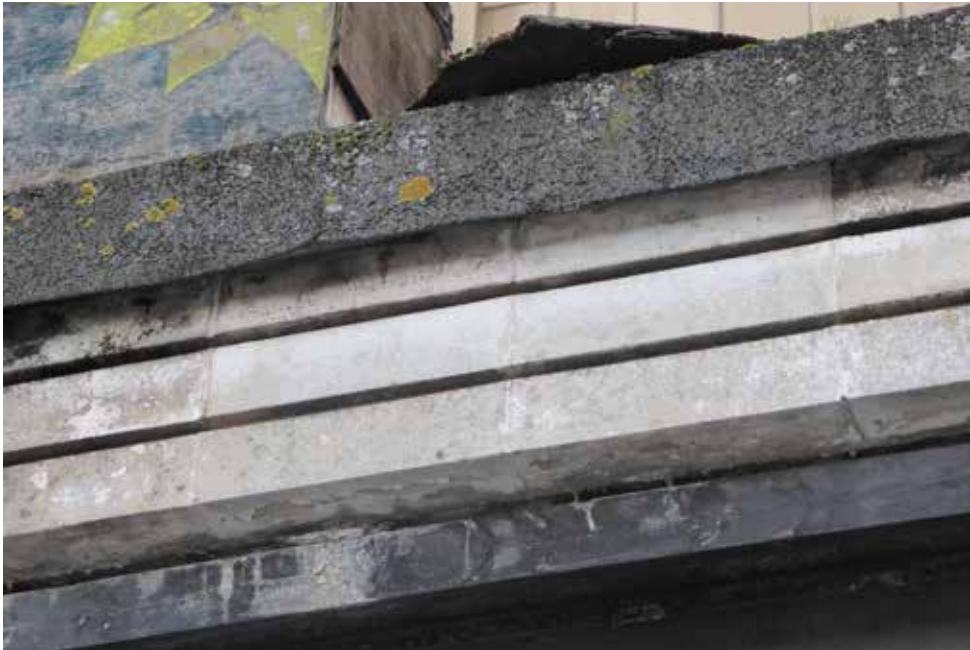
**T** Reconstituted Stone Profiled Fascia to Canopy with felt dressed
