Land Adjacent Neath Abbey Road  
Abbey Road Industrial Estate,  
Neath.  
SA10 7BR

**Load Assessment on Existing Steel Framed Buildings**

For  
Huw Jenkins

| <b>Date:</b> | 14 <sup>th</sup> November 2022 |

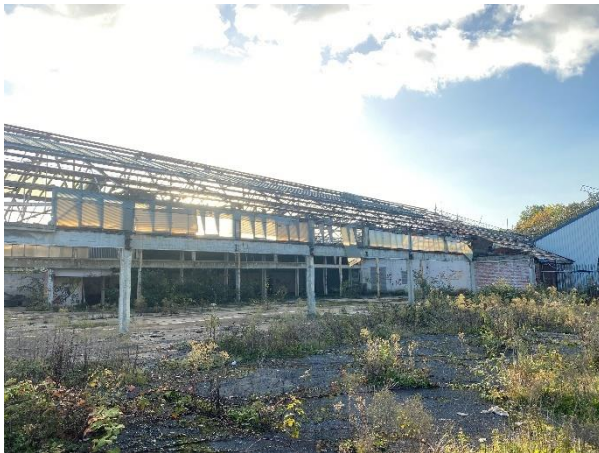
Photo B1 - GA1 - Side elevation

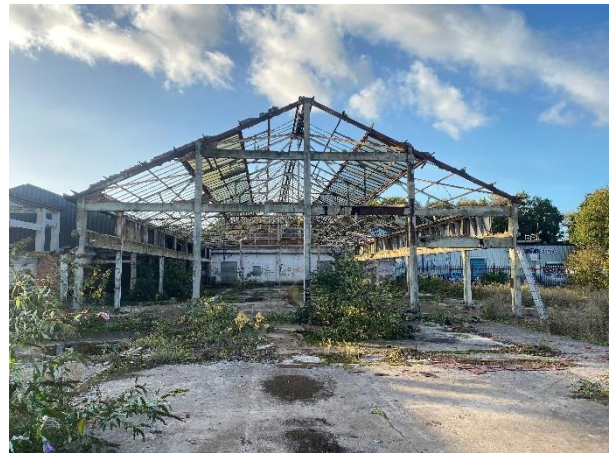
Photo B1 - GA2 - End elevation

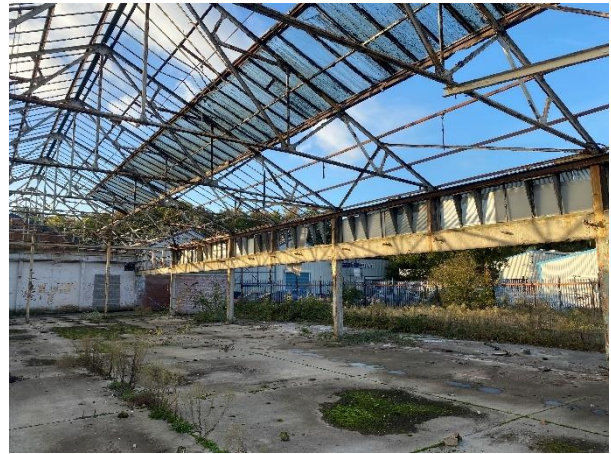
Photo B1 - GA4 - Internal elevation on gridline A

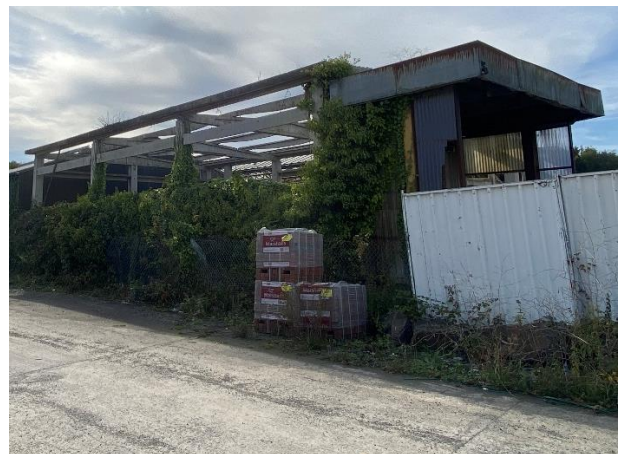
Photo B3-GA2 – Side elevation on gridline L

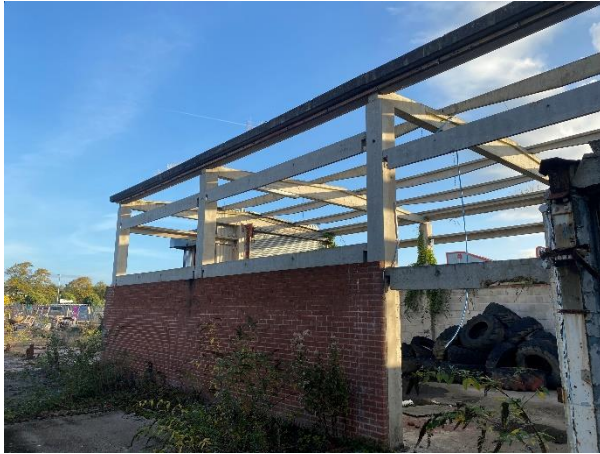
Photo B3-GA3 – Side elevation on gridline J

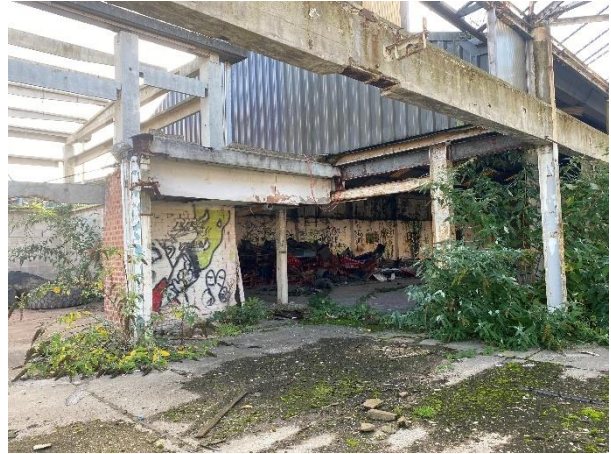
Photo B3-GA4 – Side elevation on gridline J

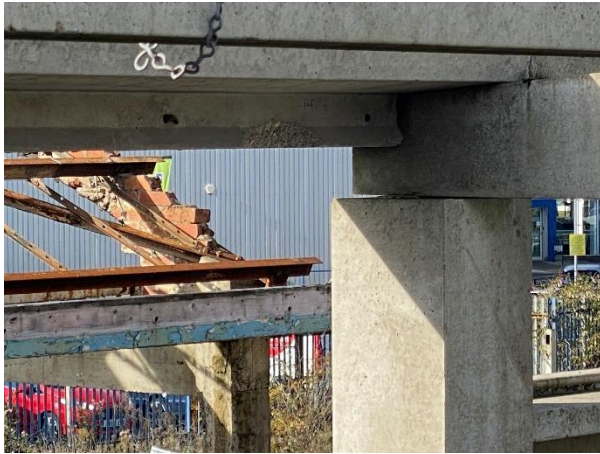
Photo B3-GA9 – Column to main roof beam connection (single bolt or grouted tendon)
