**Structural Survey (Inspection)**

**Moose Hall  
Castle Street  
Neath  
SA11 3LU**

Structural Surveys UK were commissioned to undertake a Full Structural Survey (Inspection) to a residential property at Moose Hall, Castle Street in Neath.

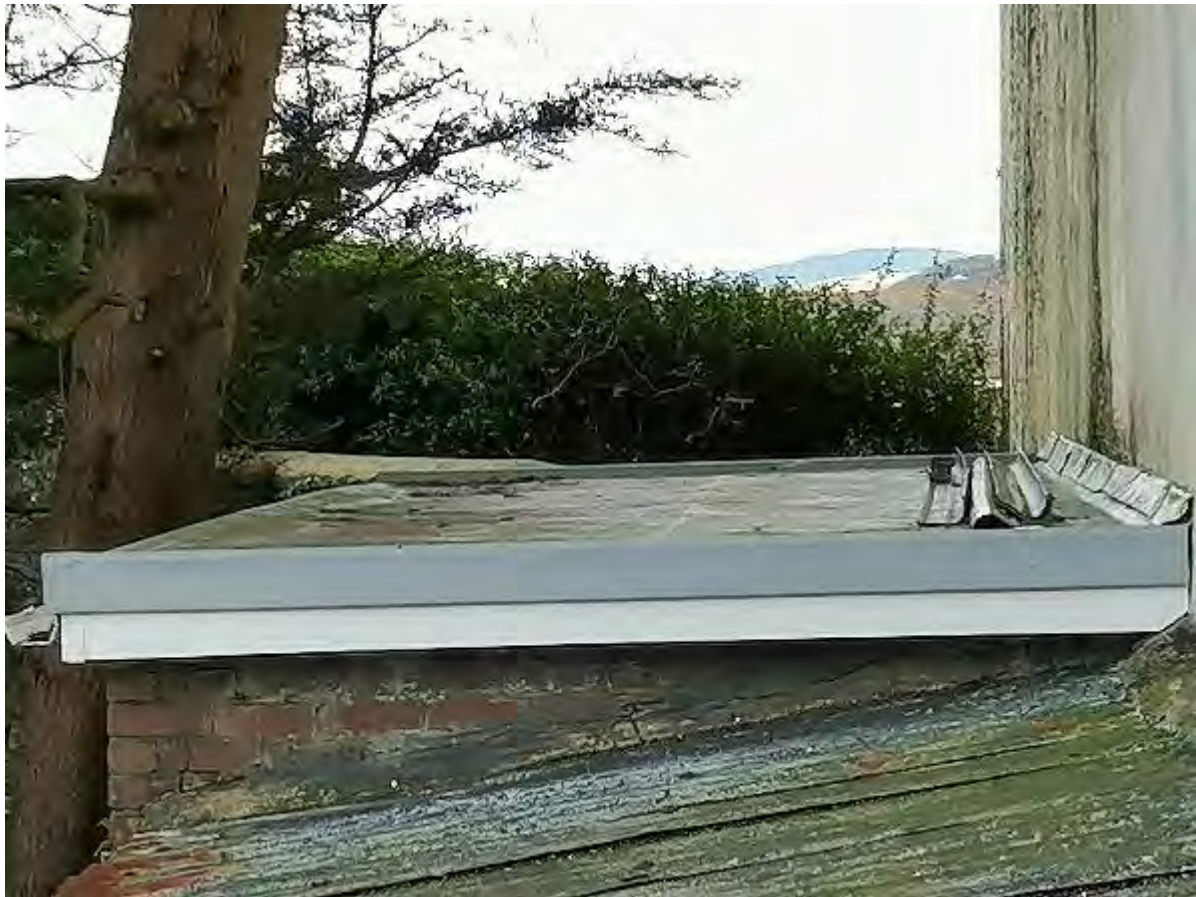
We noted no major undulation, deflection or other distortion to the roof structure of the property, i.e. sagging or leaning of the timber frames to the front or rear elevations – See Photo 1 to 10. Minor sagging was noted to the front roof profile – see photo 20 below. The alignment of the roof profile was satisfactory and did not raise concerns regards the integrity of the structural timber frameworks beneath (when inspected externally).

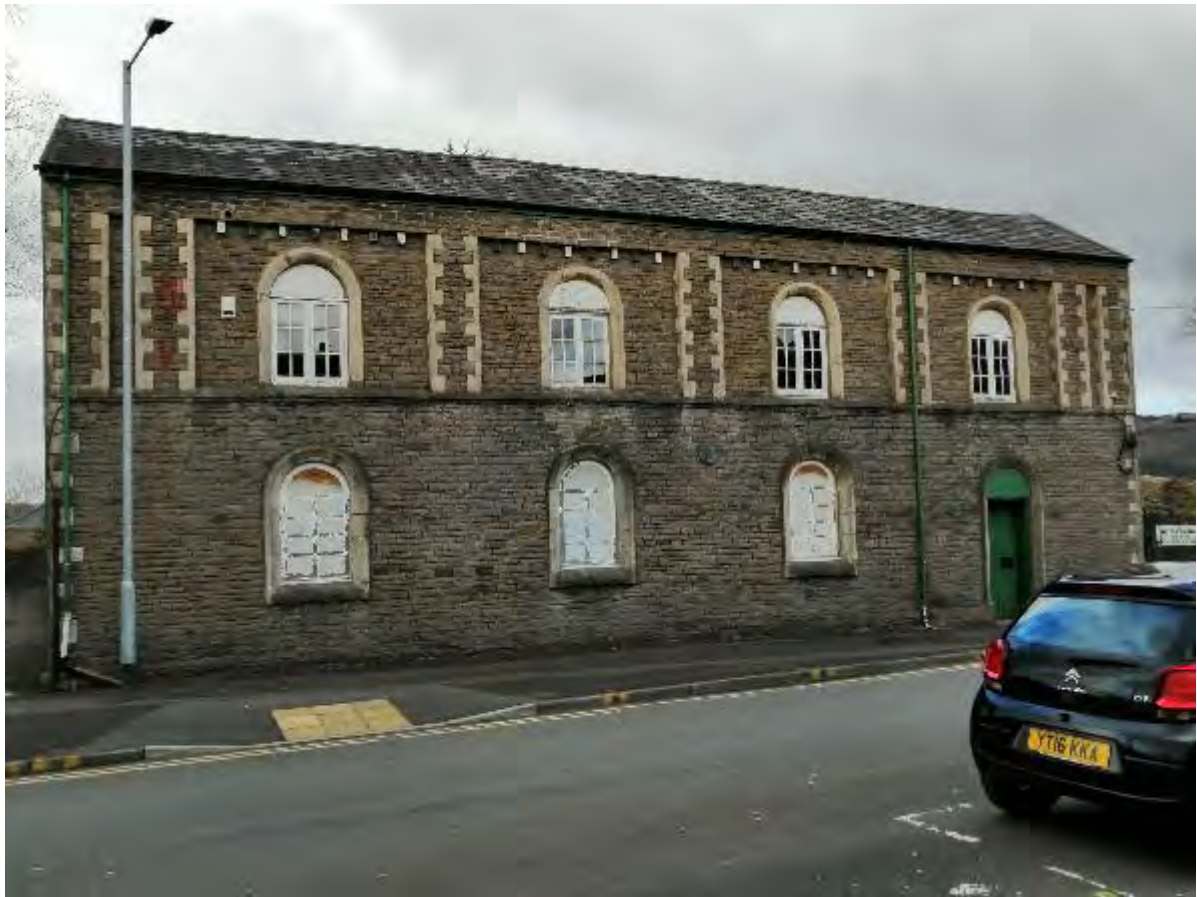
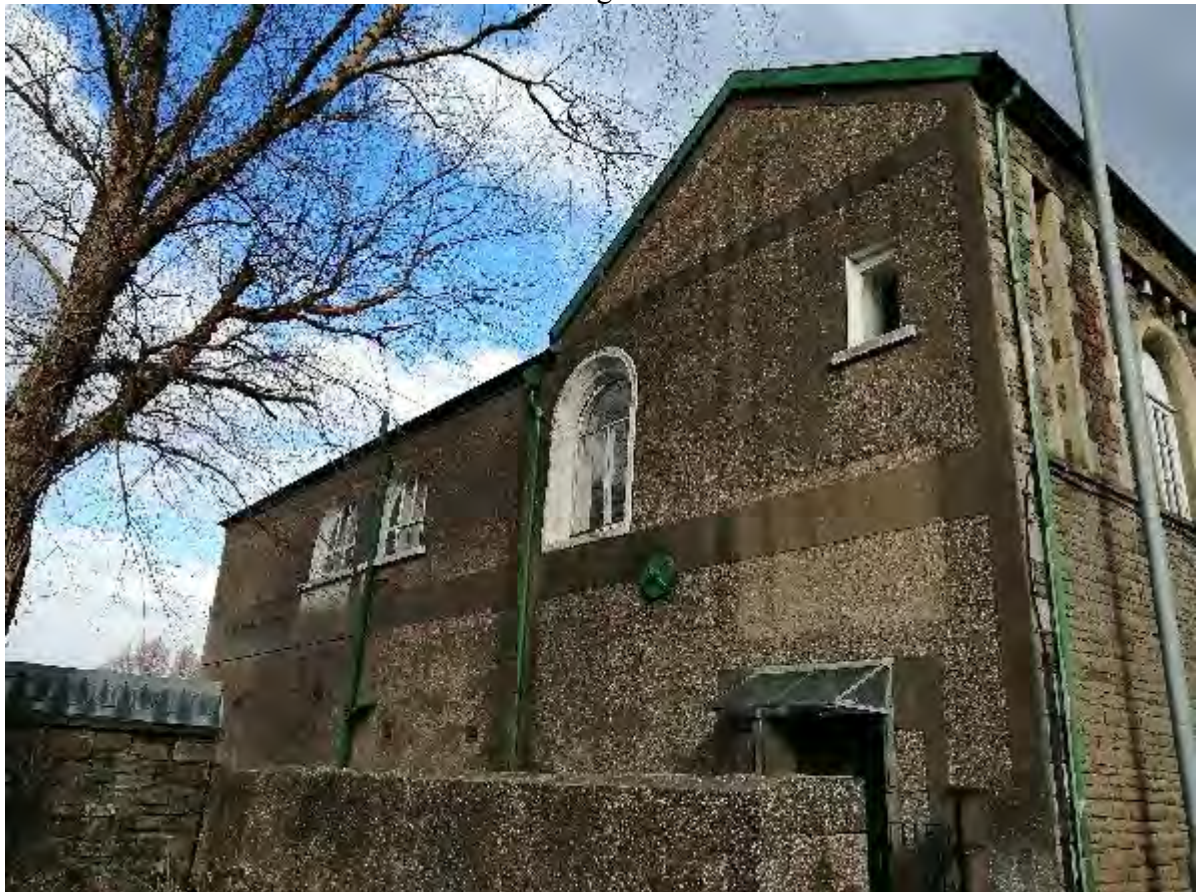
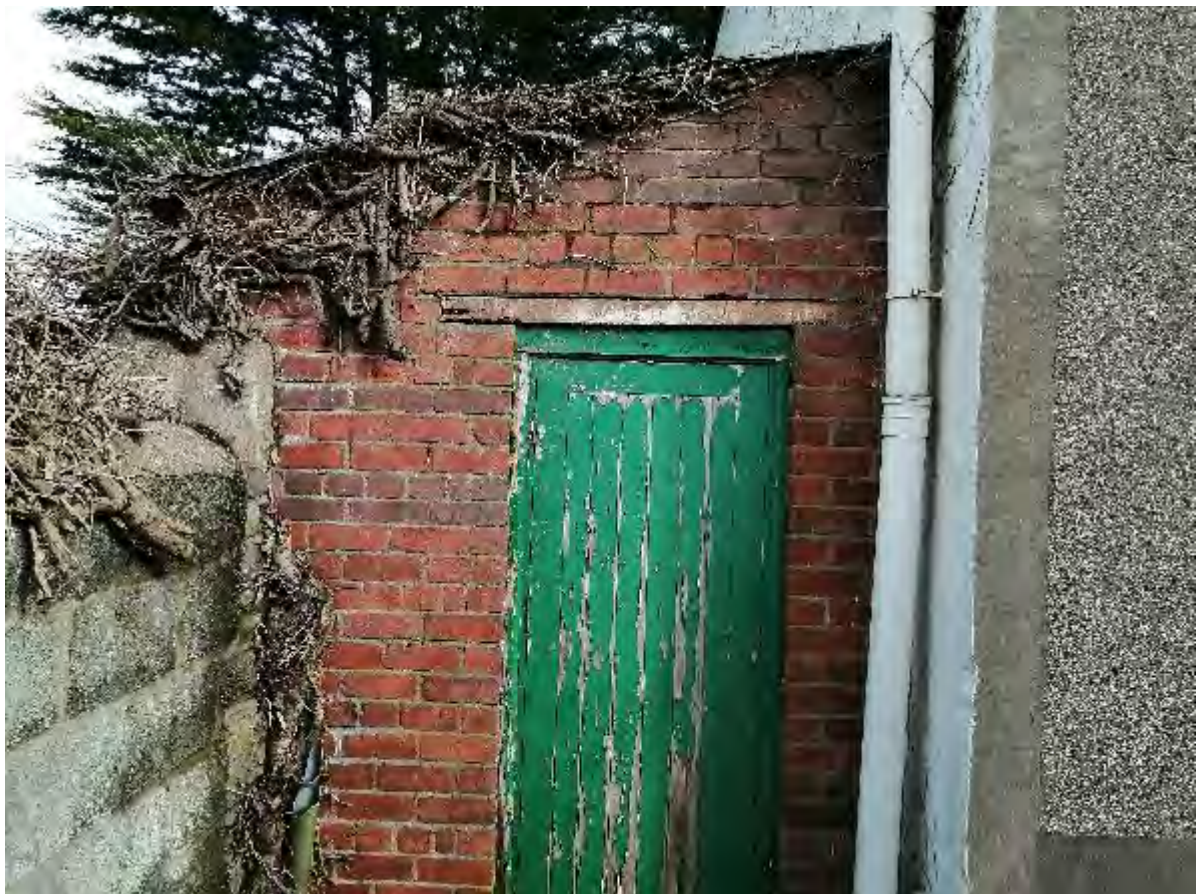
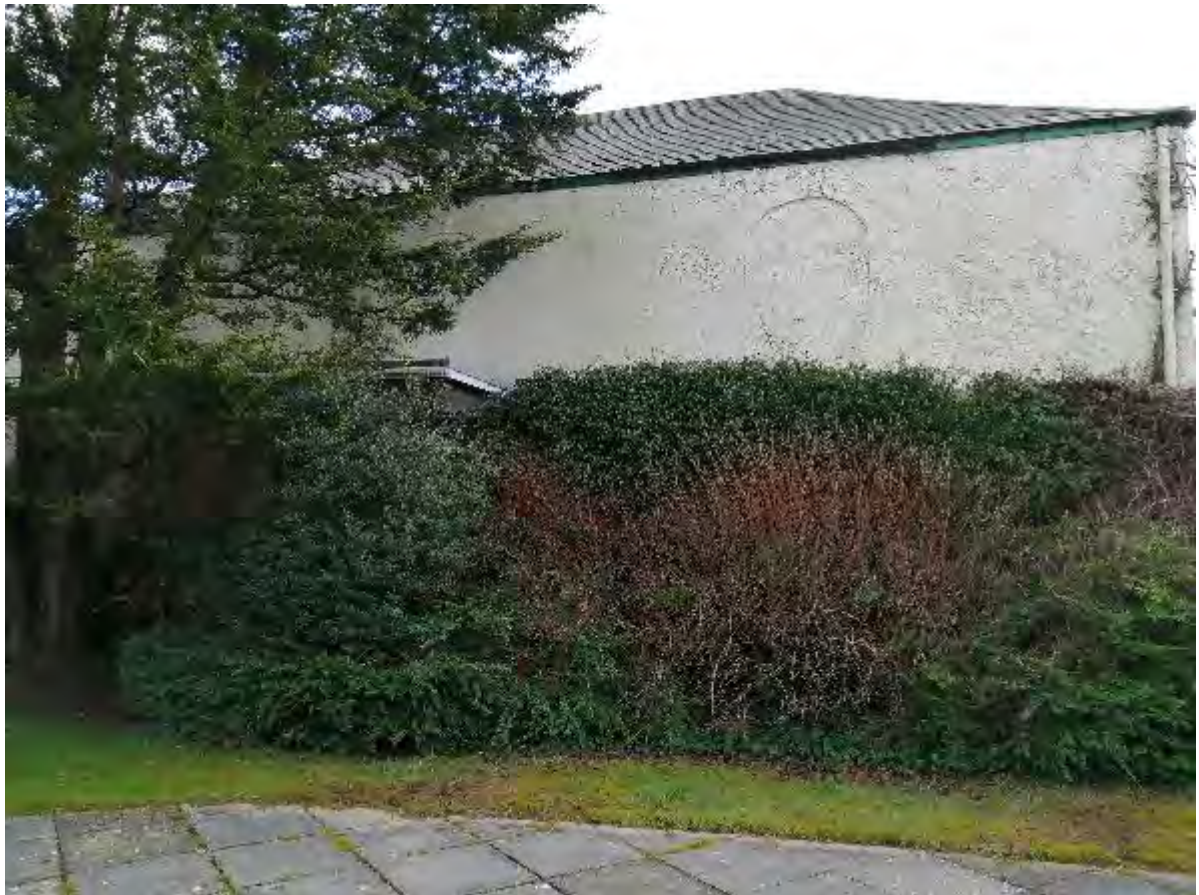
The vertical and horizontal alignment of the external walls is satisfactory, which suggests the load-bearing wall constructions continue to maintain support to the superstructure loading (i.e. roof loading, first floor loading and the load-bearing walls self-weight) – See Photos 7-11.
