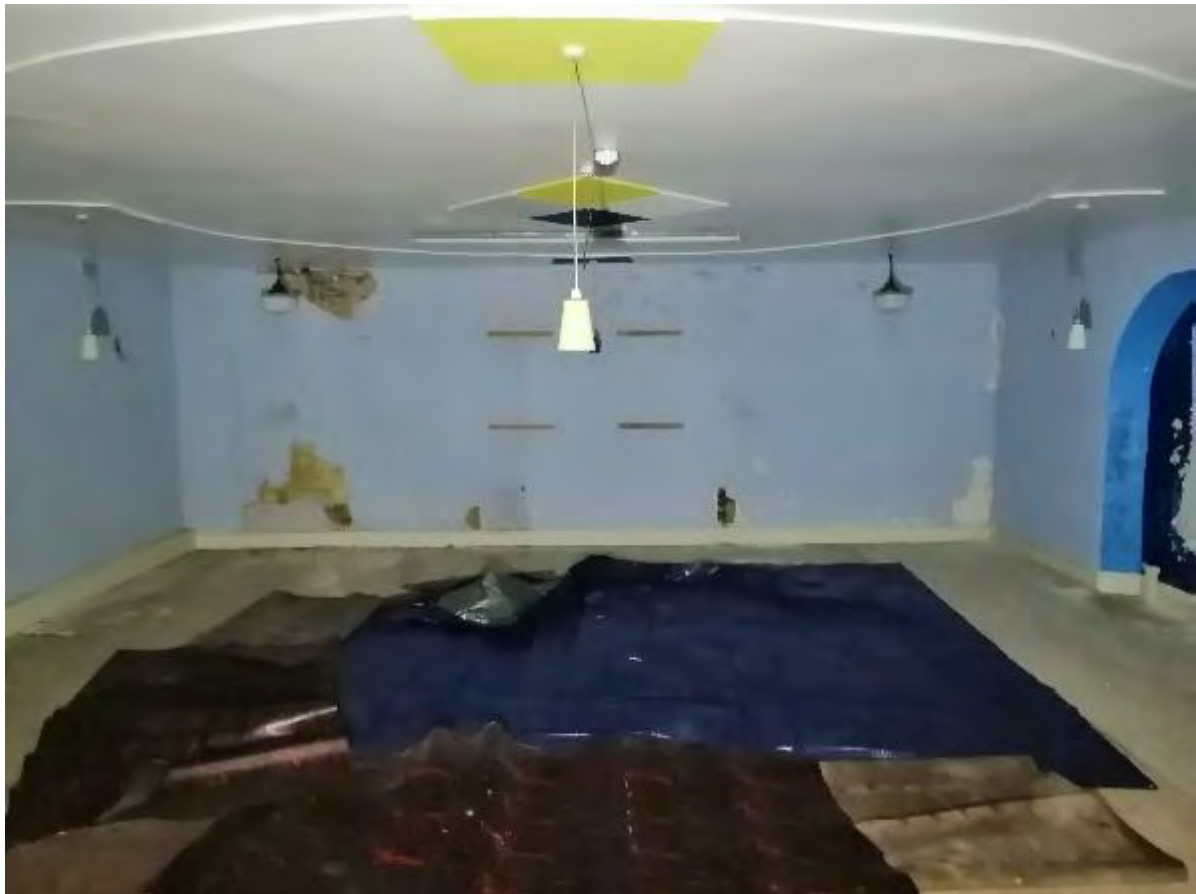
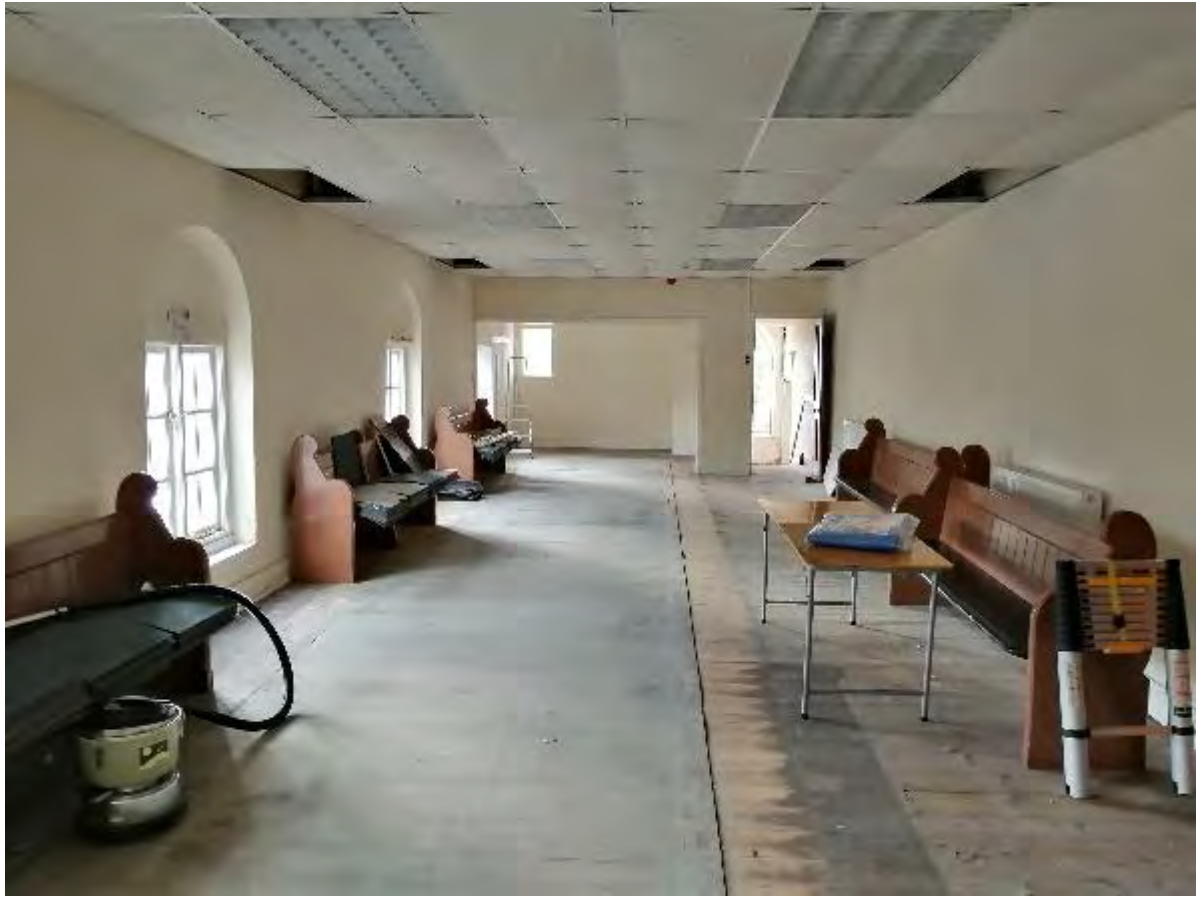
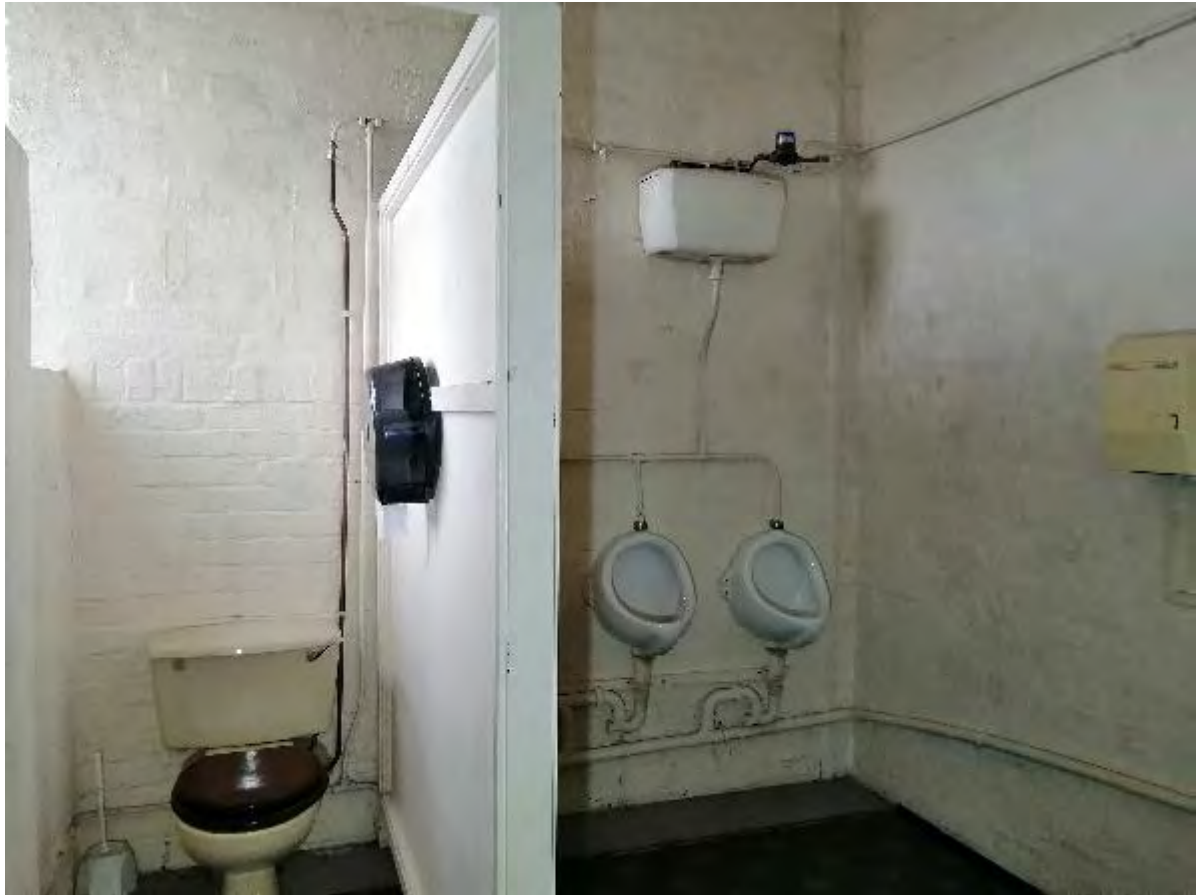
No deflection or distortion to the ceiling finishes were evident to the first floor rooms. This would suggest the horizontal timber roof beams above (which provide support to the ceiling finishes) are satisfactory from a structural perspective, continue to perform as intended and that sagging / deflection is not a concern. N.B. a number of rooms have false ceilings present and so further inspection of the void above was conducted where possible. We noted ceiling cracks to the rear room – see photos 102-112 below. These cracks are expected to be caused by minor flexure of the ceiling joists due to loading of the attic space. The cracking is considered not to be of structural concern and can be remediated through general maintenance and decoration - N.B. we recommend that all internal ceiling finishes are replaced - Condition Rating **2** See Section 7.0 Recommendations for guidance on repair works required.

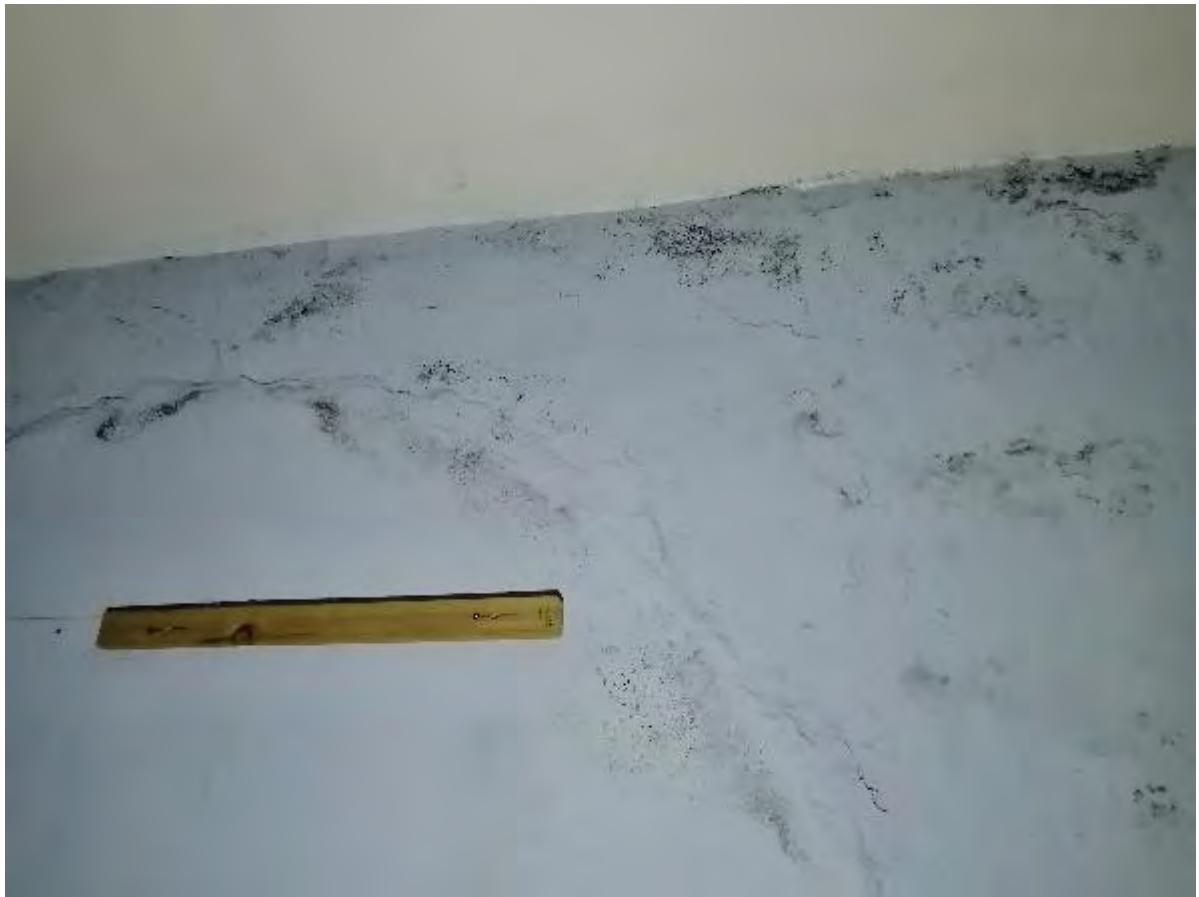
It shall be recognised that solid wall construction as adopted throughout the property offers less protection against penetrating damp when compared to cavity wall construction used in the extension. Damp can be more prevalent during winter months and can be exacerbated by cracked or defective external render and mortar joints / pointing. Damage to internal wall surfaces most commonly occur due to inadequate passive ventilation into the habitable rooms (i.e. no trickle vents or secondary locks in the window frames), where moisture and condensation is not given an opportunity to escape and ends up damaging the internal wall finishes over time (i.e. condensation damage). Condensation damp was noted in the rear room, front room 1 and male toilets – see photos 145-146, 149, 151, 153, 155 and 166 below.

To minimize and control the build up of moisture internally (and thus damage to internal wall surfaces), a passive means of ventilation is necessary as discussed above regarding trickle vents in the window frameworks - Condition Rating **2** See Section 7.0 Recommendations for guidance on repair works required.
